## ARCHITECTURAL HERITAGE IMPACT ASSESSMENT

ST KINNETH'S CHURCH Ballivor, County Meath

de Blacam and Meagher ARCHITECTS

JANUARY 2021

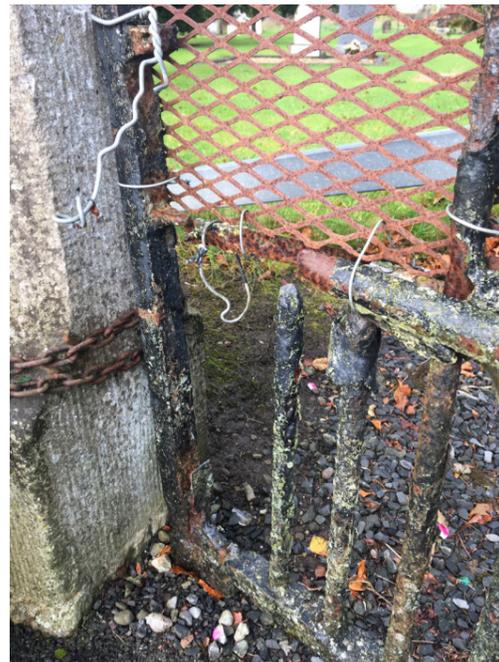
Photo of area in need of repair

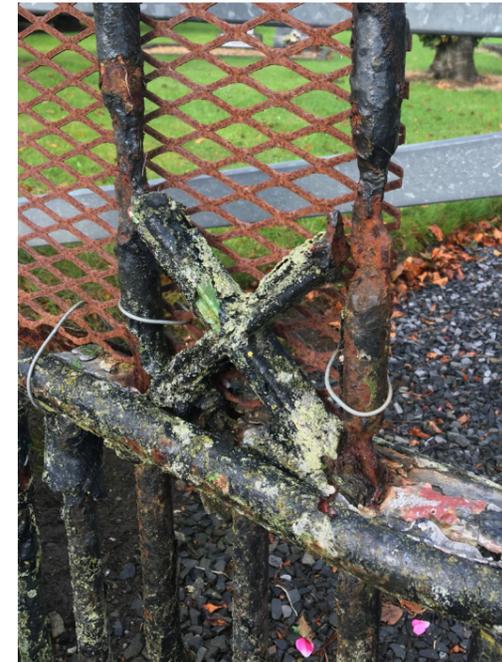
Photo of area in need of repair

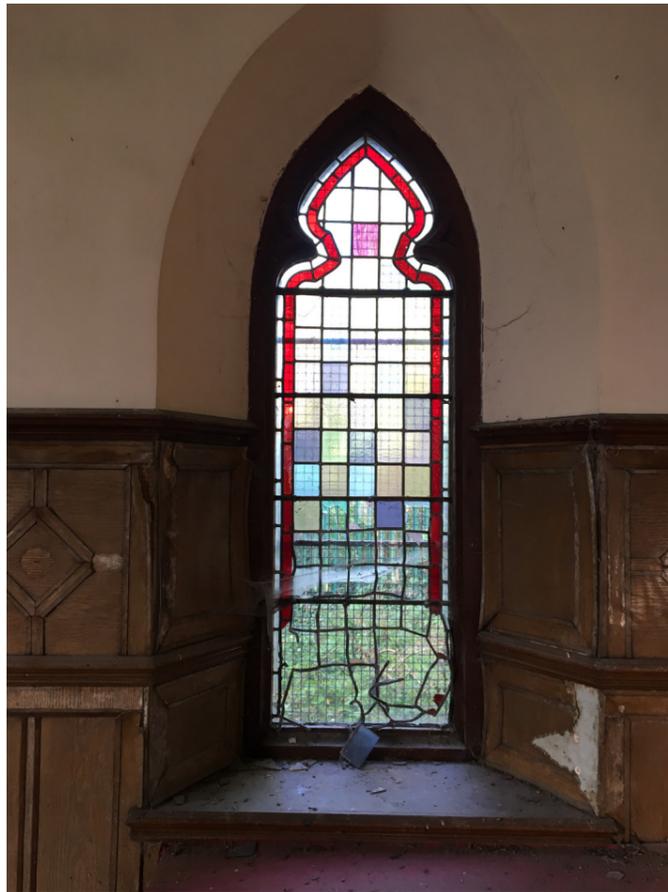
2. The bottom panels of the three stained glass windows to the chancel have been vandalised and are badly damaged. Mesh screens have since been installed on the outside to protect them.

North window

The three stained glass windows in the chancel been damaged by vandalism at the bottom 400mm of each. It is proposed that these will be repaired by a firm with specialist experience in this work, using new glass to match existing where required. It is considered that making repairs to match existing is appropriate in this instance.

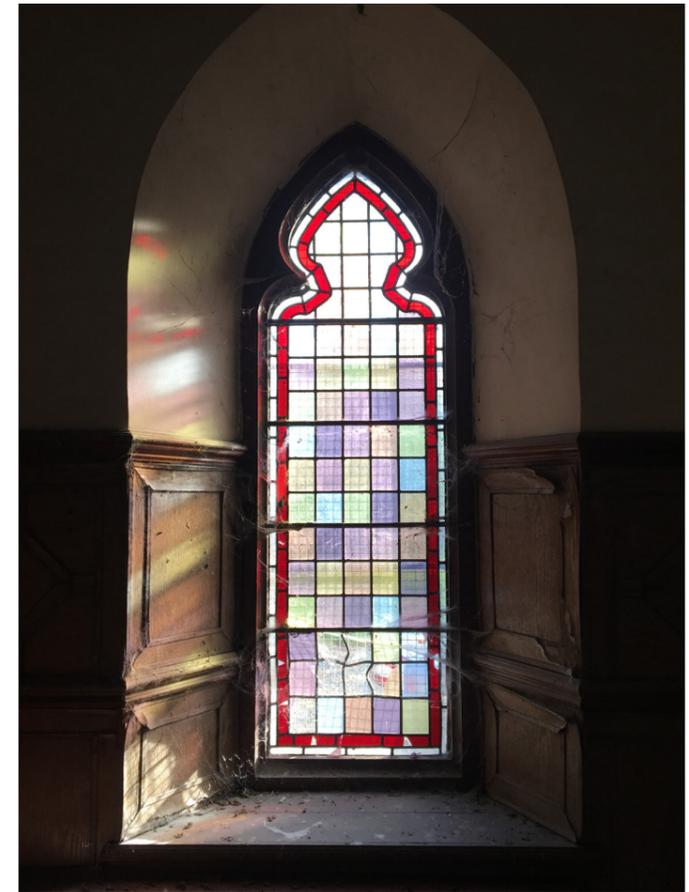
South window

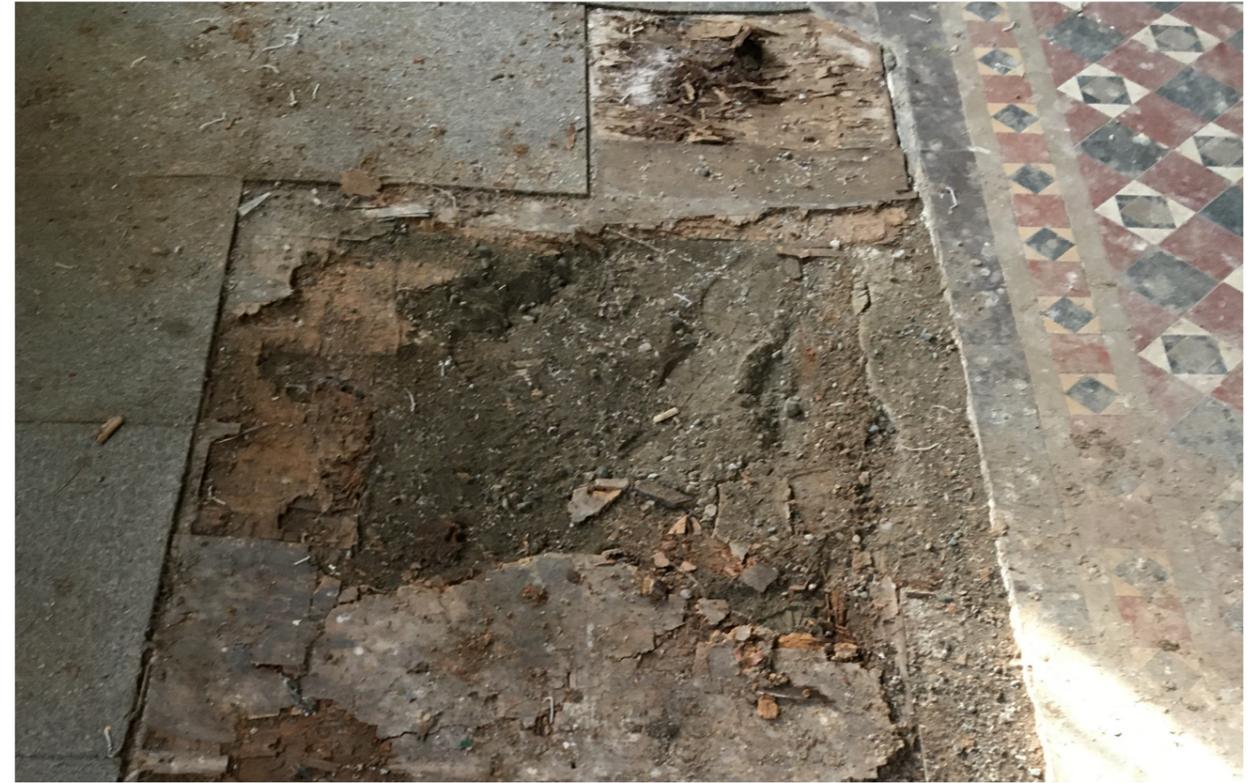
3. The floor of the nave to either side of the central tiled aisle is carpet tile on plywood laid onto soil and has disintegrated. The timber floor of the Vestry has also been damaged by installation of services.

Carpet tile on plywood on earth to either side of aisle

A. Remove carpet tiles and plywood layer on existing floor and dispose of off site. Floor boxes and trunking in these floors also to be removed. Note ceramic tiles along the centre of the floor not to be altered.

It is therefore proposed to remove the entire floor of the nave and replace it with an insulated slab and underfloor heating throughout. It is proposed that this will be finished in terrazzo to provide a high quality, natural finish, in a muted tone. The tone of the terrazzo to be similar to the tone of the stone flags in the base of the tower.

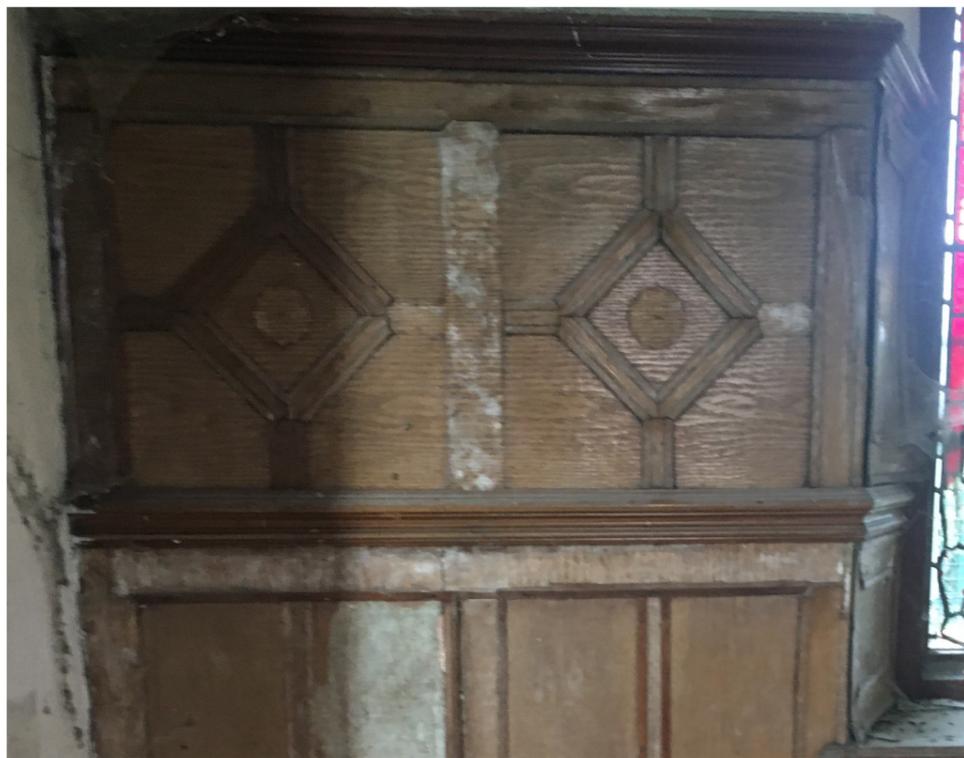
9. The veneer panelling around the chancel is disintegrating and requires to be removed.
10. The internal walls of the nave are in reasonable condition (save for the west wall as per item 1 above) but are in poor decorative repair.

Timber veneer panelling around the chancel

- Repair lath and plaster ceiling in sections where it has collapsed.
- Paint in blue with gold stars to match existing.
- Remove 1960s timber veneer panelling from the walls.
- Make good any damaged plaster using lime plaster.

The 1960s veneer panelling around the Chancel is also in poor repair and is proposed to be removed.

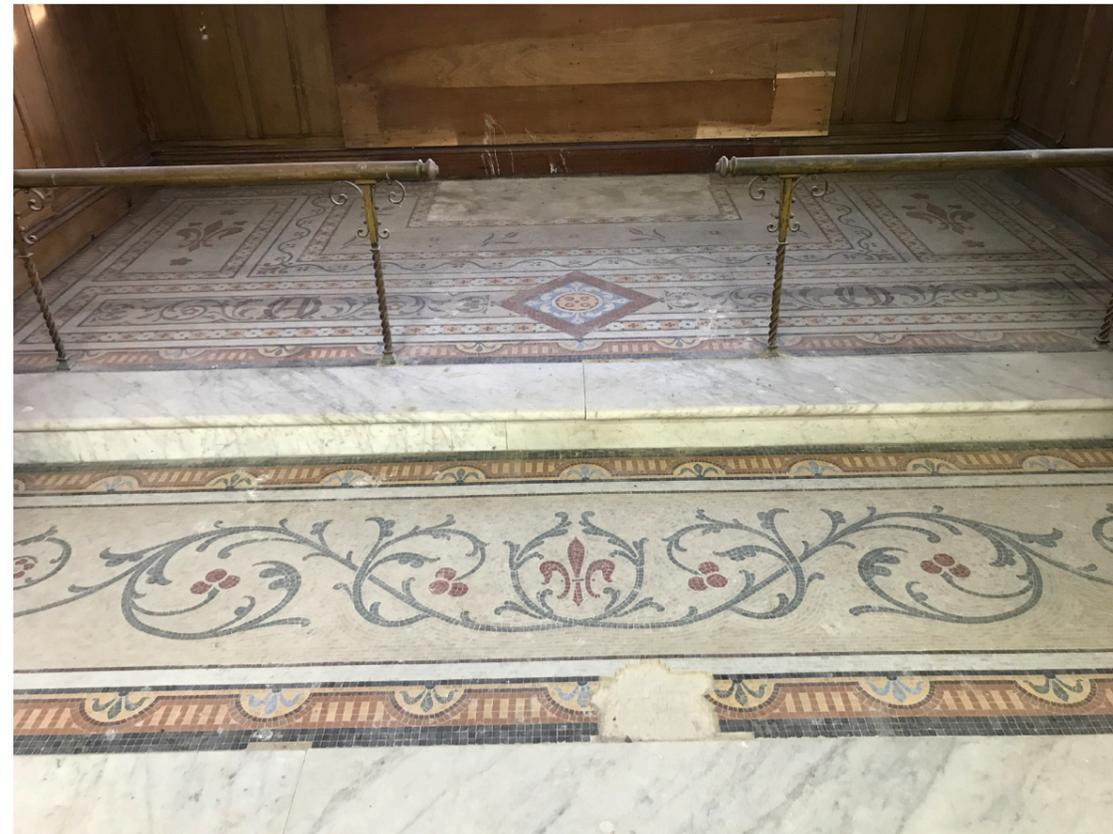
The removal of the modern built in tiered seating revealed the full extent of the stone mosaic tiling beneath. This is largely intact and in good condition. There is a rectangular section centred to the rear which has no tiles and is infilled in concrete. The border pattern on the tiles suggests that this area was never tiled and was the location of a piece of furniture. There are also minor areas where the mosaic tiles are missing and should be replaced.

Chancel floor. Note the small area of missing tiles to the front.

- Carry out minor repairs to the mosaic tiles.
- Remove 1960s veneer panelling and make good walls behind.

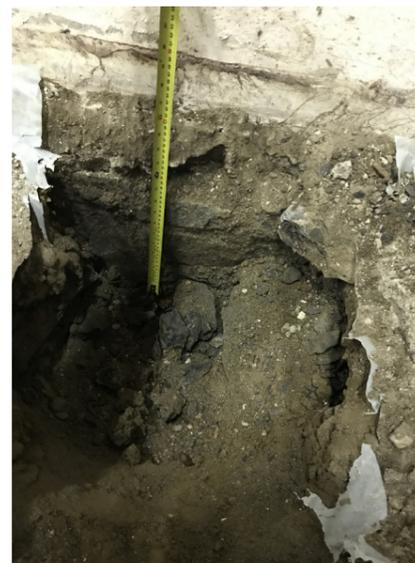
Trial hole to the edge of the nave. The external walls typically extend 500-600mm below finished floor to a stone foundation.

Trial holes and trenches have been dug which establish that the outside walls go down around 500-600mm below floor level to a crushed stone foundation. This means that a new floor construction can be installed without need for underpinning.

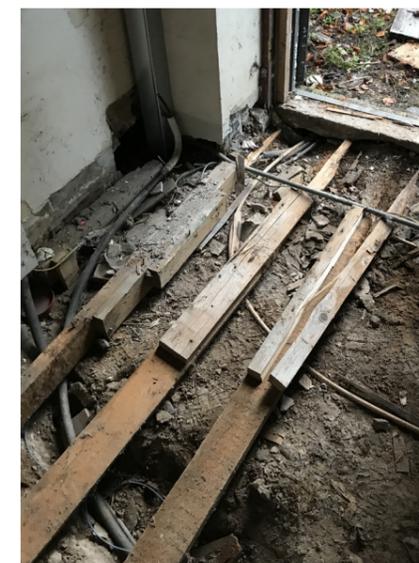
The floor boards of the Vestry were removed, revealing timber joists directly onto the soil below.

Vestry floor. Modern timber joists directly onto soil

H. Existing timber floor in vestry to be removed and disposed of off site. This is in poor repair and has been partly removed to add modern services. It is proposed to hand-dig a trial trench c. 600mm deep here to review the possibility of adding an insulated concrete slab to this area in the same manner as item B.

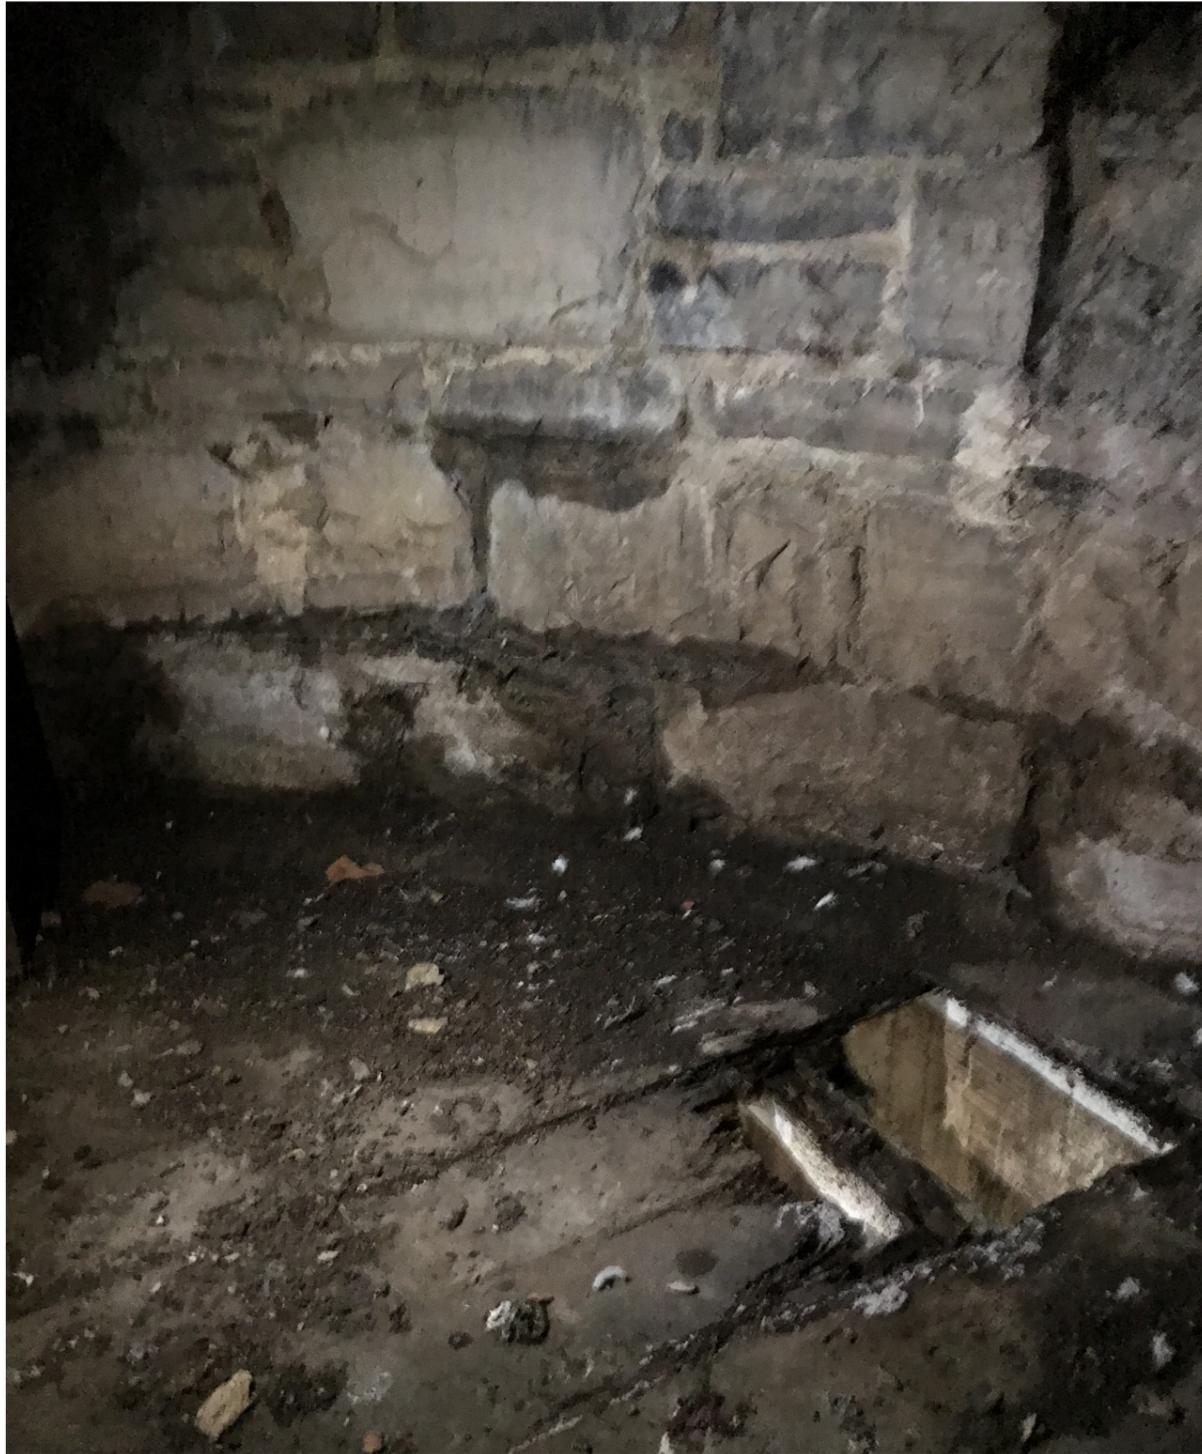
During the strip out works access was provided to inspect the interior of the tower. The stonework is in reasonably good condition, though there is evidence of damp throughout. The damp ingress appears to start at the base of the spire, which is roofed in lead, installed in the recent past. There is damp apparent on all sides of the tower, which has caused damage to the joist ends of the timber floors.

Damp patches in the wall of the tower.

There is considerable water ingress at the tower. This is evident both inside the belfry and on the west gable of the nave. It appears that the most likely source of water ingress is at the leadwork between the base of the spire and the castellations. This lead has already been replaced in the recent past but appears to have failed and the water ingress is causing considerable damage inside. It is proposed to lift and replace the lead.

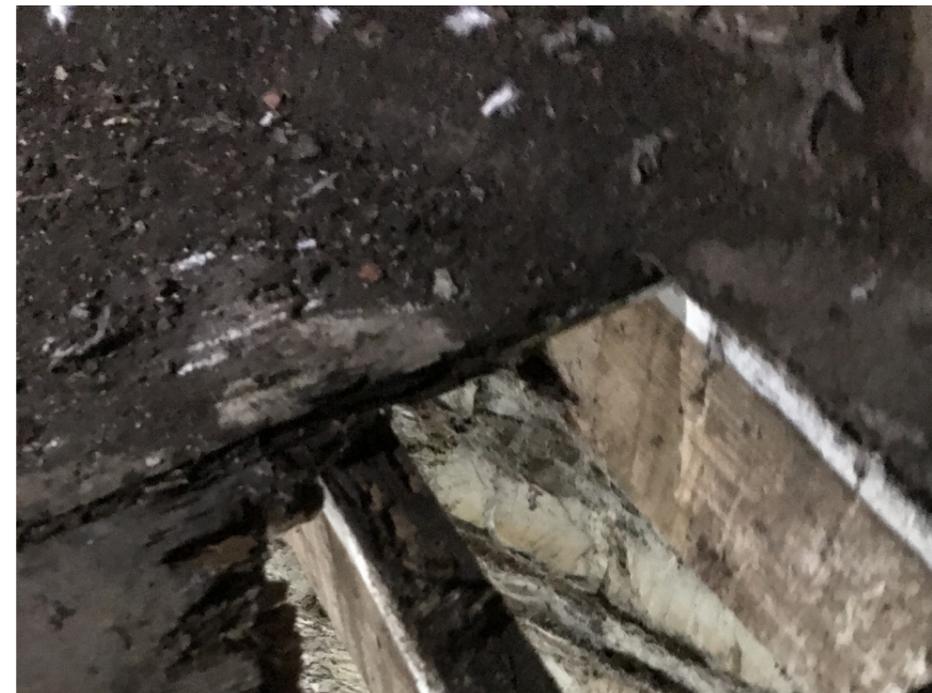
Water damaged joist ends and timber floor in the tower.
