## **Condition Report**

**Existing derelict dwelling**

**Swan Lane (Eircode C15 RD82) Balreask Old, Navan**

**Meath County Council**

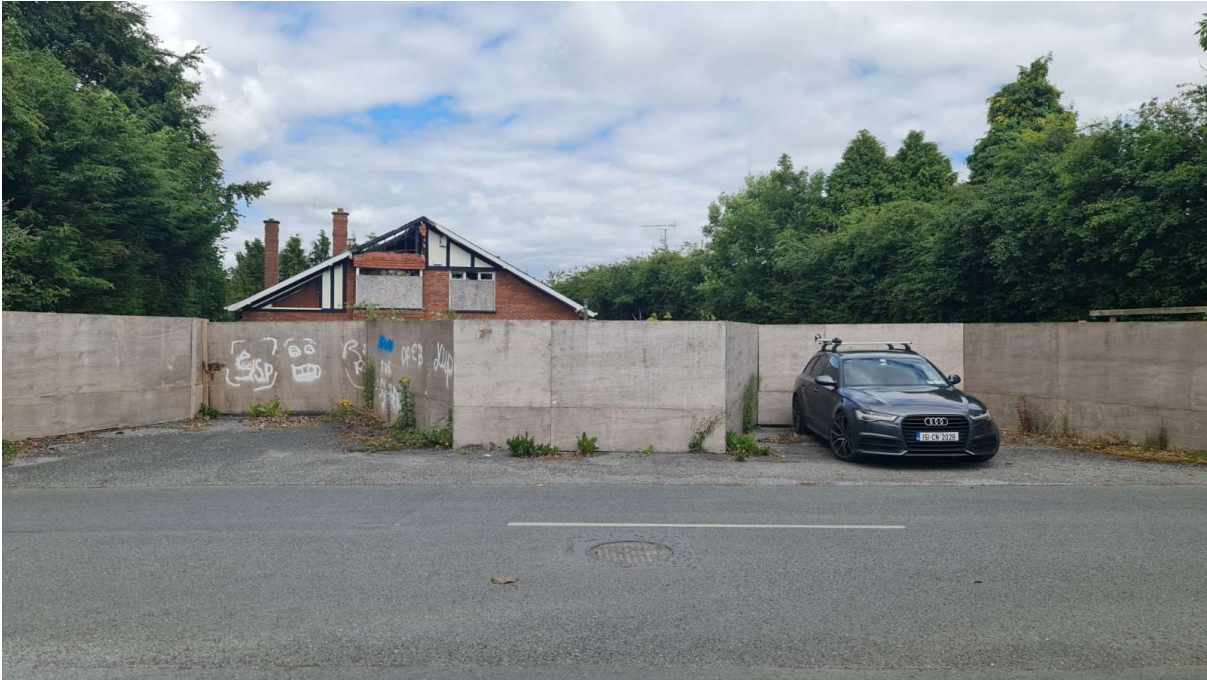
Property as seen from Swan lane.

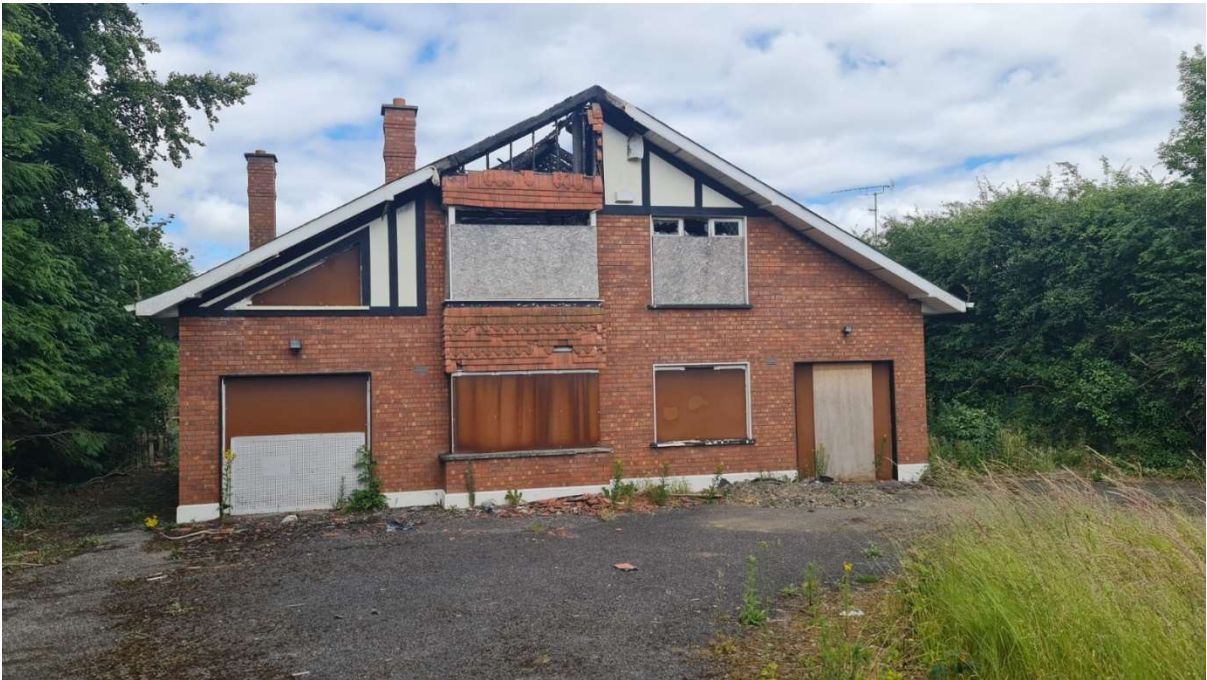
- 4.4 The roof structure and existing intermediate floors have suffered significant fire damage. The timber structures have suffered from a partial collapse and are at risk of complete collapse. The roof offers no resistance to water ingress. Whilst the perimeter walls are currently predominantly intact, the collapse of the roof structure would present a significant risk to their integrity.

Front elevation of property with partially collapsed roof and wall at high level

- 5.1 It is apparent that this property is in an extremely poor state of repair. The partial collapse of the roof and intermediate floors has resulted in the existing structure being considerably compromised. It is my opinion that the remaining fabric has suffered such extensive damage and is of such poor condition that the refurbishment and restoration of same is not feasible. As such I would recommend the demolition of this structure.

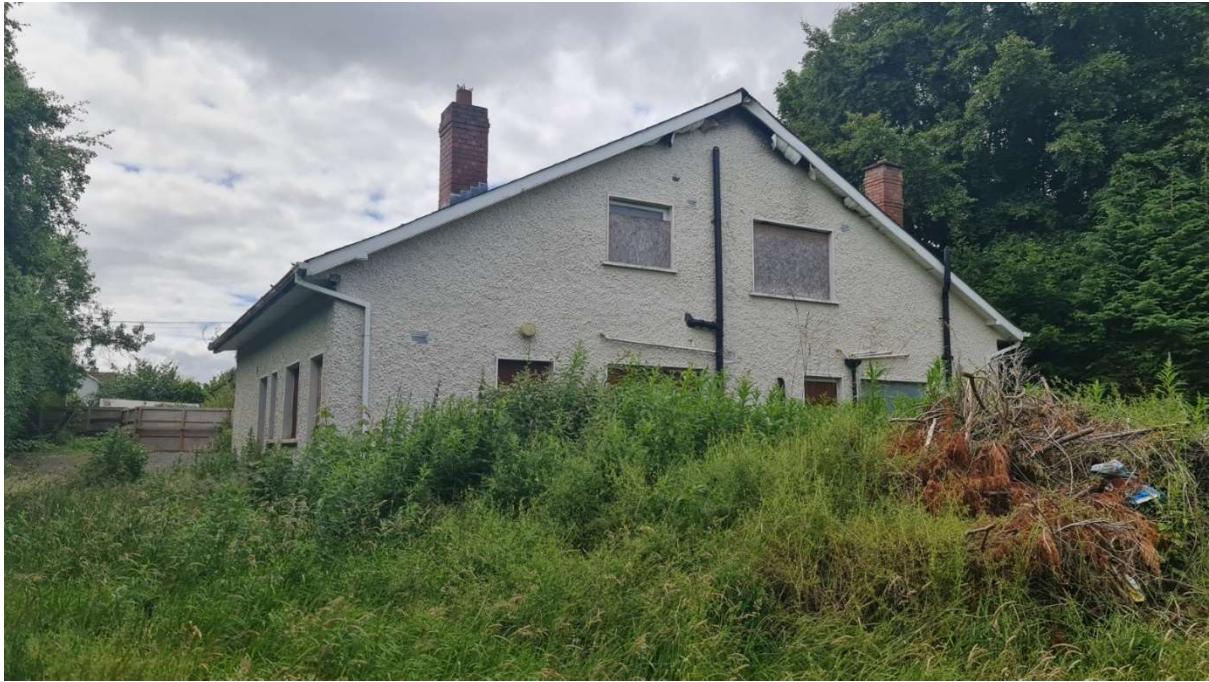
- 4.7 Extensive vegetation growth has concealed all external surface and foul drainage, as such it was not possible to examine their condition.

Rear elevation, with significant overgrowth in the foreground.

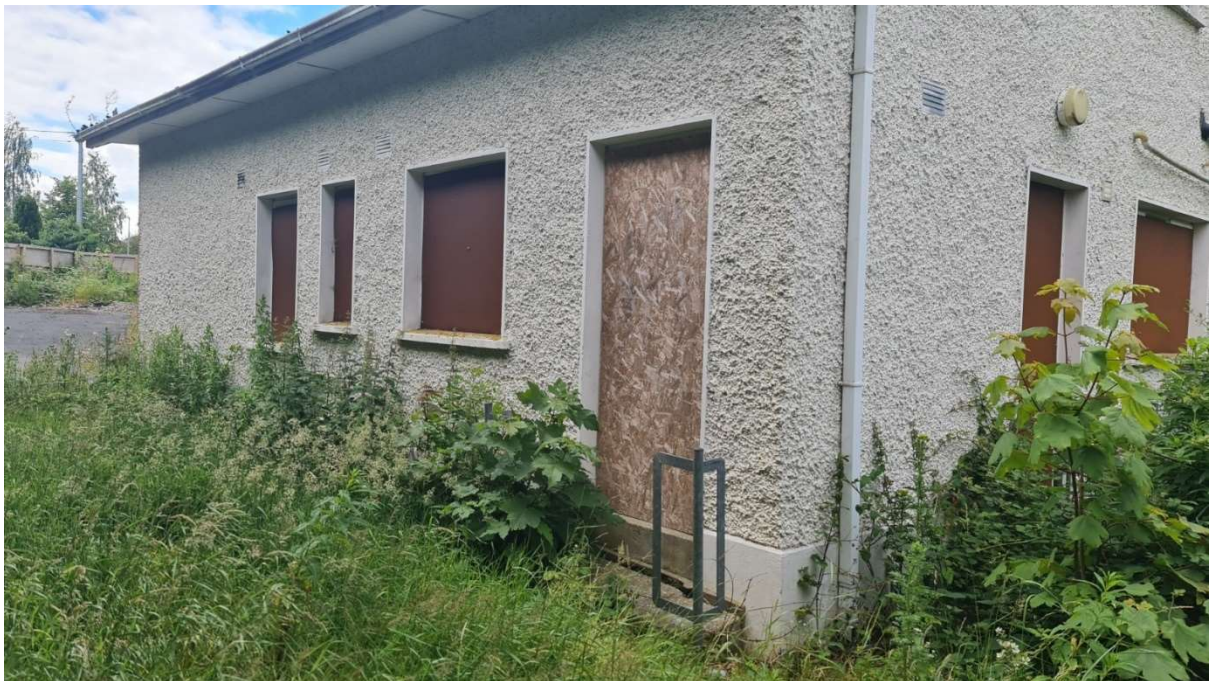
- 4.5 Internal partitions and all internal joinery, fixtures and fittings have suffered severe damage.
- 4.6 The existing windows and doors have suffered from significant damage and retain no functionality. These are currently boarded up with plywood and metal to prevent access to the building.

Side elevation with all opes boarded up.

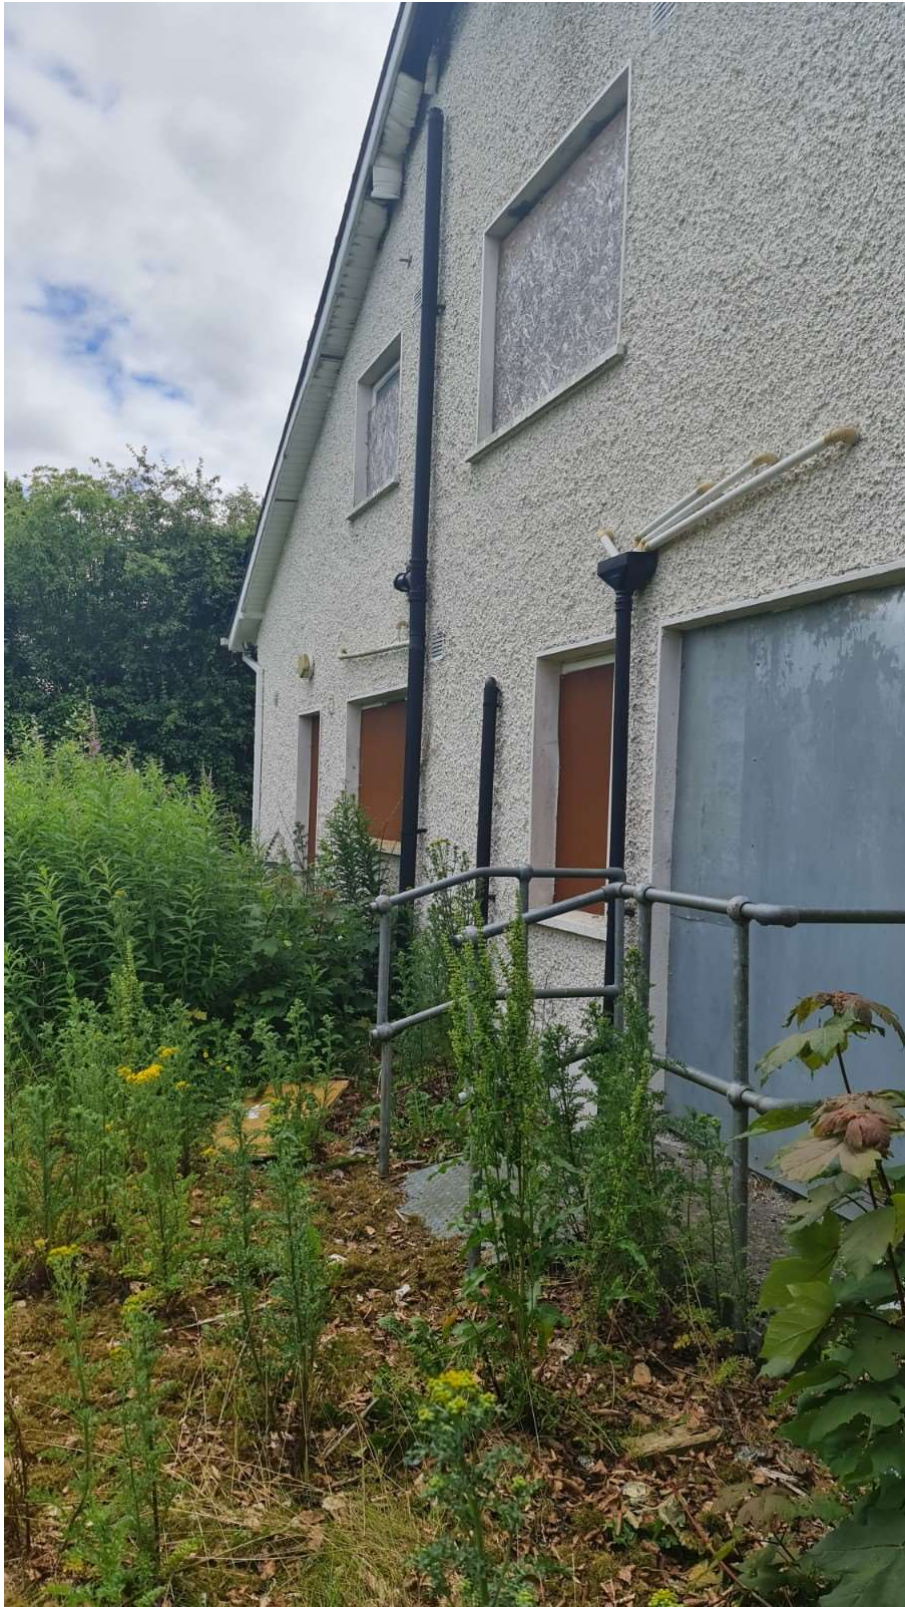
Close up of rear elevation, with all opes boarded up.
