## **Condition Report**

**Existing derelict dwelling**

**Pitcher Lane, Kells, Co. Meath (in the townlands of Townparks and  
Archdeaconry Glebe)**

**Meath County Council**

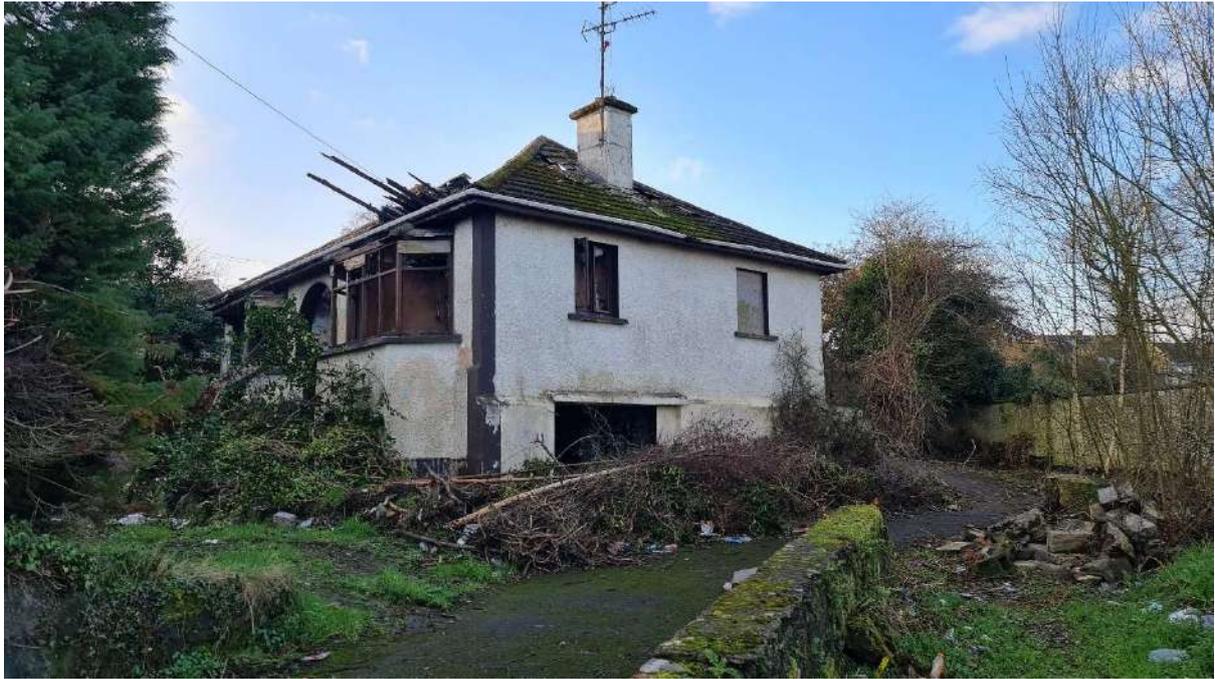
- 4.4 The roof structure and existing intermediate floor have suffered significant fire damage. The timber structures have suffered from a partial collapse and are at risk of complete collapse. The roof and window offer no resistance to water ingress. Whilst the perimeter walls are currently predominantly intact, the potential further collapse of the roof structure would present a significant risk to their integrity.

Front & north-east elevations of property with partially collapsed roof and significant overgrowth in the foreground

- 5.1 It is apparent that this property is in an extremely poor state of repair. The partial collapse of the roof and intermediate floor has resulted in the existing structure being considerably compromised. It is my opinion that the remaining fabric has suffered such extensive damage and is of such poor condition that the refurbishment and restoration of same is not feasible. As such I would recommend the demolition of this structure.

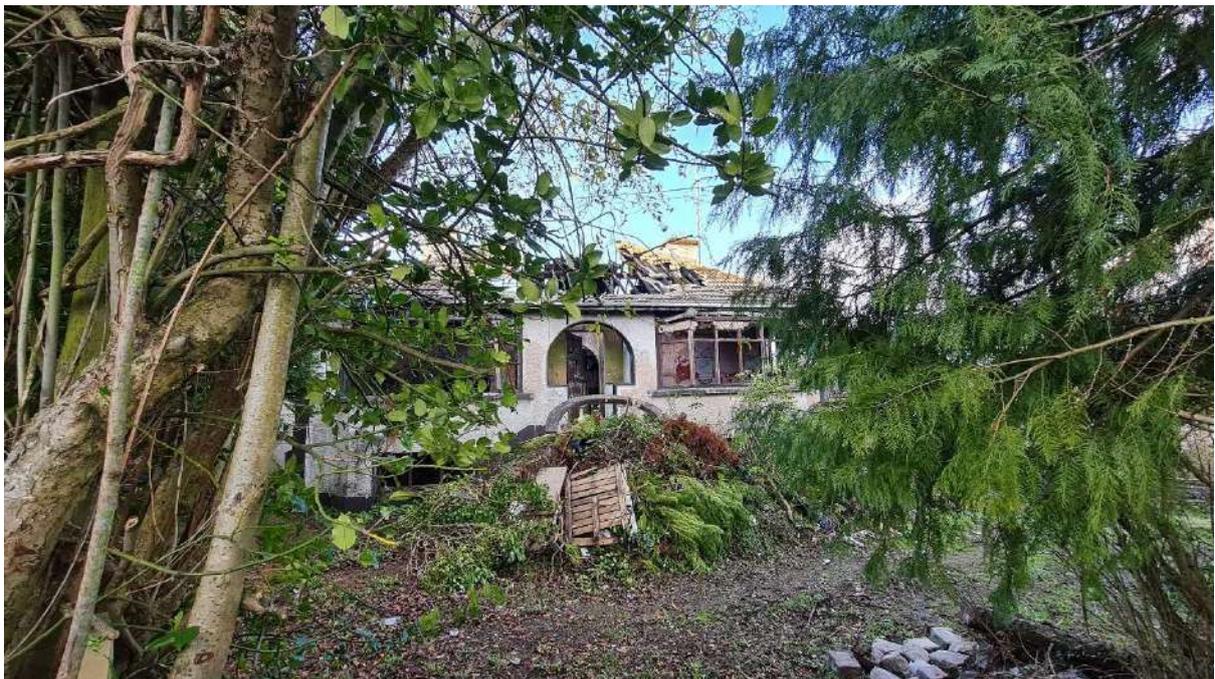
- 4.5 Internal partitions and all internal joinery, fixtures and fittings have suffered severe damage.
- 4.6 The existing windows and doors have suffered from significant damage and retain no functionality. Some are currently boarded up with plywood to prevent access to the propoerty but the majority are damaged and accessible (however the site hoarding restricts access to the site).

Front elevation, with partially collapsed roof and damaged windows

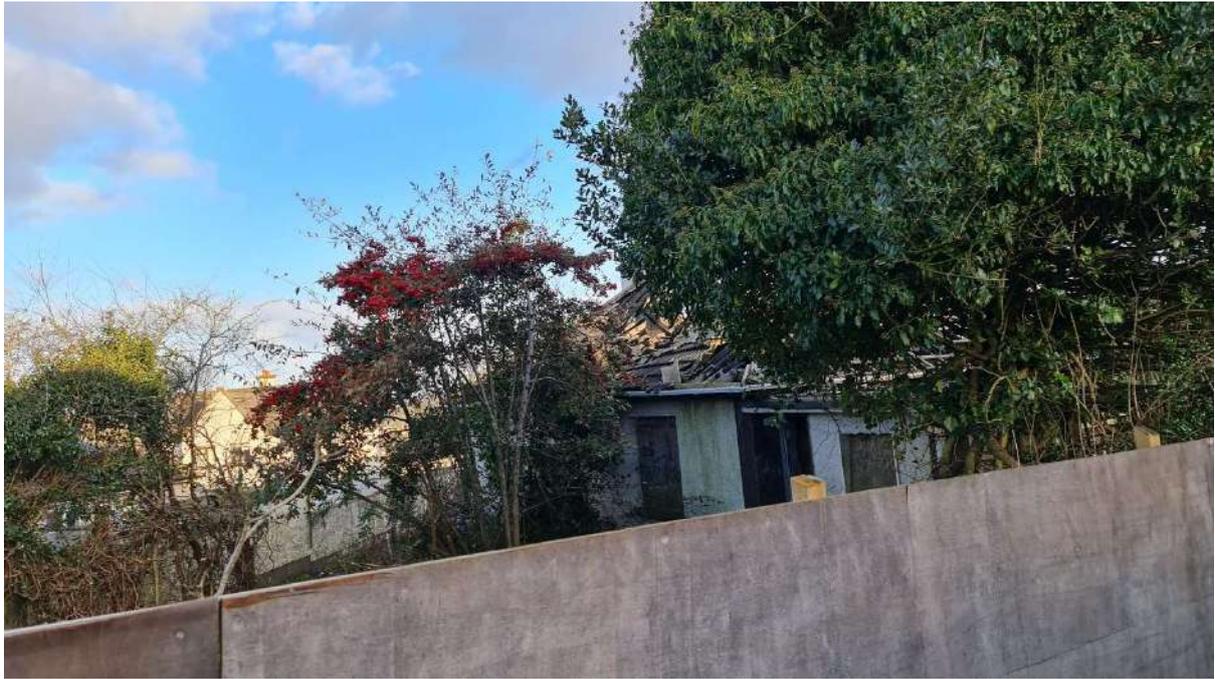
Rear elevation with opes boarded up
