**ARBORICULTURAL ASSESSMENT
IMPACT
&
TREE PROTECTION REPORT**

**OLDCASTLE
CO. MEATH**

Project No.	Project name	Date	Revision
TOLD004	Oldcastle Public Realm	22/05/23

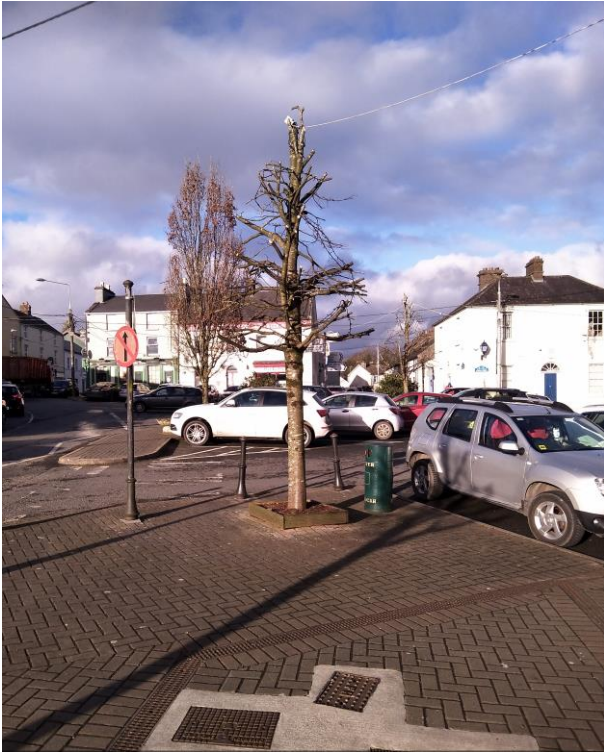
It should be noted that limes and hornbeams respond well to pruning so although the degree of pruning could be considered excessive their future management could allow them to develop into defined shapes to give them an architectural quality whilst reducing their potential impact on neighbouring buildings. The same options are not available for the management of the fastigate oak which should only be pruned in response to structural issues or storm damage etc. The narrow nature of the oak crowns limits their potential impact on adjacent buildings.

Image 2. Lime.
Note extensive canopy reduction

There has been a tendency for small areas to be created at the base of trees (images 2, 3 & 4) into which summer bedding is planted. This could lead to a degree of bark damage from soil contact where rings separating the soil from the tree trunks are not in place. From an arboricultural management viewpoint, it would be preferable for these planters to be removed and replaced with tree grills or permeable surfaces to allow more water to reach root zones.

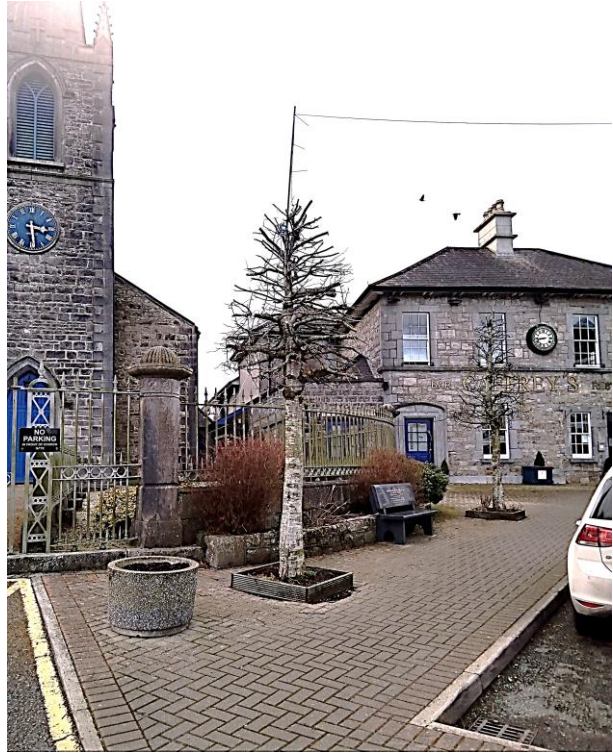
Image 3. Hornbeam in front of St Brides Church
Note extensive canopy reduction

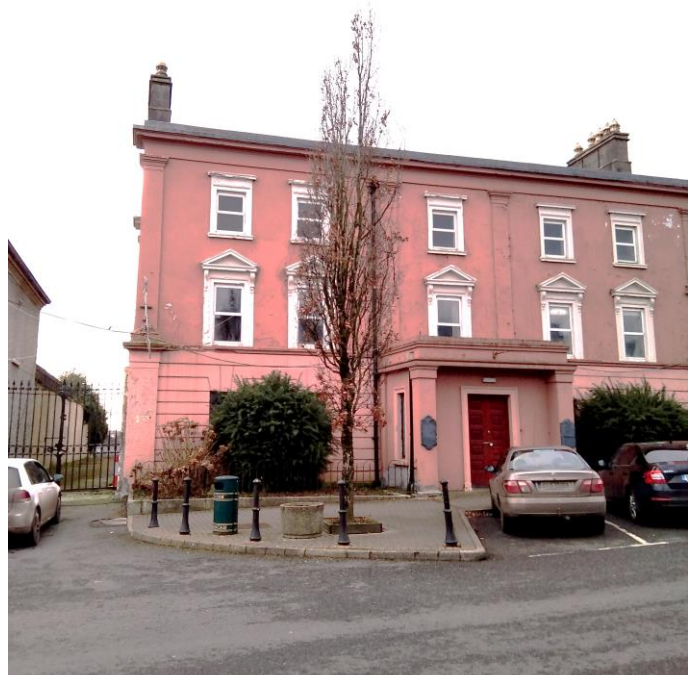
Image 4. Fastigate oak. Note planting area at base of tree.
