CUNNANE STRATTON REYNOLDS

TREE SURVEY

Pedestrian / Cycle Scheme,
Ratoath,
Co Meath.

March 2022

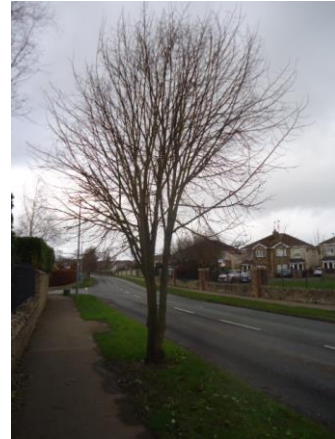
T85

3.6 A total of 9 trees (T85-89 & T139-142) are in direct conflict with the layout are proposed for removal along the Woodlands Park and Steeplechase Roads to facilitate the scheme. Although relatively young all these trees have been classified as B2 class primarily for their cumulative value as part of a larger roadside tree planting group.

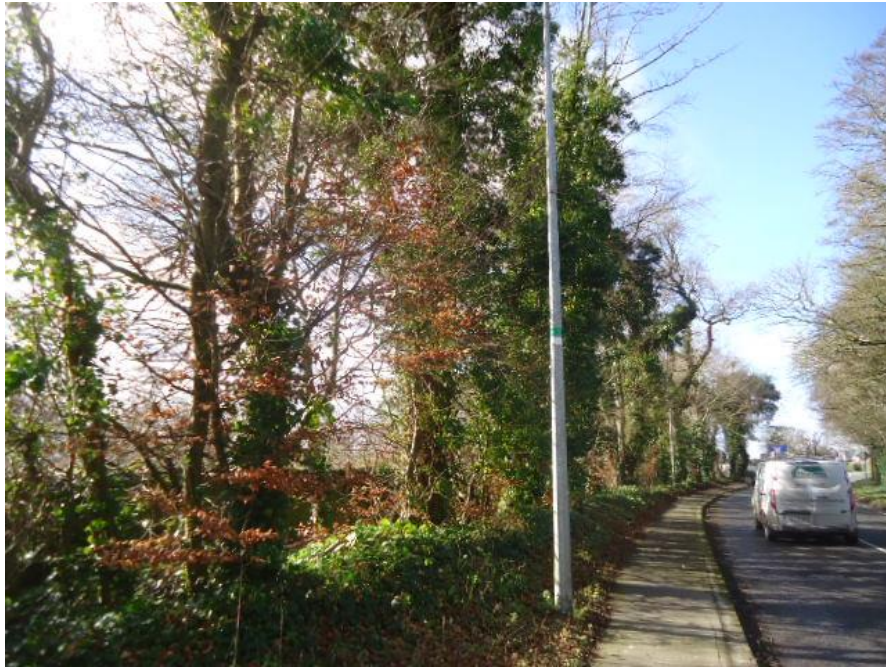
Tree Group 1 is located along the Dunshaughlin Road. This group contains a mix of mature and juvenile trees that are somewhat overcrowded but generally in good health.

3.5 It is worth considering, as part of an ongoing management program, the selective thinning of a limited number of young trees within Tree Group 1. Removing those specimens which have bolted, and or are of relatively poor form, will facilitate improved development of other trees within the group which are currently overcrowded and have inadequate space for strong future development.

Most of the larger trees within this group are obscured by ivy, (which should be carefully removed to facilitate full inspection), however they appear to be in good physiological condition in general. Given their roadside location it would be prudent to consider a crown cleaning exercise to remove rubbing limbs, future compression forks and also reduce the length of limbs overhanging adjoining carriageway along with any other imbalances in growth.

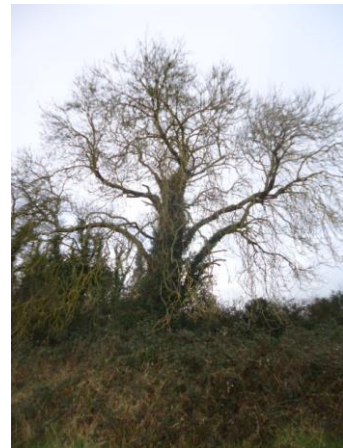
T145

3.2 Category 'U' trees are recommended for immediate removal, (fell or monolith to safe height), on general management grounds, irrespective of site development – eight were identified during this survey (T144, T145, Tree Group 2, part of Tree Group 4).

It is evident that Ash Dieback Disease had taken hold in at least eight of the trees located along the Fairyhouse Road. These trees are predicted to die over the following few years and as such it is recommended that they are felled to minimise the potential for falling deadwood as well as the spread of the disease to other trees. Unfortunately, it is considered likely that the disease may have already infected some adjacent Ash trees nearby, with possible early symptoms already suspected in some.

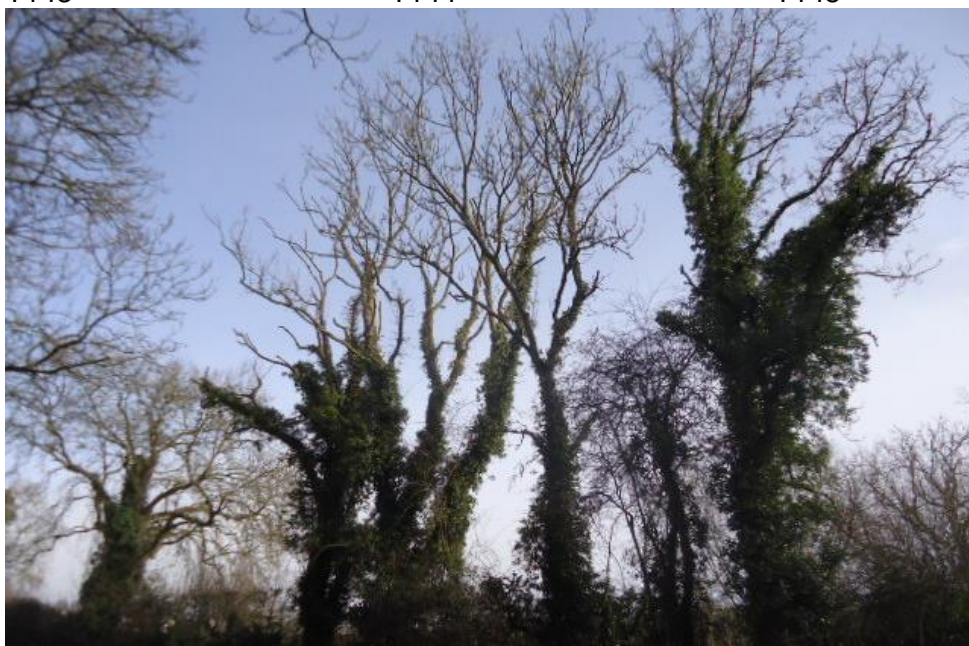
Tree Group 2

The trees (T143-145) / tree groups (TG2-4) situated along the Fairyhouse Road are contained within hedgerows and field boundary scrub vegetation. These are a mix of relatively young trees many of which have 'bolted' (due to overcrowding and the resultant competition for light), interspersed with a smaller number of more mature trees. Most of the trees present are Ash, though a small number of Sycamore are also present. Some Ash trees have already succumbed to Ash dieback disease, while others appear to be displaying symptoms.

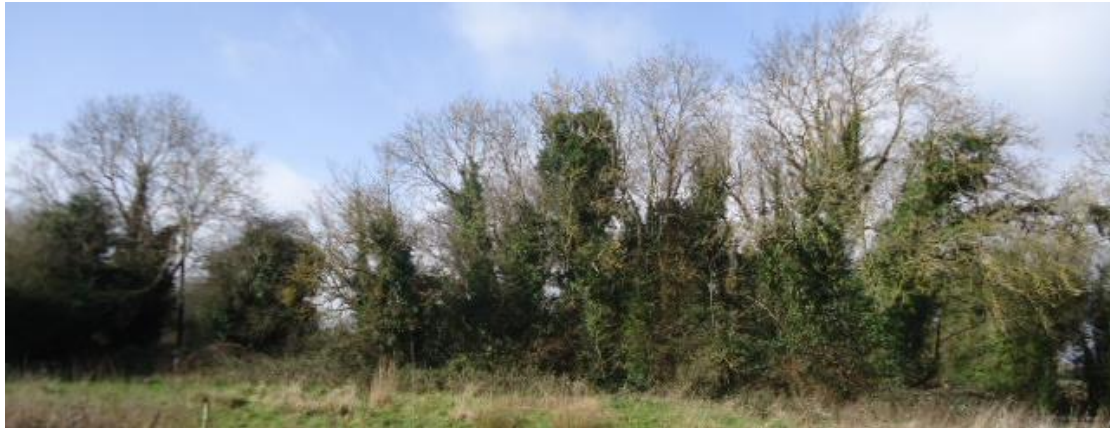
Tree Group 3

Mature trees/tree groups located along the Fairyhouse Road are also in direct conflict with the proposed path/cycleway alignment. The majority of these tree are Ash and most appear to be suffering from or already succumbed to Ash Dieback disease. Given the very strong likelihood the few remaining Ash trees will also become infected and die over the short to medium term, it is not considered worthwhile using the non-dig cellweb system in this location. Replacement planting with suitable native tree species would significantly mitigate against the loss of trees and hedgerow in this location.

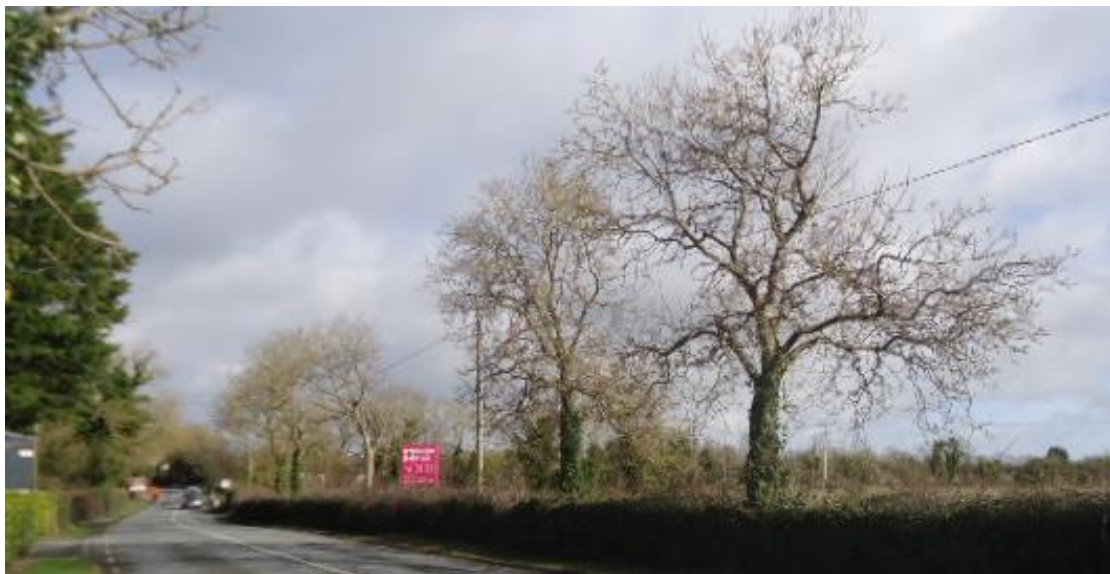
Some additional trees are also in conflict long the Fairyhouse Road, primarily due to their root protection areas clashing with the proposed scheme layout. These are as follows; one B class (T143) and two U class (T144 & 145) mature Ash trees require to be removed. In addition one U class tree group (TG2) and one B class tree group (TG3) as well as two B class and two U class trees within Tree Group 4 require to be removed.
