Structural Report

Derelict Properties at

42,43 & 44 Brews Hill,
Navan,
Co Meath.

Meath County Council

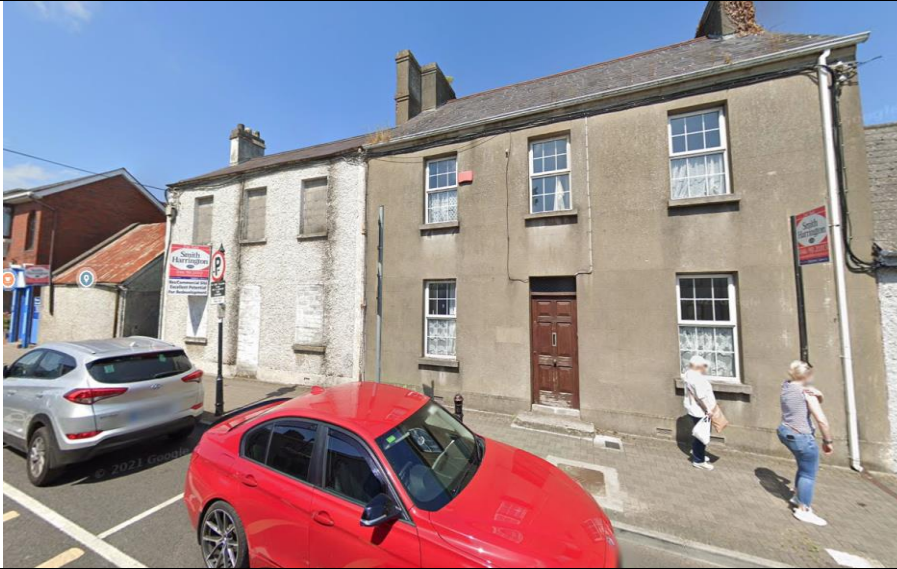
3.

Streetscape from 42 to 44 Brews Hill.

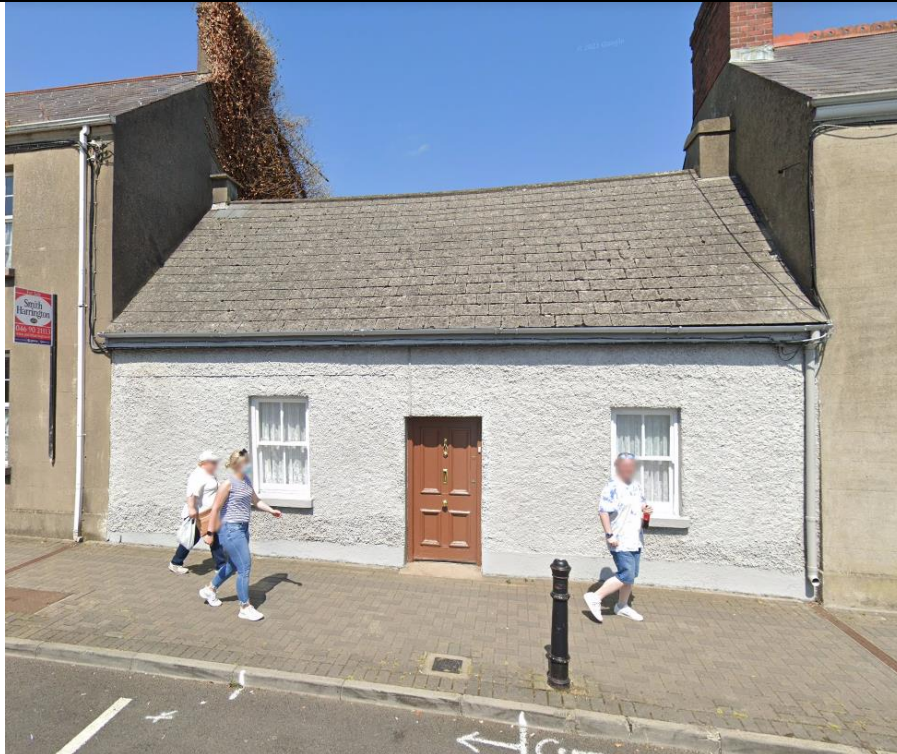
4.

Adjoining property to 44 Brews Hill which has a shared boundary/ party wall.

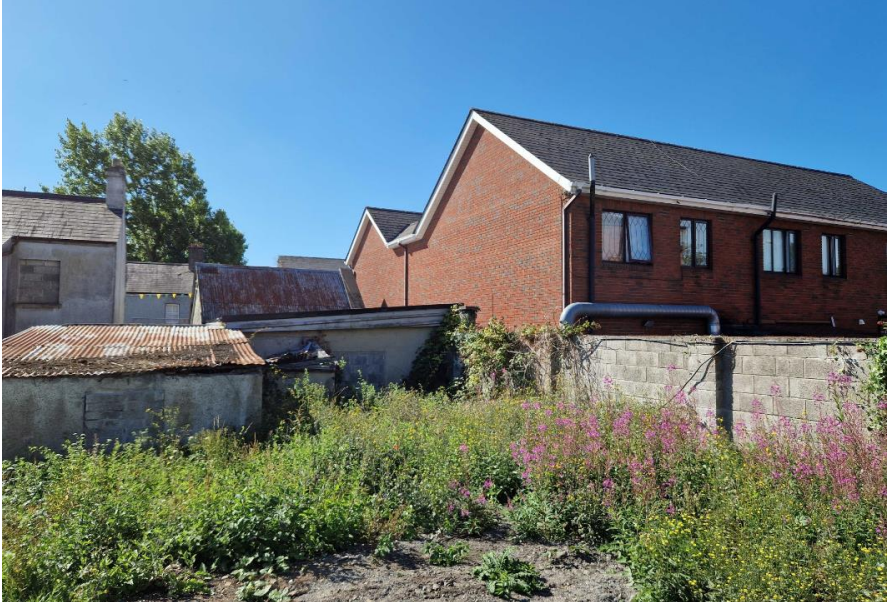
7 .

More recent adjoining brick building which is not connected to property.
8 .

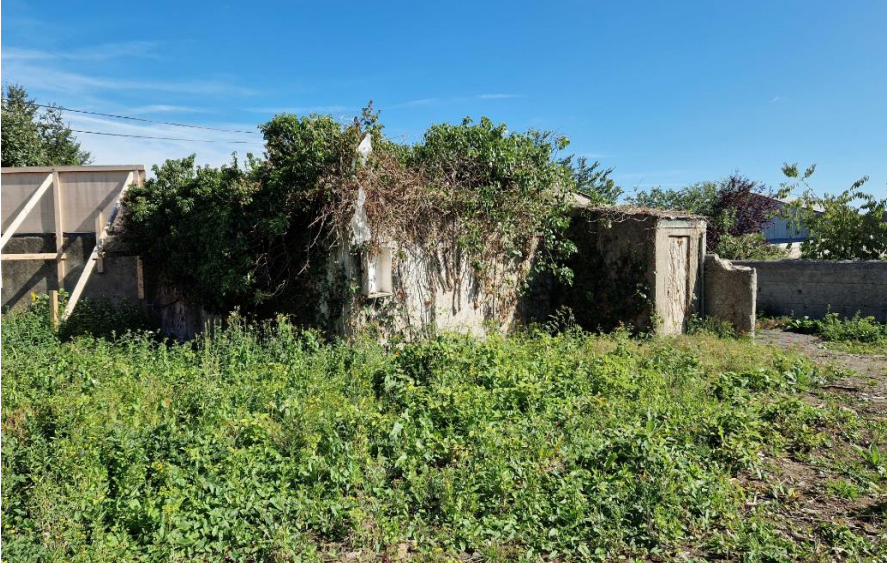
Sheds to rear of site overgrown in ivy and in poor condition.

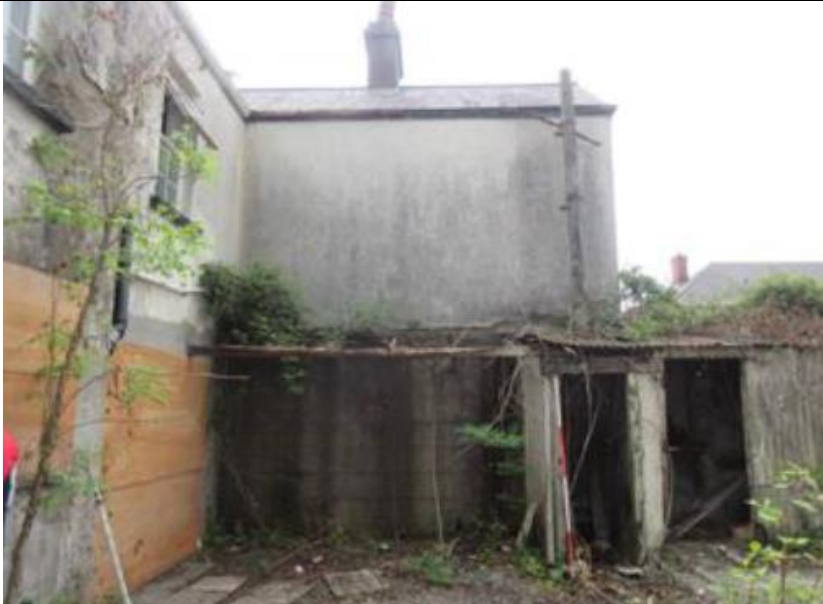
9.

A photograph showing the rear of an L-shaped building. The main building is a two-story structure with a grey, weathered facade and a chimney. A lower, partially collapsed structure is attached to the side, with its roof and walls in a state of disrepair. A wooden fence is visible on the left side of the lower structure.	Rear of L- Shaped Building. Some partially collapsed lean too roof structures.
10.

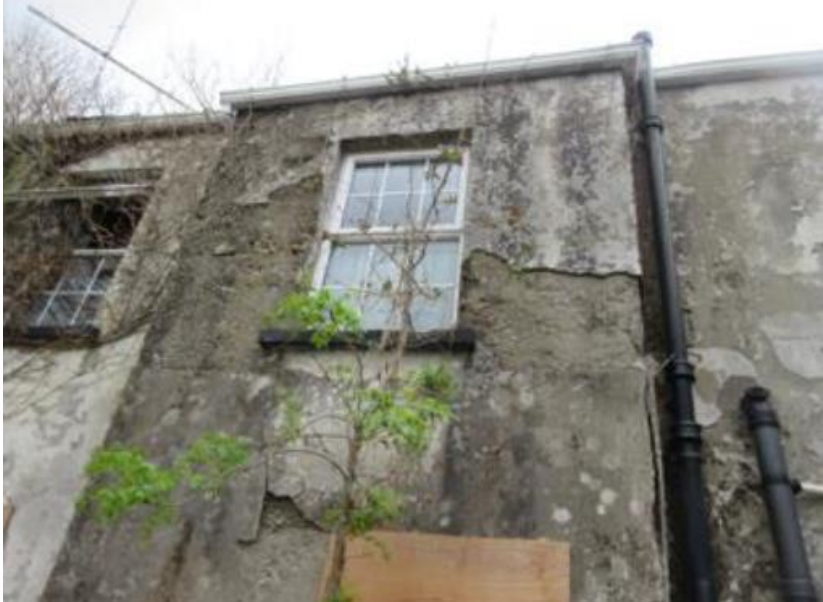
- 4.4 There is significant detached render to the rear elevation which indicates walls are of mass concrete which appears loose and crumbly which may be due to persistent damp penetration. Given the age of the property it is assumed that some walls will also be a mixture of brick and stone rubble most likely constructed of lime mortar.
- 4.5 There is a suspended wooden floor to 42 Brews Hill which is rotten due to wetrot and does not allow full access to property. It would appear that subfloor vents are also provided to 43 Brews Hill which would indicate that suspended timber floors are also provided to this property.

A close-up photograph of a building's exterior wall. The wall is made of mass concrete and shows significant signs of deterioration, including peeling and detached render. A window with a white frame is visible, and a black downspout runs vertically along the wall. A small tree is growing in front of the wall.	Rear of No 44 in poor condition with detached and boast render. Mass concrete walls in poor condition due to damp penetration.

- 5.3 The walls of this property are of mass concrete and/or stone with lime mortar and from the age of the building the lintels would most likely be of hardwood timber. As the property has not been adequately maintained for some time water has been allowed to penetrate internally due to missing slates, gutters and damaged window and doors. This dampness may result in wetrot of timber lintels and beams. All timber lintels should be replaced with concrete. Cracks to existing stone walls will also require stitching where movement has occurred.

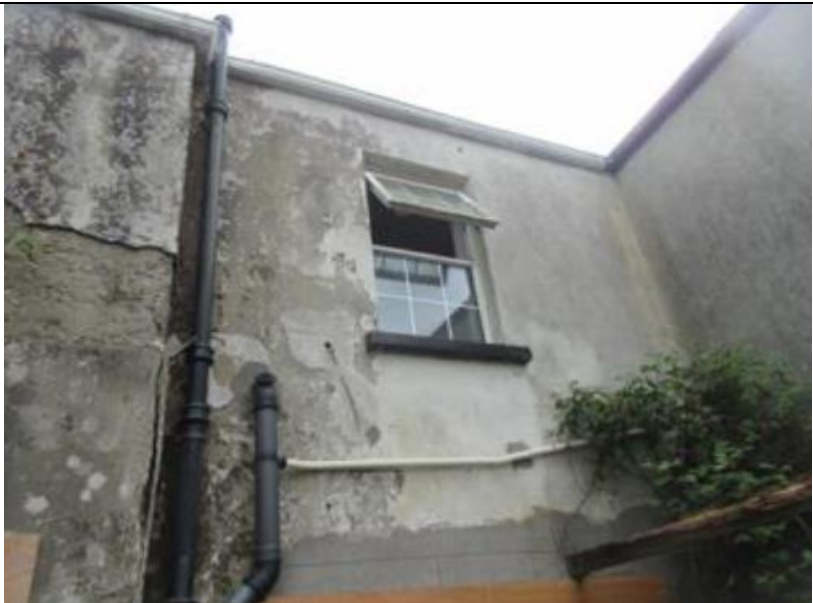
11.

An exterior photograph of the rear of a building, No 44. The walls are in poor condition, showing significant peeling and detached render. A window with a white frame and a small awning is visible. A black downspout pipe runs vertically along the left side of the wall. The sky is overcast.	<p>Rear of No 44 in poor condition with detached and loose render. Mass concrete walls in poor condition due to damp penetration.</p>
12.

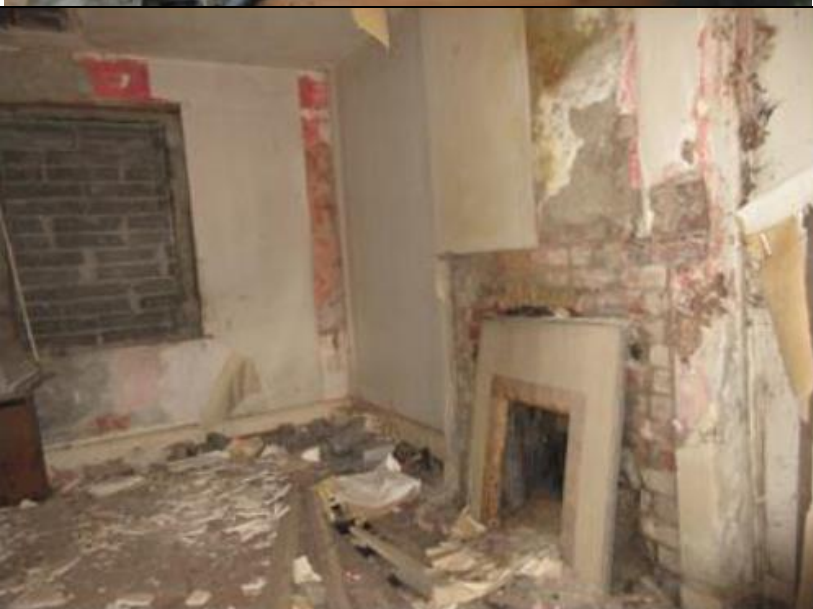
An interior photograph of a room in No 43. The room is in a state of significant disrepair. The walls are heavily damaged, with large areas of peeling plaster and exposed brickwork. A fireplace is visible in the foreground, and a window with a dark frame is on the left. The floor is covered in debris and appears to be in the process of being cleared or repaired.	<p>Internal view of No 43 with significant damp penetration.</p>

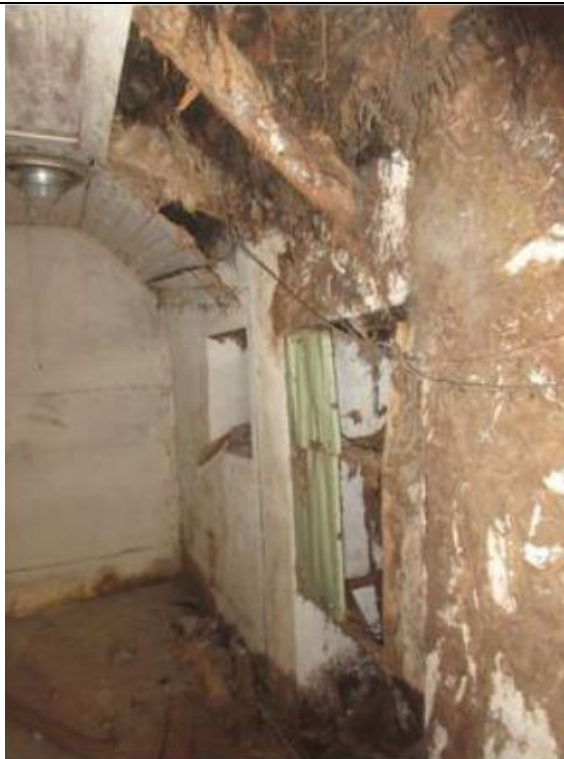
15.

Considerable damp penetration to 42 Brews Hill.
16.

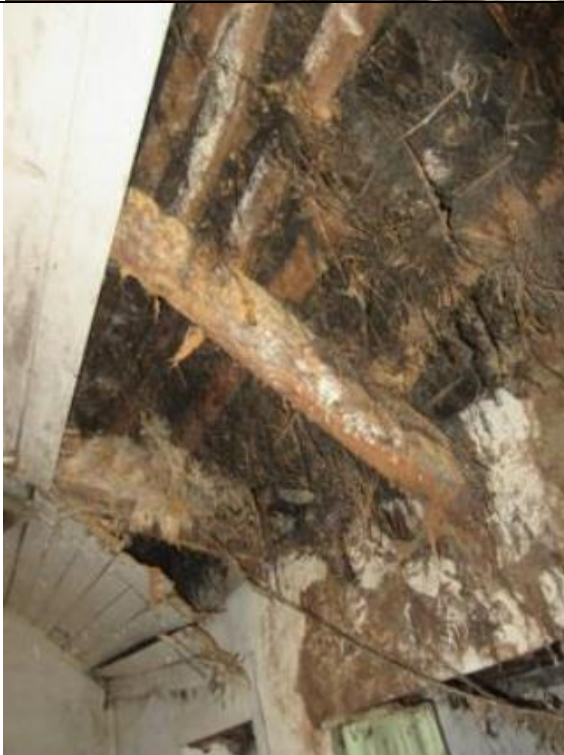
- 4.3 There was no access internally to No 43 & 44 Brews Hill as it was deemed to be unsafe due to the poor condition of the property. Given the extent of missing roof slates there will be considerable damp penetration which will have a negative effect on structural timbers which will result in wetrot. This wetrot will result in collapsed ceilings and floors. The roof of 42 Brews Hill is covered in corroded corrugated sheeting and supported on a timber truss with t&g ceiling which is partially collapsed. It would appear that this property was originally covered in thatch with some remaining above the t&g sheeting ceiling.

Old thatch roof evident above t&g sheeting.

- 5.5 The fixings for the natural slate are starting to corrode and fail as there are a lot of slipped and missing slates. The entire roof structure will require replacement and it would be recommended to provide a breathable roofing felt under the new slatting battons.
