**Re: An Arboricultural Assessment of the Trees along the Boundary of
'St. Michael's Loreto Convent' Grounds with 'Convent Road', Athlumney, Navan,
Co. Meath.**

An Arboricultural Assessment of the Trees Along the Boundary of 'St. Michael's Loreto Convent' Grounds with 'Convent Road', Athlumney, Navan, Co. Meath.

Prepared for: Meath County Council.

Date: 12th September 2018

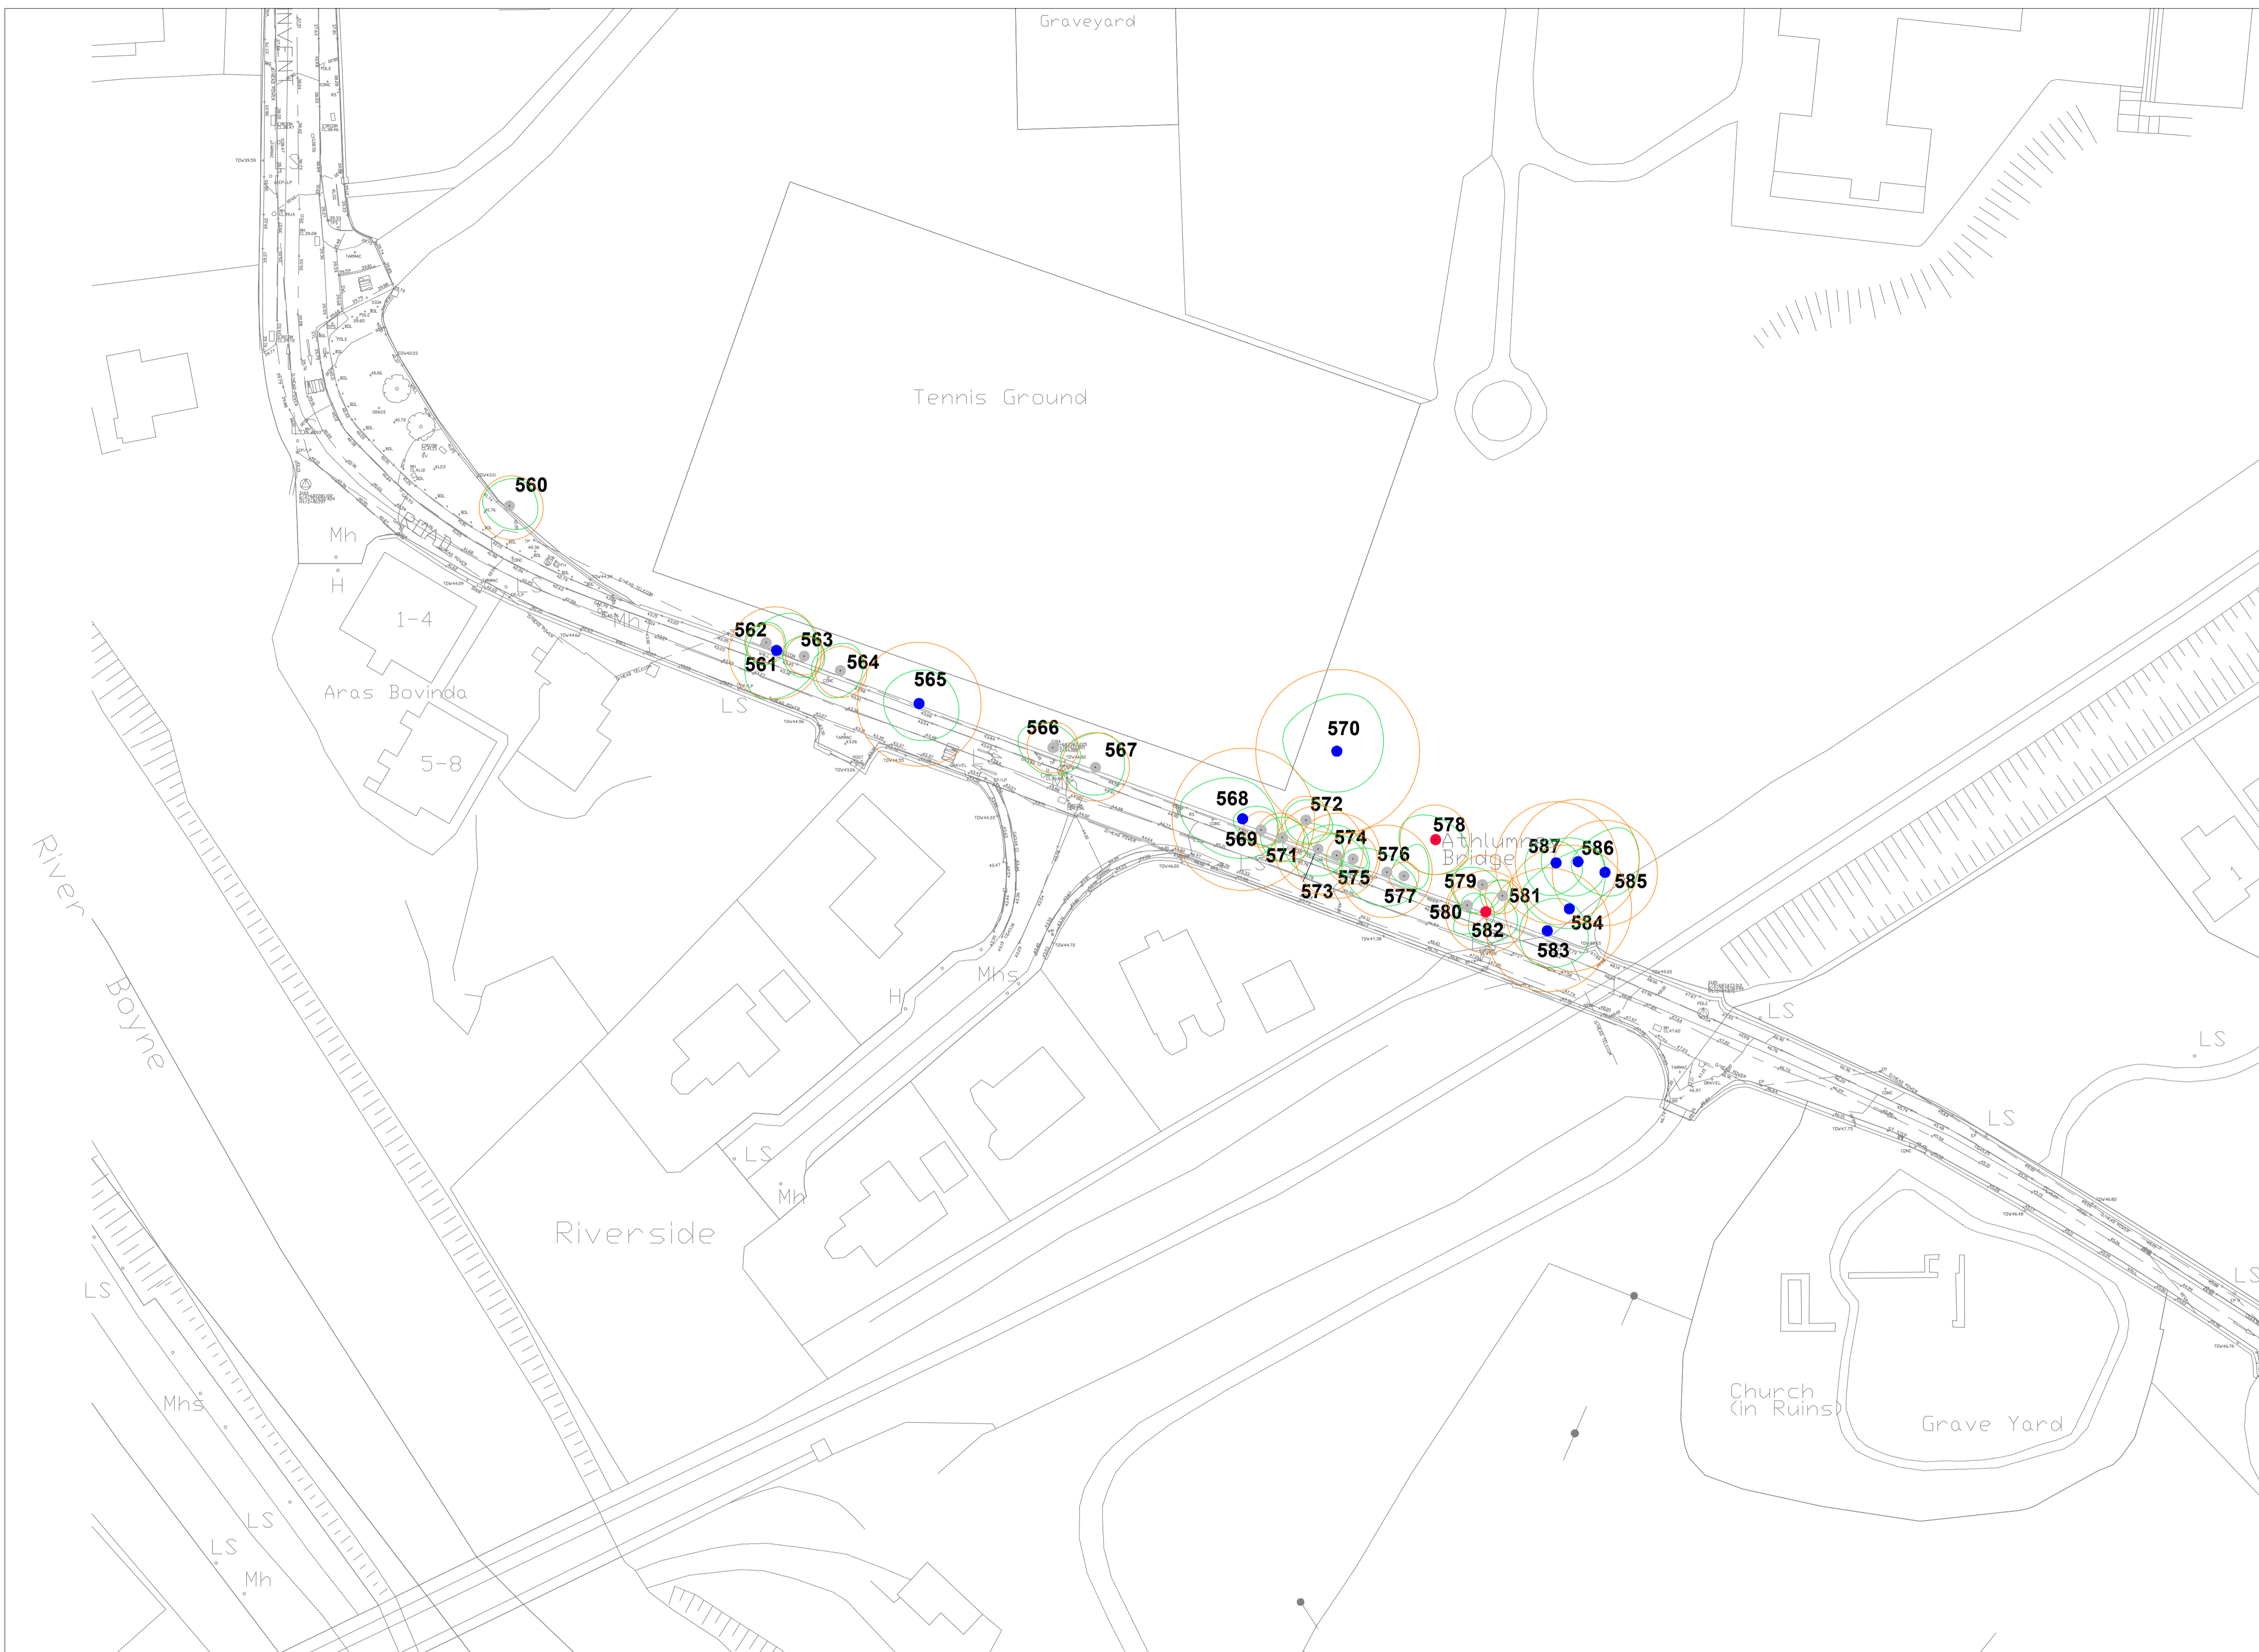
TITLE: Tree Constraints Plan
Site: Trees on Boudnary of Convent Road, Navan, Co. Meath.
DATE: Dwg No. CRN001 Scale 1:500 @ A1

Any category 'U' trees identified have been shown on our drawings (Nos.CRN001 & CRN002) with a 'Red' donut around their trunk positions. Due to the condition of these trees, they should not be considered a constraint on the design layout of the road alignment works.

Any category 'B' trees identified have been shown on our drawings (Nos.CRN001 & CRN002) with a 'Blue' donut around their trunk positions.

0561	Ash <i>Fraxinus excelsior</i>	14	540	4N 6S 6E 7W	5	Mature	Fair	Fair It is a tall, prominent tree with heavy Ivy cover on the main trunk extending up into its crown. It is located tight to the base of the boundary wall and is causing some structural damage to the wall. The lower branches have been removed in the past in order to raise up its crown and some pruning wounds have been created as a result. This pruning has also left its crown slightly top-heavy as a result.	Remove dead/unstable growth from within its crown. Cut Ivy at ground level and remove to a height of c.2m to allow a more detailed assessment of its base and lower trunk. Tidy up the undergrowth. Monitor the structural damage being caused to the boundary wall.	20+	B1
0562 & 0563	Sycamore <i>Acer pseudoplatanus</i> Goat Willow	A 9	A 90 X 6 Stems	A 3N 3S 3E	A 4	Early Mature	Fair	Fair/Poor It consists of a group of Sycamore seedlings growing into multi-stemmed trees from where they were cut down previously with one Goat	It would recommend the removal of those located closest to the boundary wall a part of management and to reduce pressure to the boundary wall.	10+	C1

0583	Sycamore <i>Acer pseudoplatanus</i>	24	720	4N 6S 5E 5W	6N/5S	Mature	Fair	Fair It is a large, prominent visual tree located on the railway soil embankment inside the boundary wall. It forms part of the group canopy formation, in particular with the neighboring Ash tree with an asymmetrical crown as a result leaning towards the road.	Remove dead/ unstable growth from its crown. Remove basal sucker and cut Ivy at ground level. Monitor the boundary wall for structural damage.	20+	B1
