## Lough Bracken Enhancement Feasibility Study and Landscape Master Plan

**By:** Flynn, Furney Environmental Consultants **For:** Meath Partnership on behalf of the Meath LAG

**Date:** February 2022

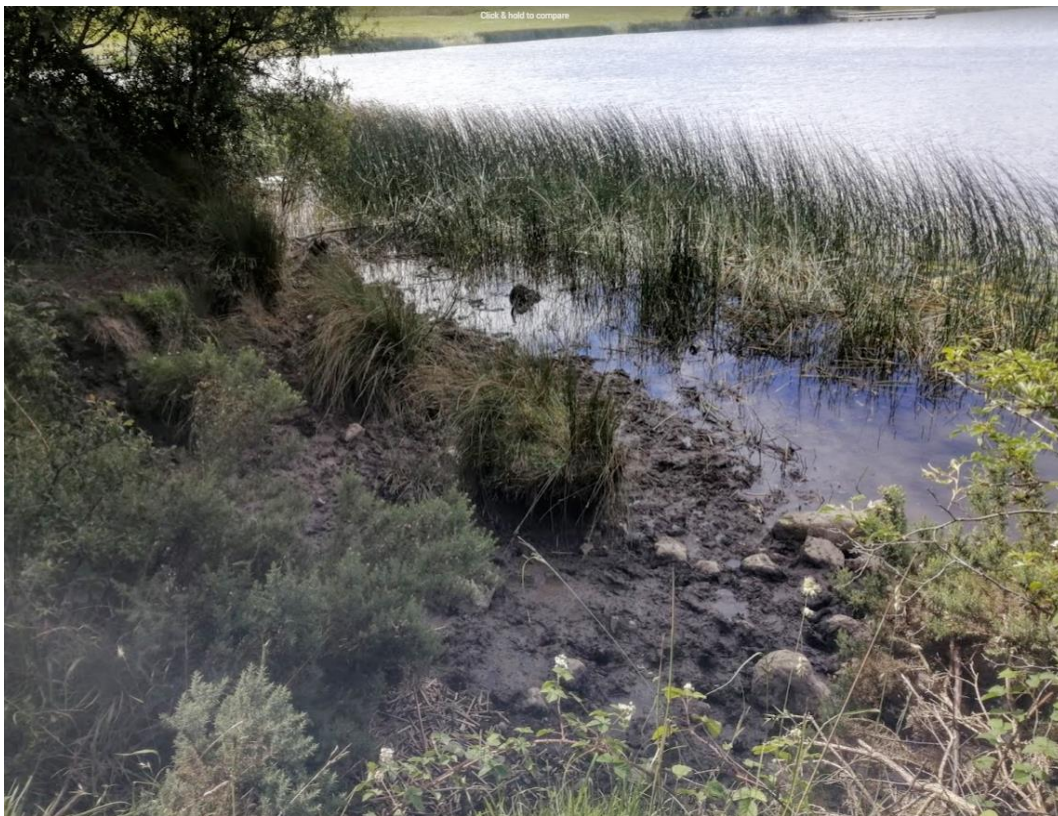
Much of the reed bed habitat surrounding the lake has become highly degraded as a result of cattle having access to the water's edge. This has meant the capacity of the reed fringe to complete these functions has been diminished.

**Figure 2: Poaching and degradation of the reed fringe**

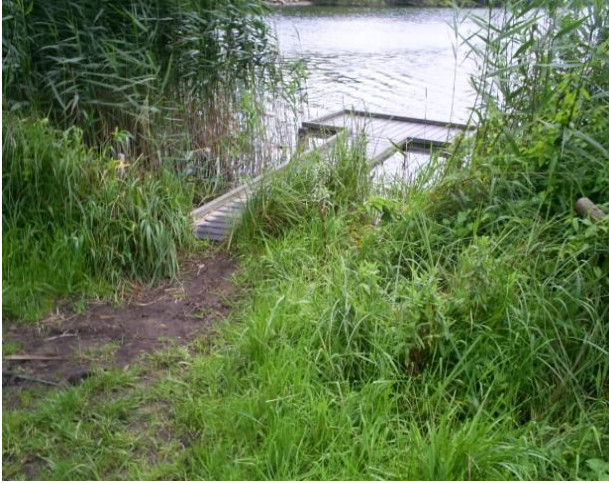
Angling is one of the main formal activities carried out at Lough Bracken. At least 10 formal and informal angling stands are found along the lake shore. Most of these are informal and consist of areas of cleared bank vegetation. Three formal angling stands were previously installed by Inland Fisheries Ireland. These however, have been poorly maintained and appear to be rarely used.

**Figure 5: One of the lake’s current poorly maintained angling stands**

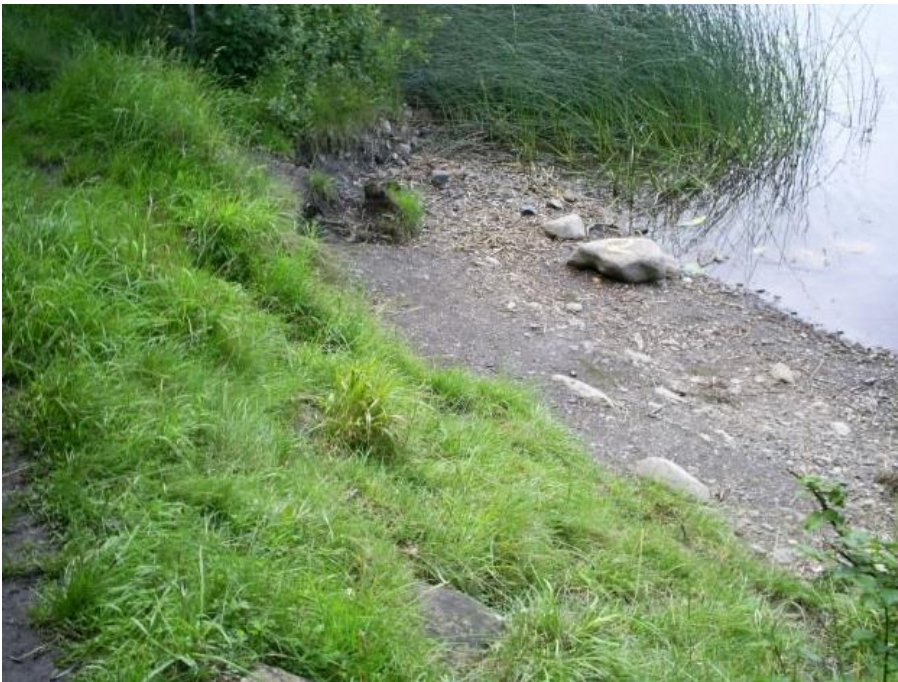
Erosion has become a major concern at a number of these stands and gabions have been placed along the track to halt any further subsidence. A rehabilitation plan and angling stand design has been provided in the Landscape Masterplan document. This consists of bank stabilisation works and the creation of permanent ecologically sensitive angling stand designs.

**Figure 6: Severe erosion around informal angling stand**

On the eastern side of the lake, accessed for angling has created erosion of the bank with some near-vertical slopes being created. These are very close to the main (informal) access track and as such are somewhat hazardous for walkers and other site users. Gabions have been placed in order to reinforce the bank. However, these cannot be considered a safe surface for angler access.

Aesthetically they are also poorly located and will never become revegetated. A plan for the rehabilitation of this area as well as angling stand designs have been provided in the Landscape Masterplan document. This allows for bank stabilisation works with natural materials and the creation of permanent and more ecologically sensitive angling stands.

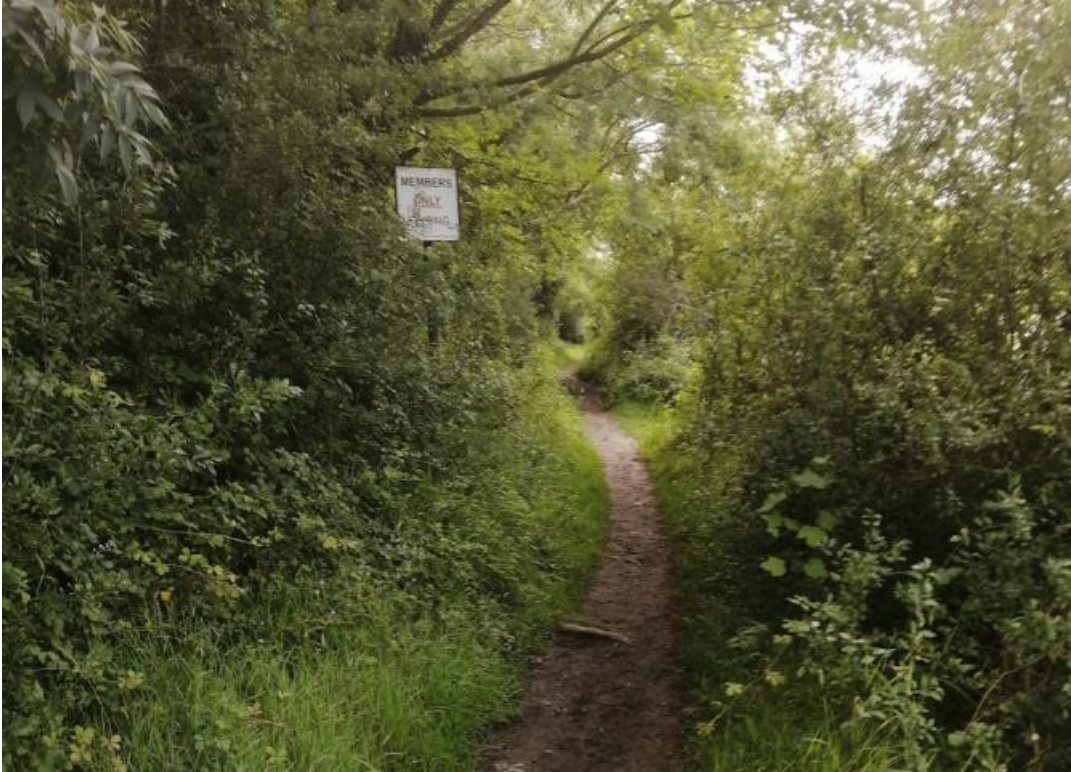
The entire lake is looped by a 1km walking track. Track condition and surface varies significantly along its extent. Going clockwise from the car park the track is composed of crushed rock but has become muddy due to lack of maintenance, footfall and cattle access. A stile is found approximately 200 metres from the trail head. This has become obsolete as cattle bypass it through the lake and poached shoreline. Beyond the stile the track becomes informal as it moves through marsh and agricultural grassland, crossing a bridge into further open grassland before arriving at the water pumping station.

**Figure 7: Semi-formal track near the car park. The hedgerow on the left of this photo has sadly been removed**

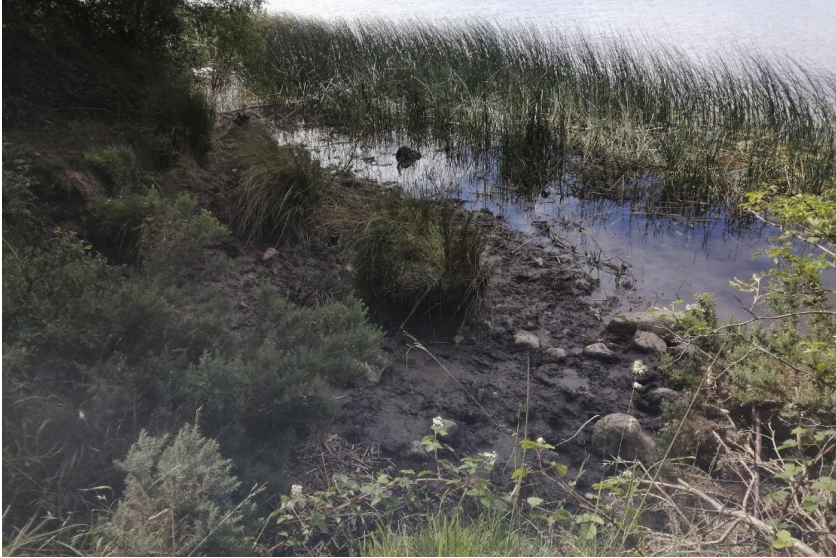
**Figure 8: Poaching from cattle along the shoreline**
