**Ratoath pedestrian and cycle scheme
Ratoath,
Co. Meath**

Desk Based Review and Assessment

Niall Roycroft

22nd November 2018

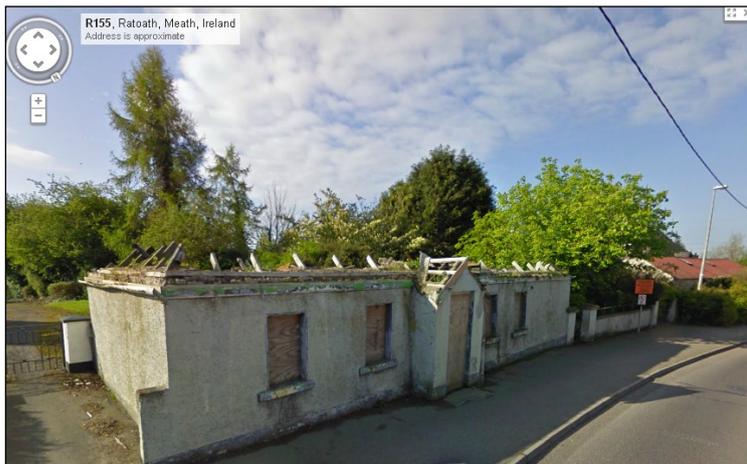
Detached five-bay single-storey house, built c.1800, with gabled central porch. Hipped corrugated fibre cement roof with a red brick chimneystack. Roughcast rendered walls, rendered to porch.

Meath RPS number: None: partly demolished by 2011 (see below)

Google Image April 2011

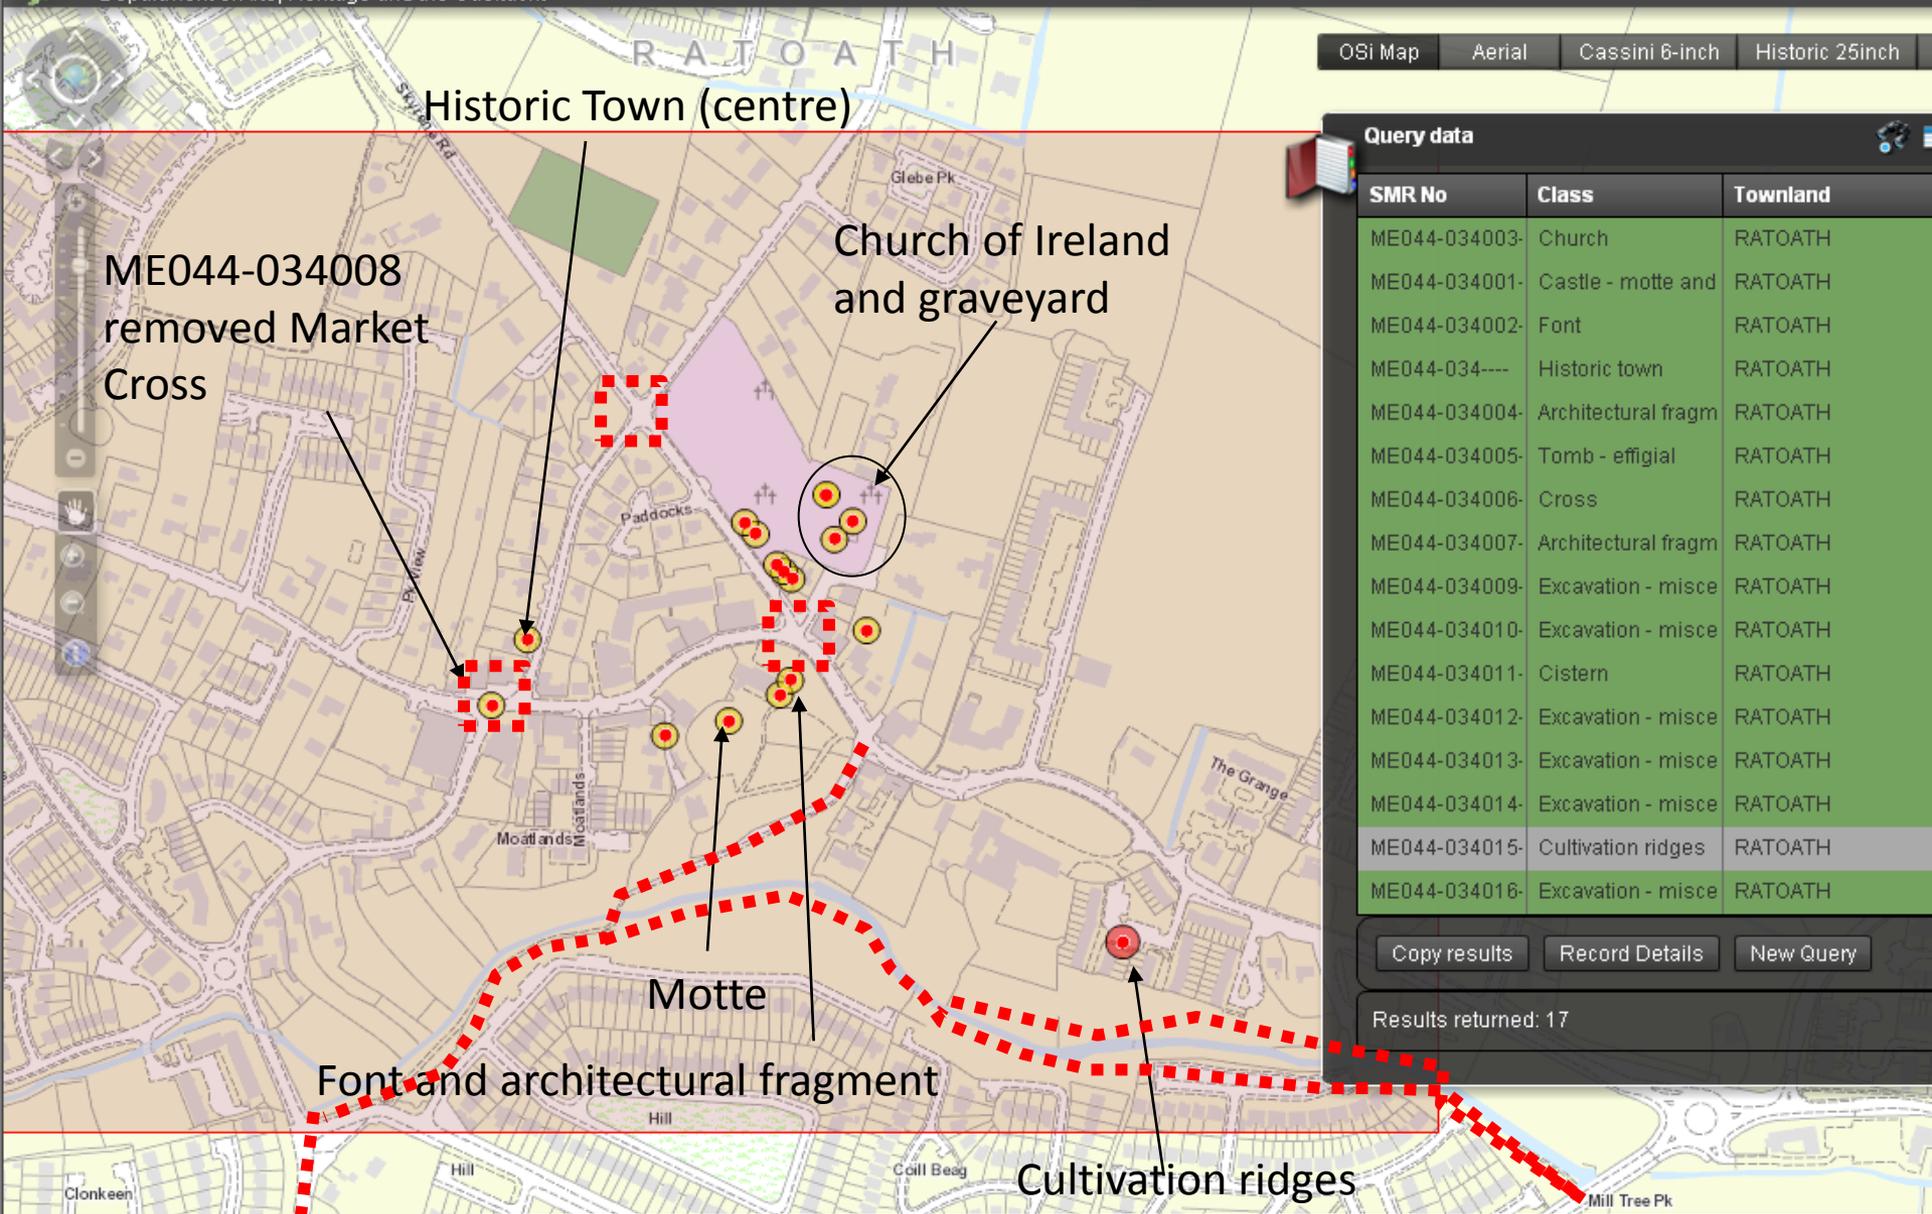
Fig 4: Summary of recorded sites in Ratoath in relation to proposed works (dotted line)

There are 16 records on the Sites and Monuments record of Monuments and Places for Ratoath (Fig 4). These include six records connected with the archaeological works results above, but since the RMP files require updating, not the others. The RMP records focus on the medieval town, the medieval motte and items in and around the Church of Ireland church and cemetery on the Skryne Road.

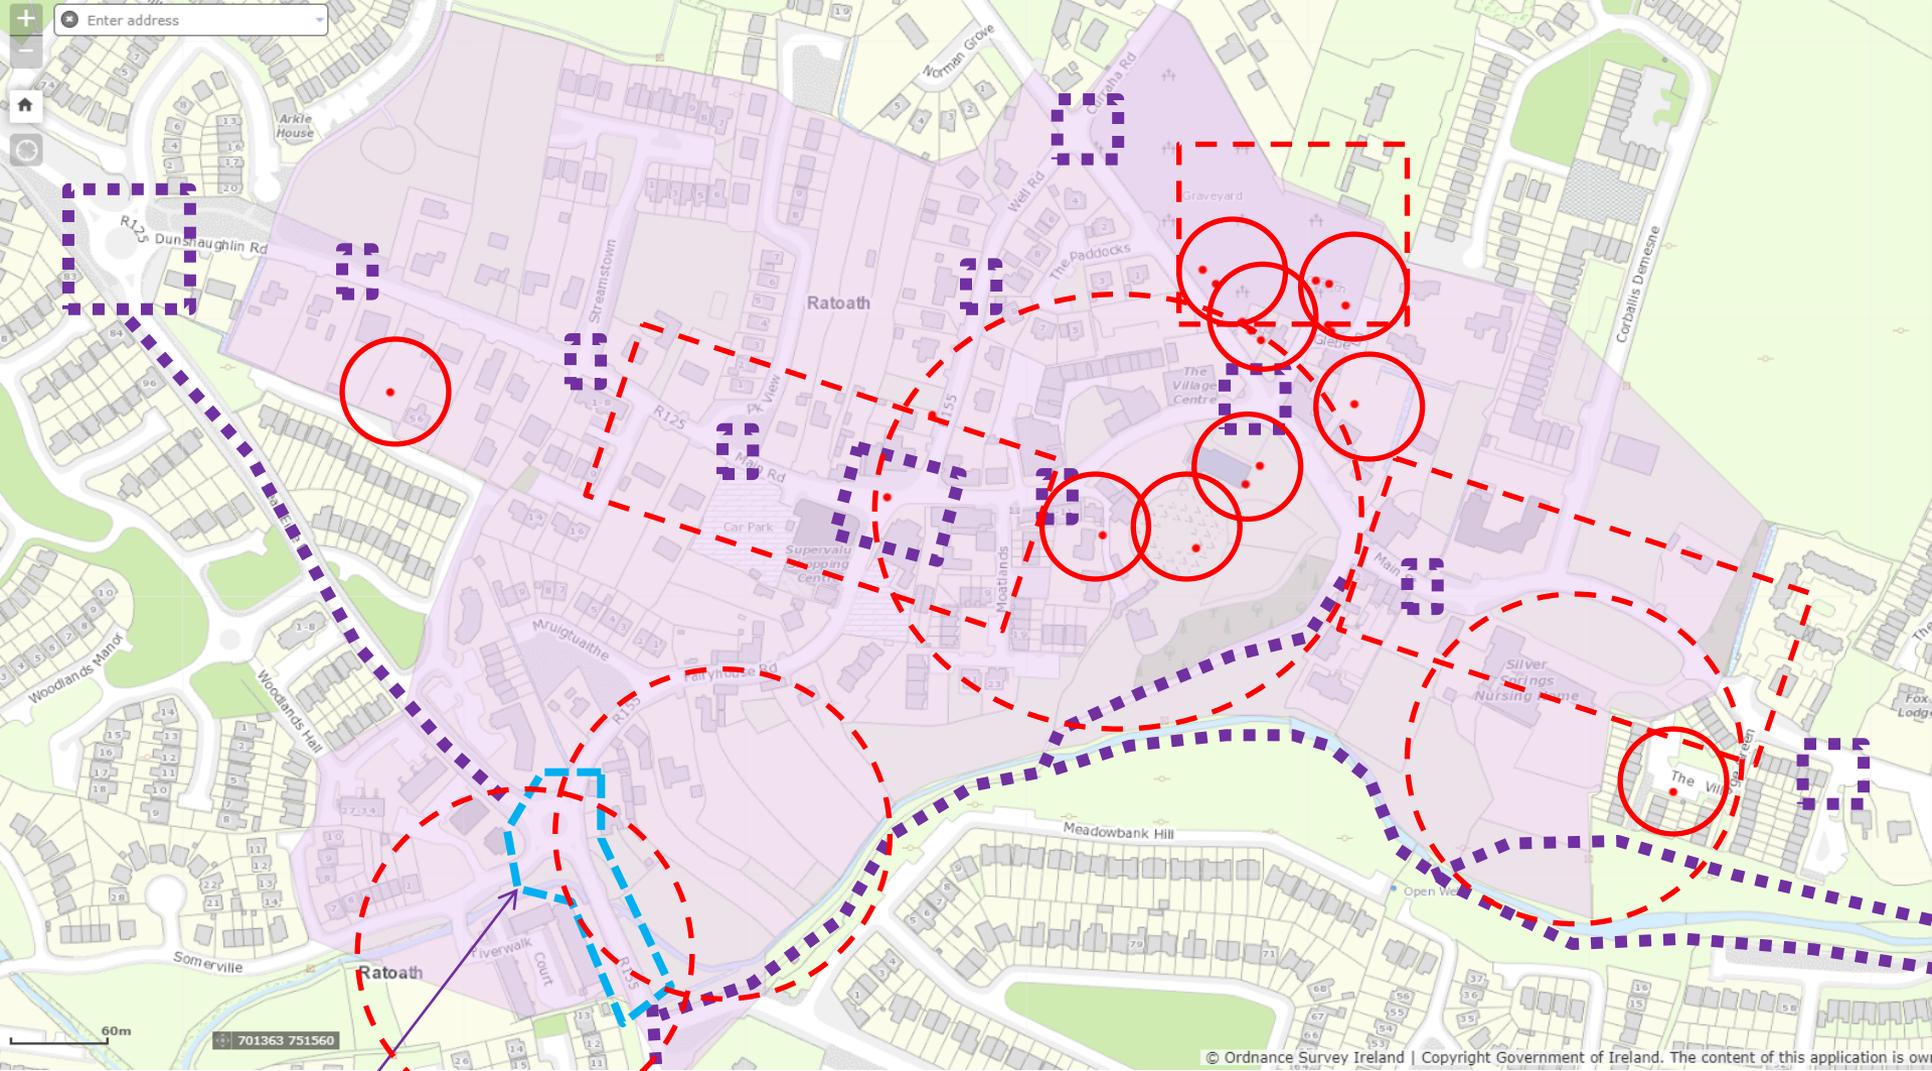
Fig 8: Summary of proposed works that are within or adjacent to ME044-034: Ratoath Historic Town. Red dots = recorded monuments or excavations. Red circles / squares = key areas of the oldtown. Purple dashed lines = proposed areas of works

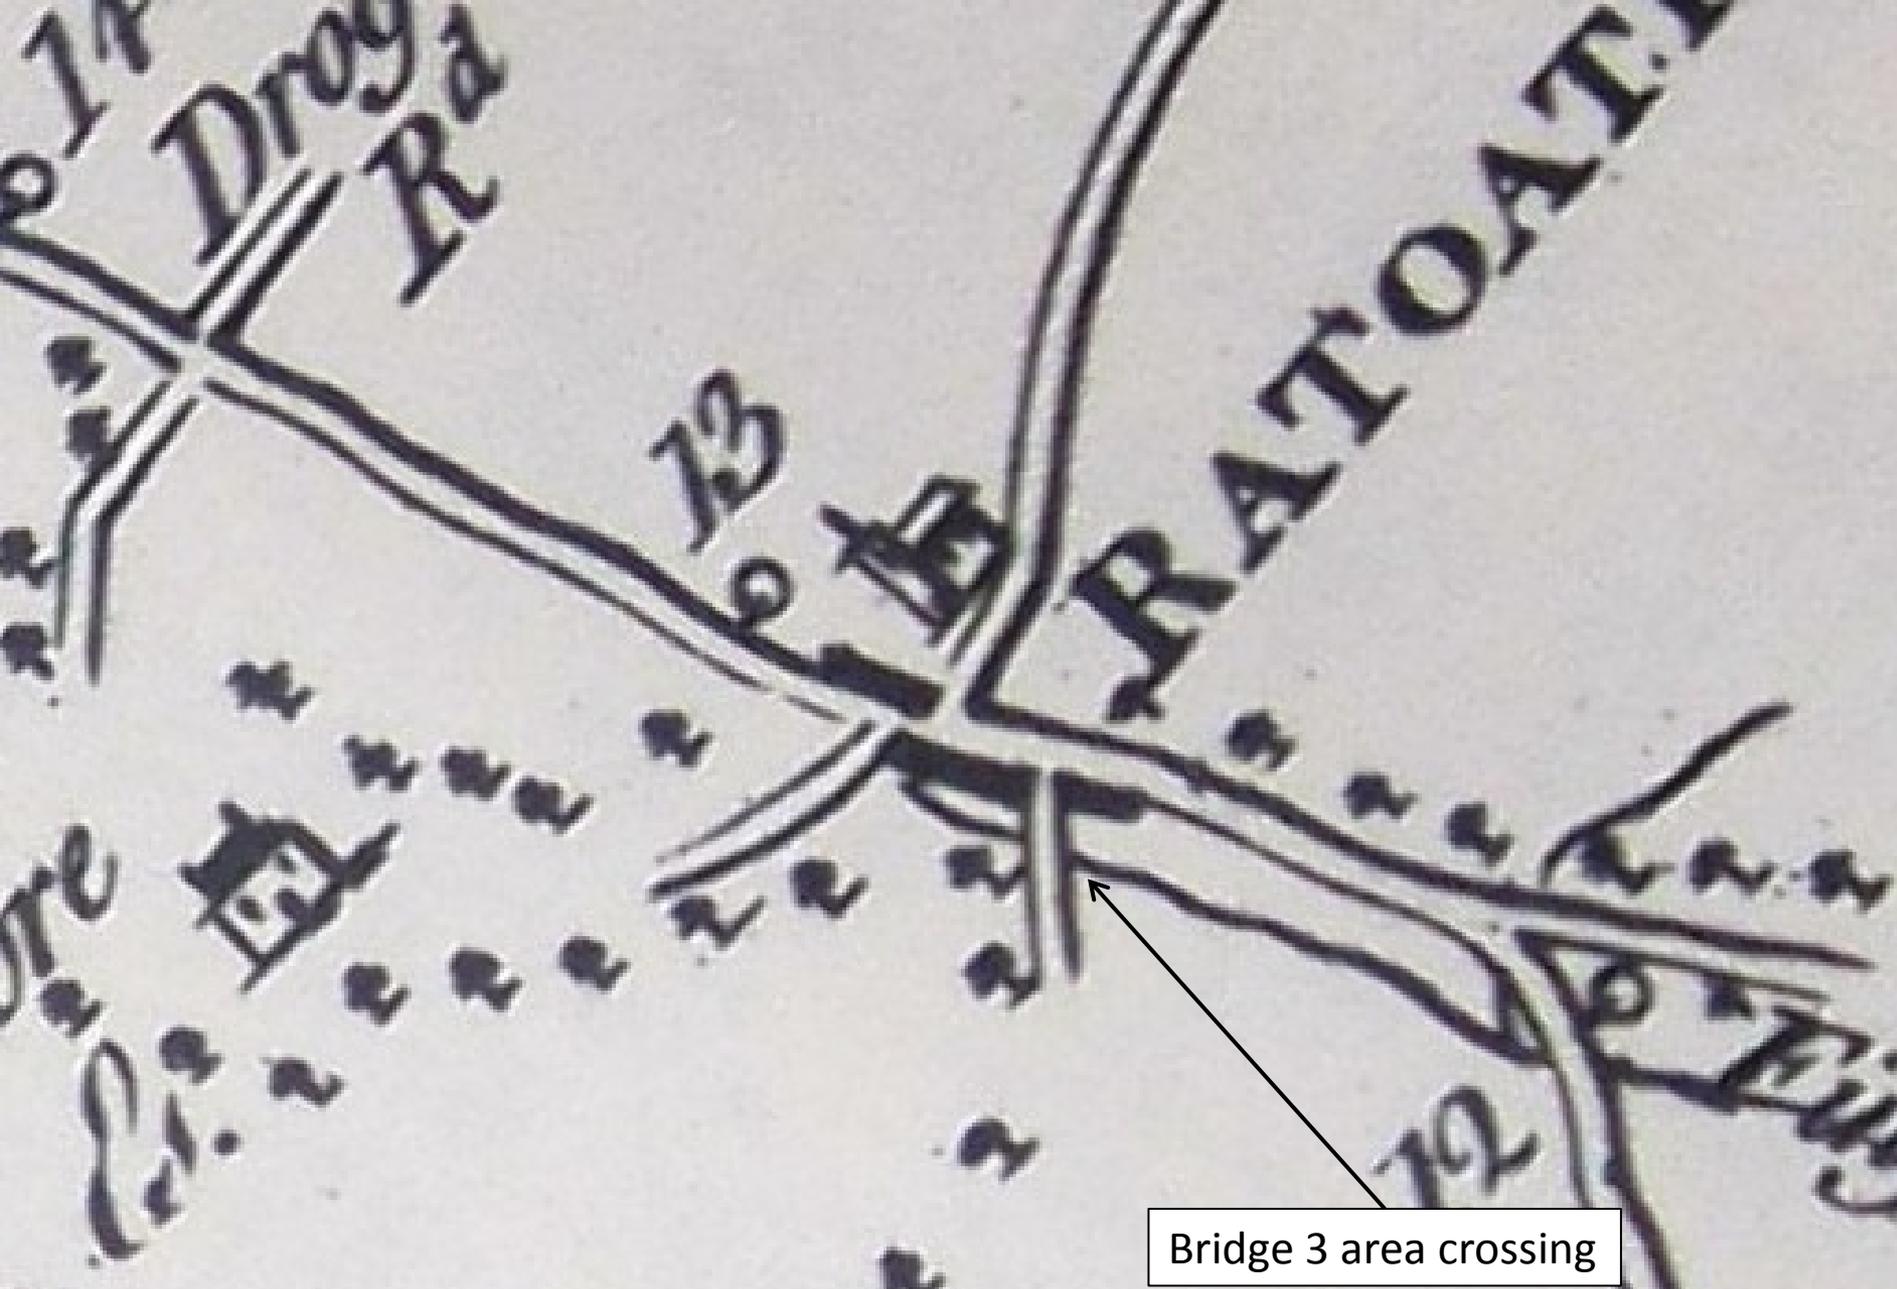
Fig 14: 1777-85 Taylor & Skinner Map 44 Detail showing Ratoath . Note the position of the Church to the previous Curraghera Road (present Glebe Lane)

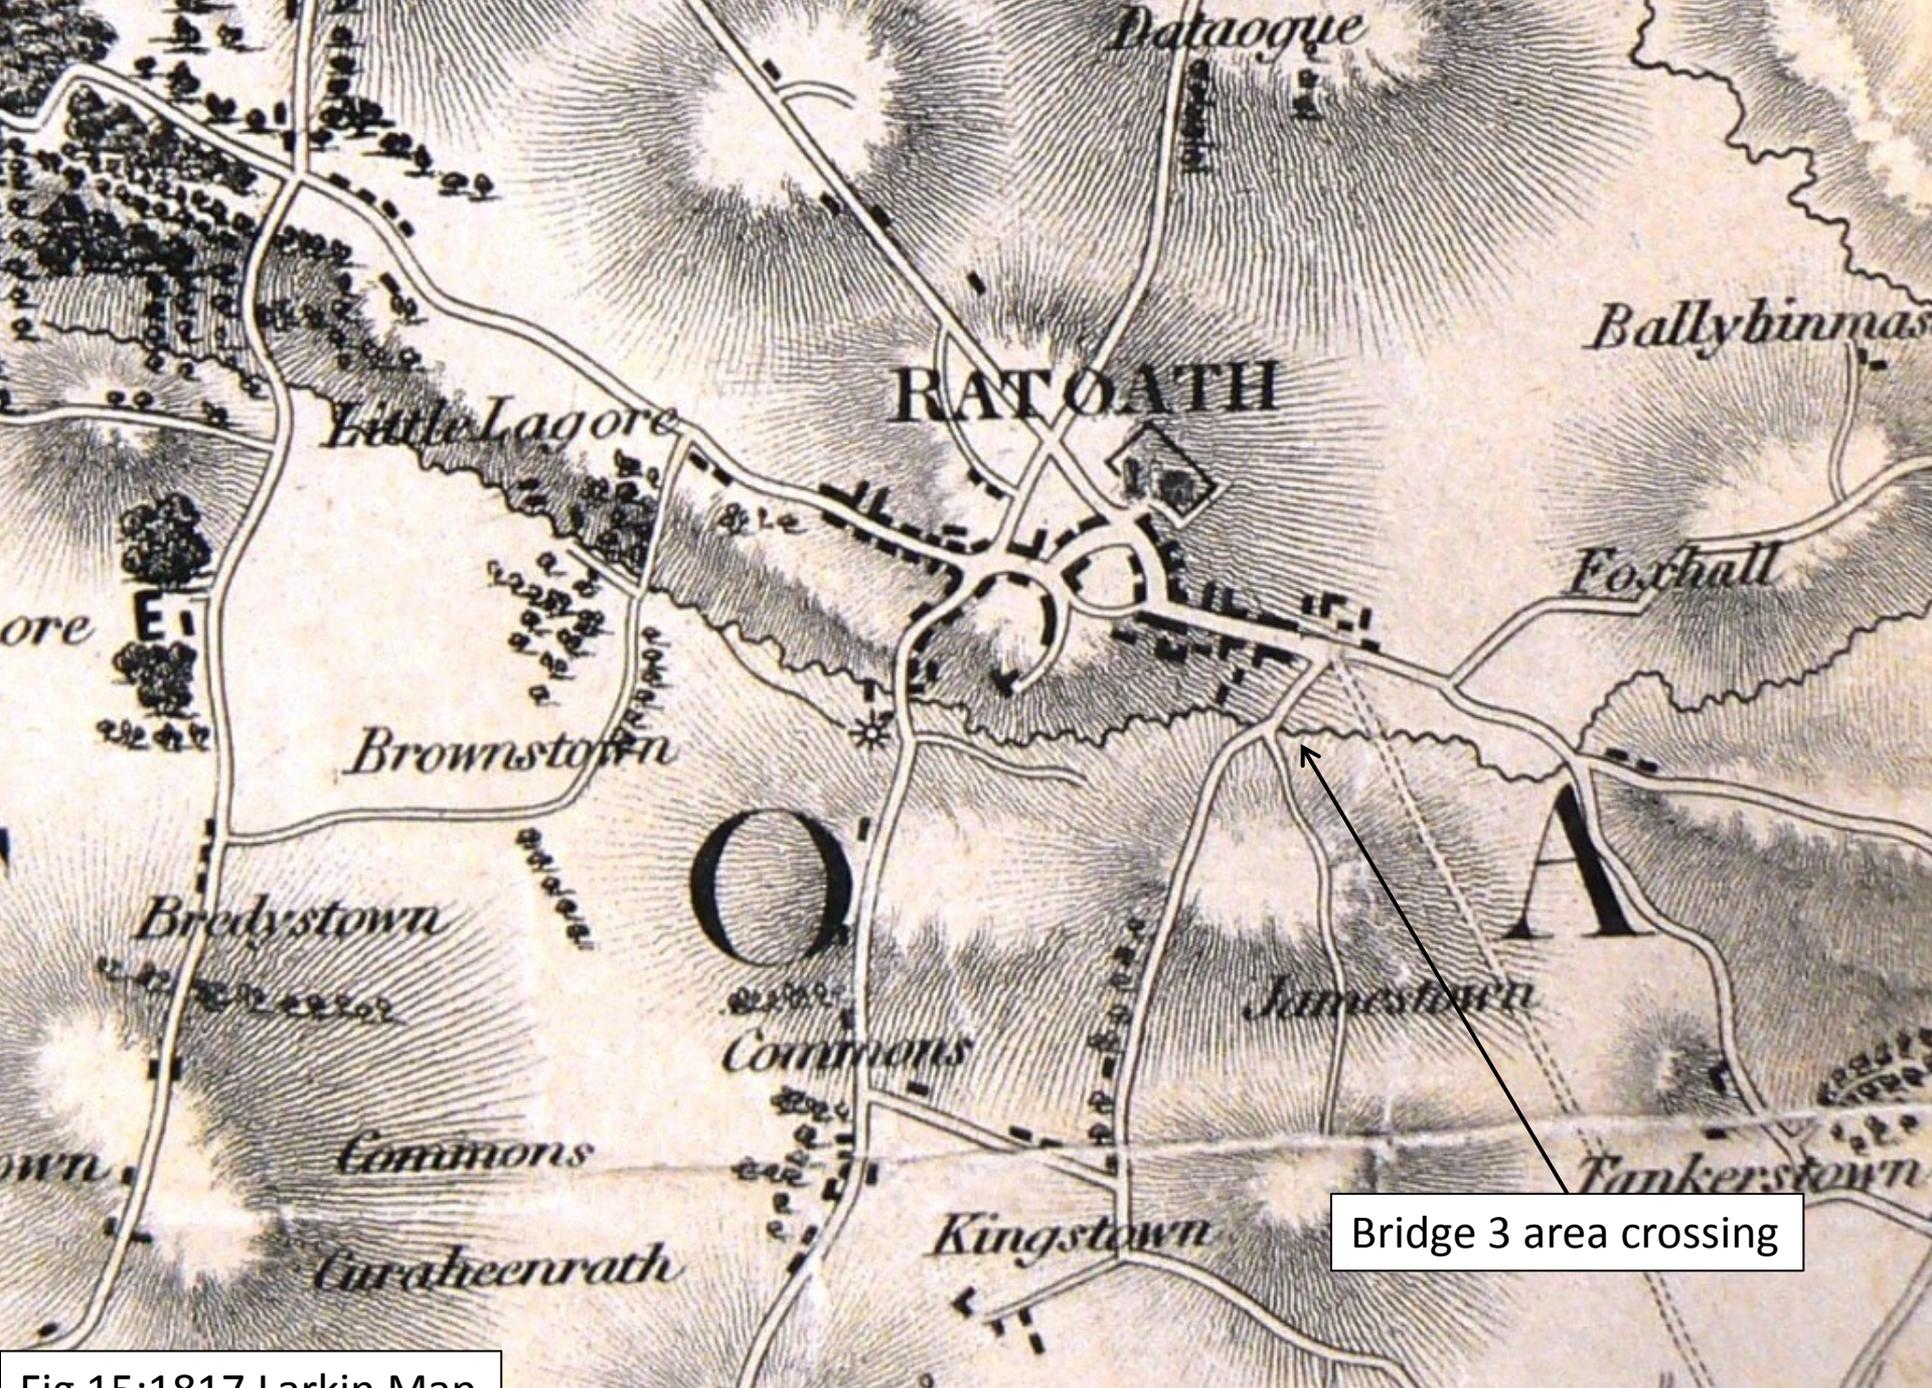
Bridge 3 area crossing

Fig 15:1817 Larkin Map

The main element here is a single arched, masonry bridge over the Broad Meadow River. The bridge (Bridge 3) appears to have a three-centre arch (similar to the bridges over the Boyne Navigation) with well cut voussoirs and rusticated abutment quoins. The bridge is slightly skewed NE-SW and has very low parapets with a cow-and-calf soldier course. A modern wooden paling fence on iron supports has been built to raise the parapet heights and there is a concrete bollard at the northern end to prevent vehicle traffic crossing. There is no bridge shown here on the 1837 OS but one is shown on the 1913 OS, leading to Jamestown House (demolished) to the south. The 1913 OS shows a previous fording point on the Broad Meadow River approximately 60m to the east and there may well have been a previous ford in the area of the present Bridge 3. The crossing point is shown as a townland boundary on the 1837 OS, but this boundary is moved eastwards when the Bridge 3 was built (or the 1837 is slightly inaccurate at this point). The present riverbanks have clearly been raised and formalised since the 1913 OS, but there is perhaps some rock armouring of the southern bank of the river channel that is probably older. The southern river bank is a quasi-vertical 'build' that perhaps reflects the location of a riverside road here.

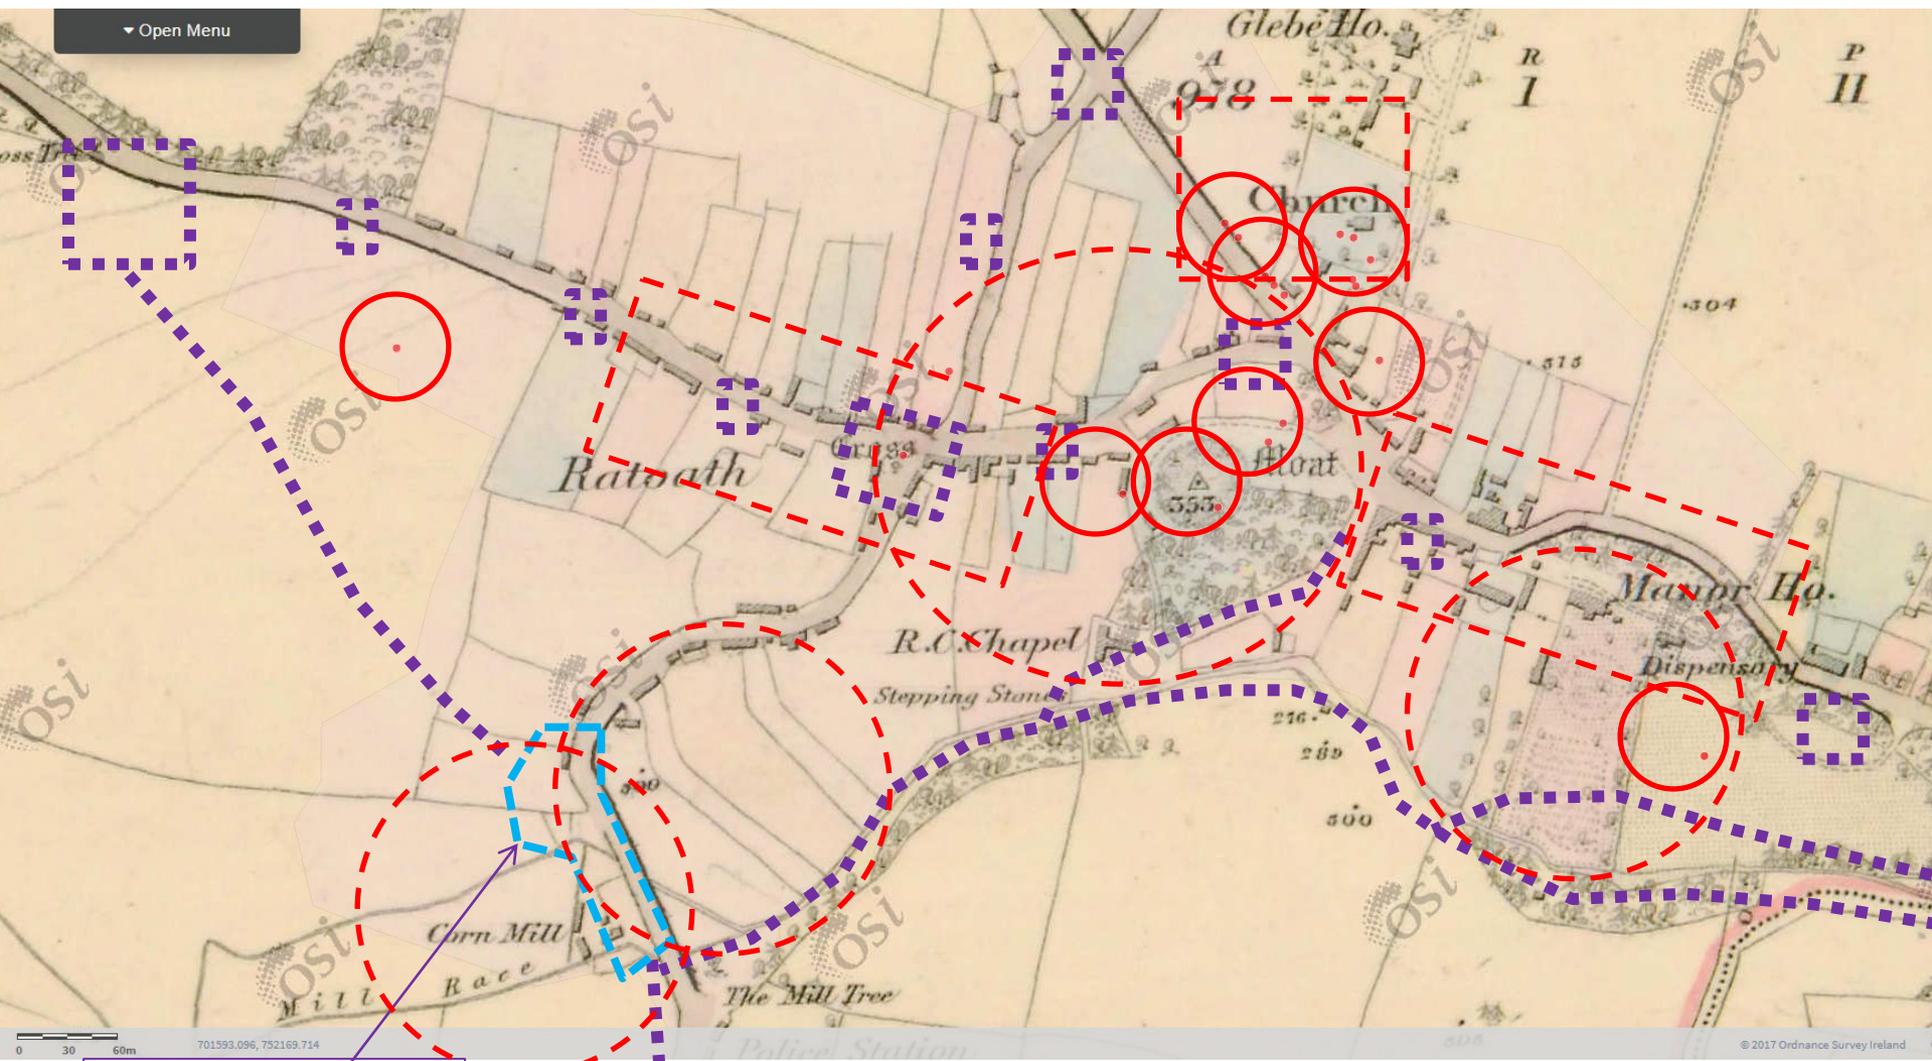
Fig 16: 1837 OS with proposed areas of works in purple dash

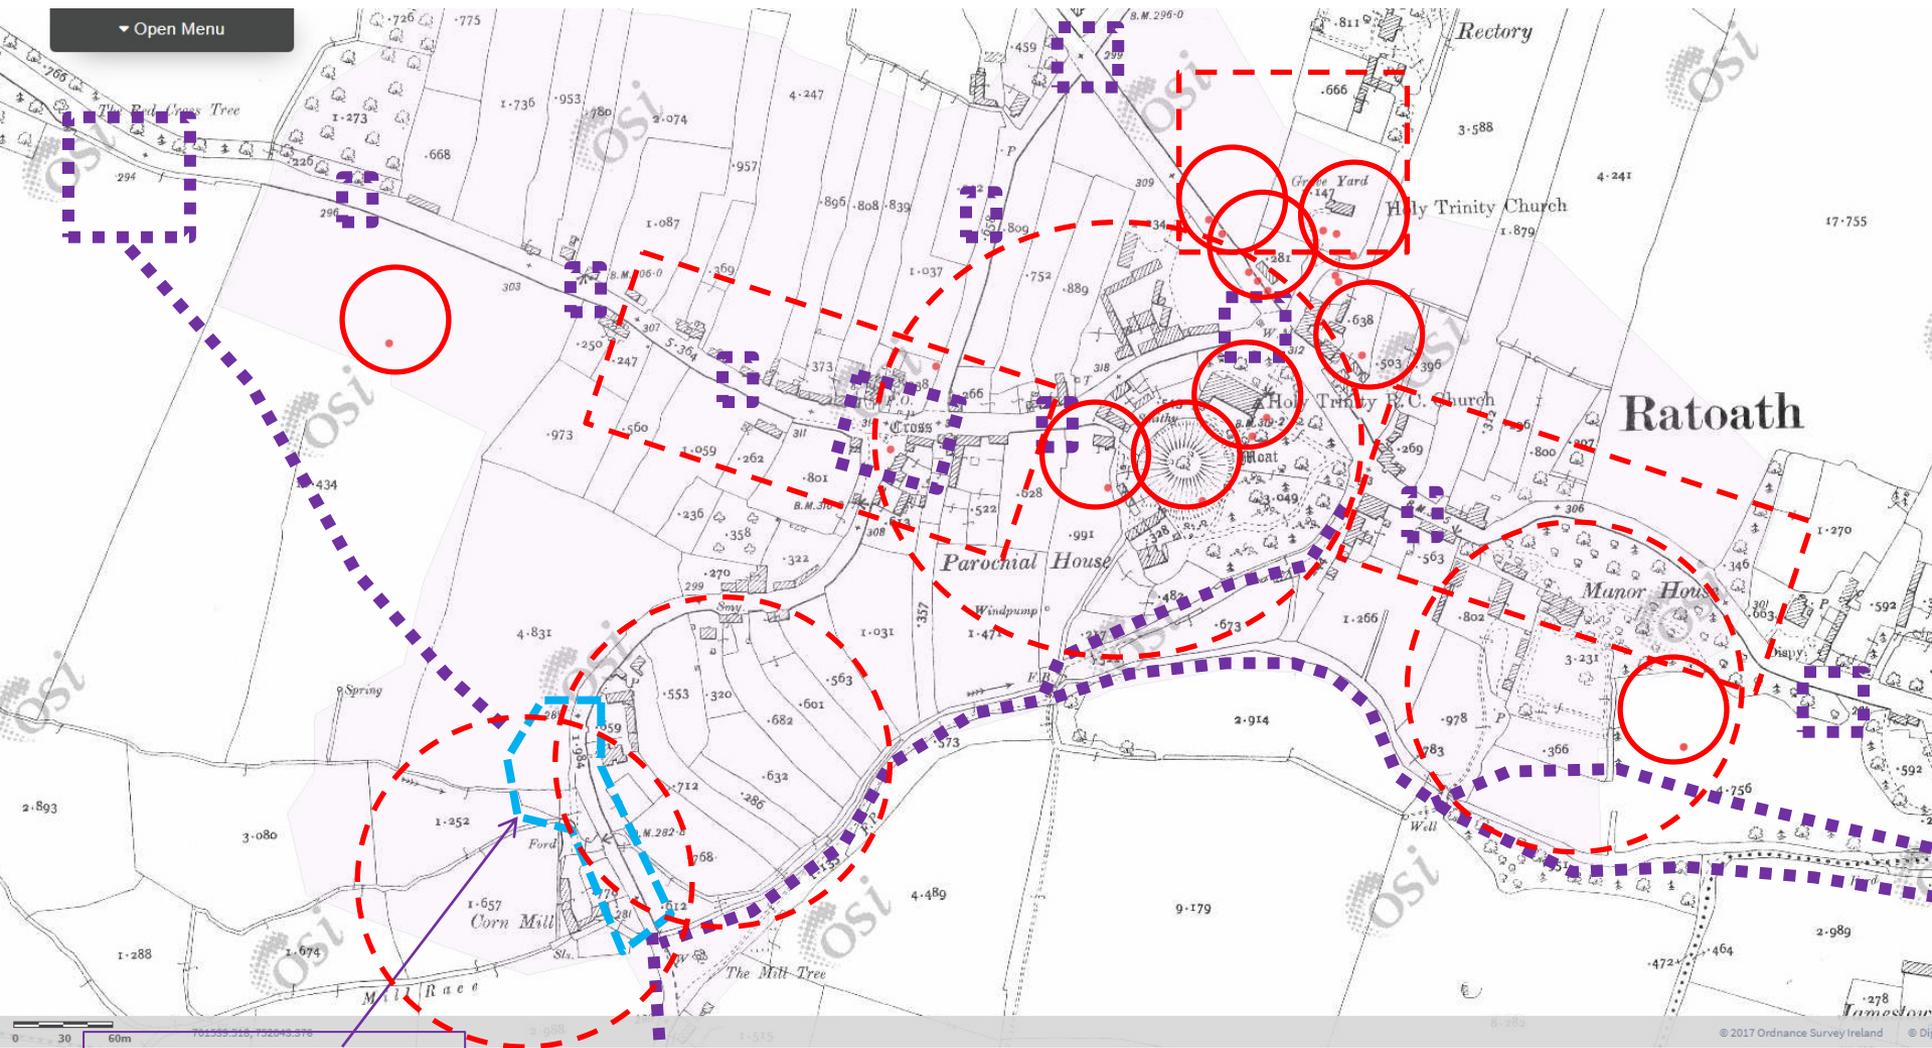
Fig 17: 1913 OS with proposed areas of works in purple dash

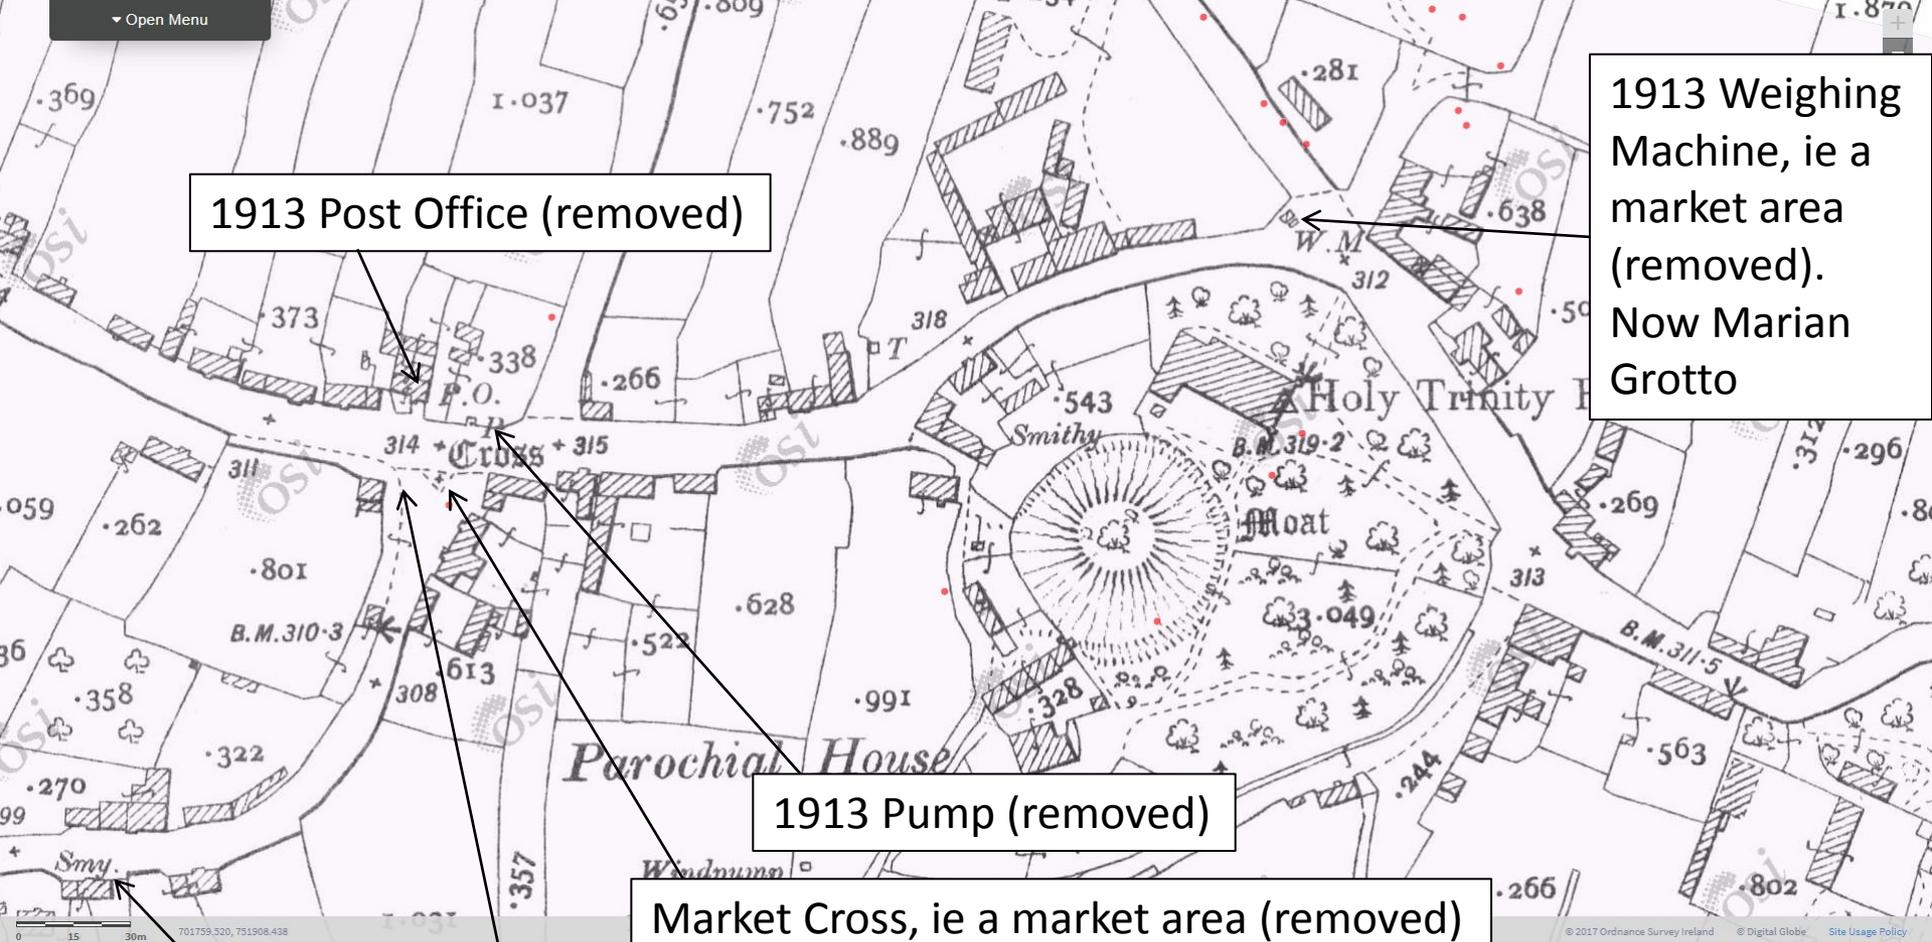
1913 Post Office (removed)

1913 Weighing Machine, ie a market area (removed).
Now Marian Grotto

Smithy – retained but disused

Fig 21: 1913 OS detail with discussion elements

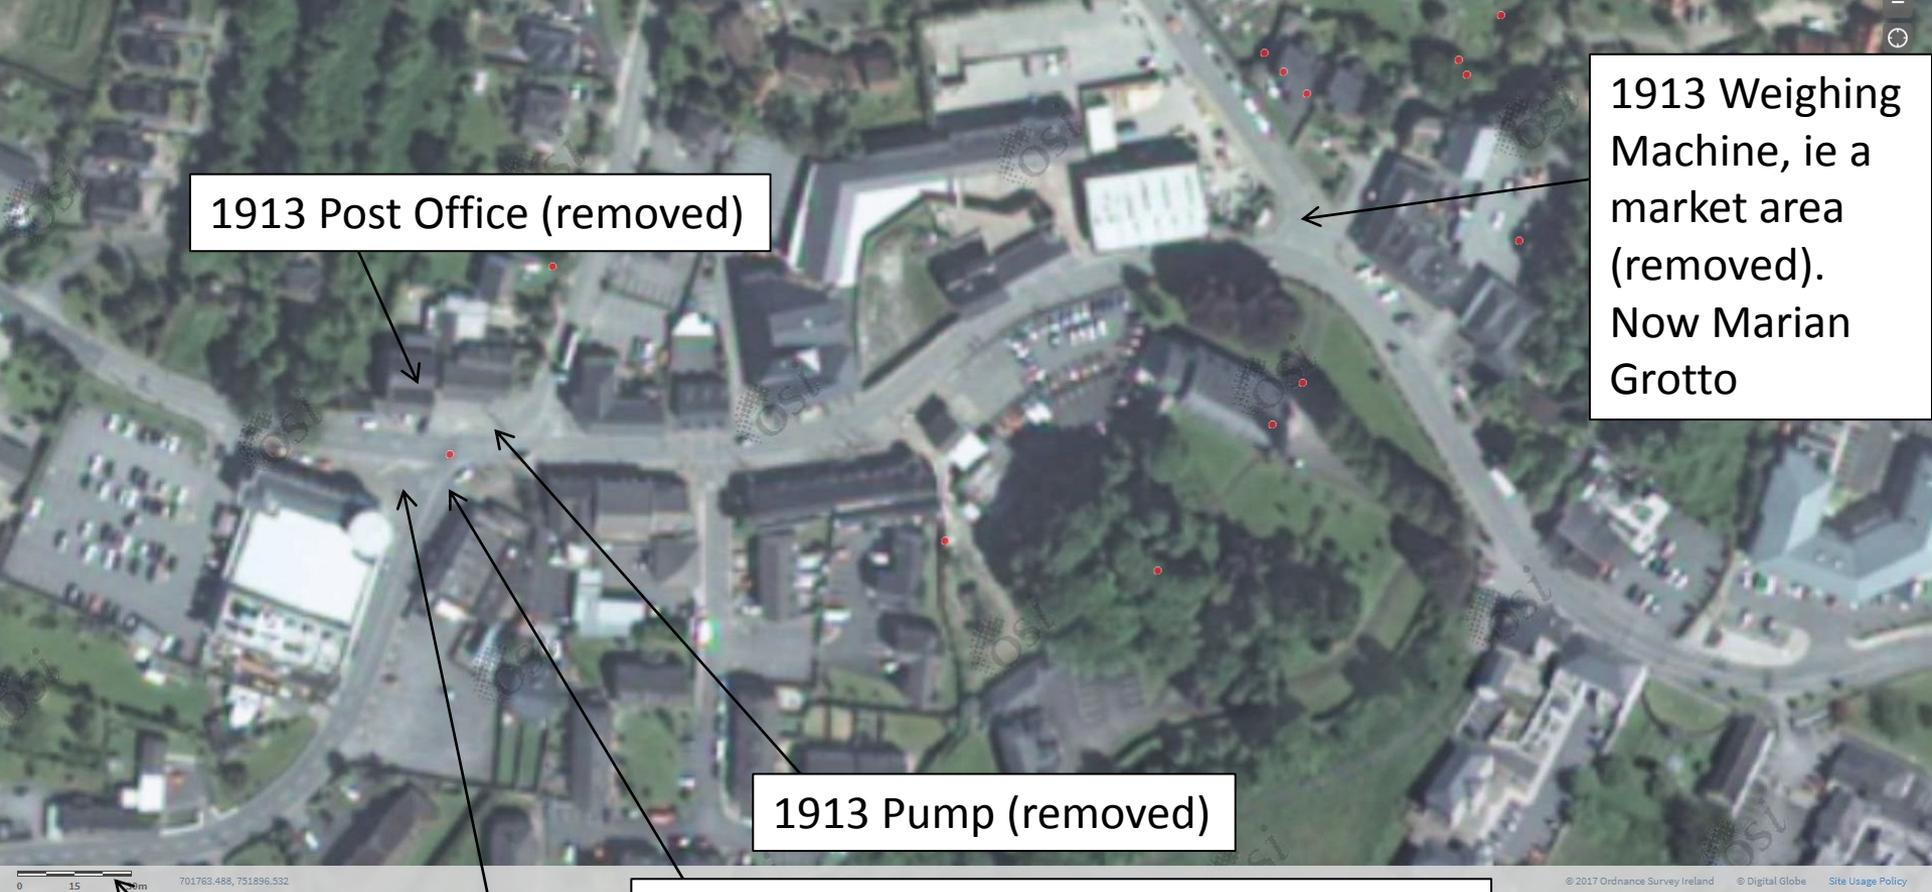
1913 Post Office (removed)

1913 Weighing Machine, ie a market area (removed).
Now Marian Grotto

Smithy – retained but disused

Fig 23: Present aerial detail with discussion elements

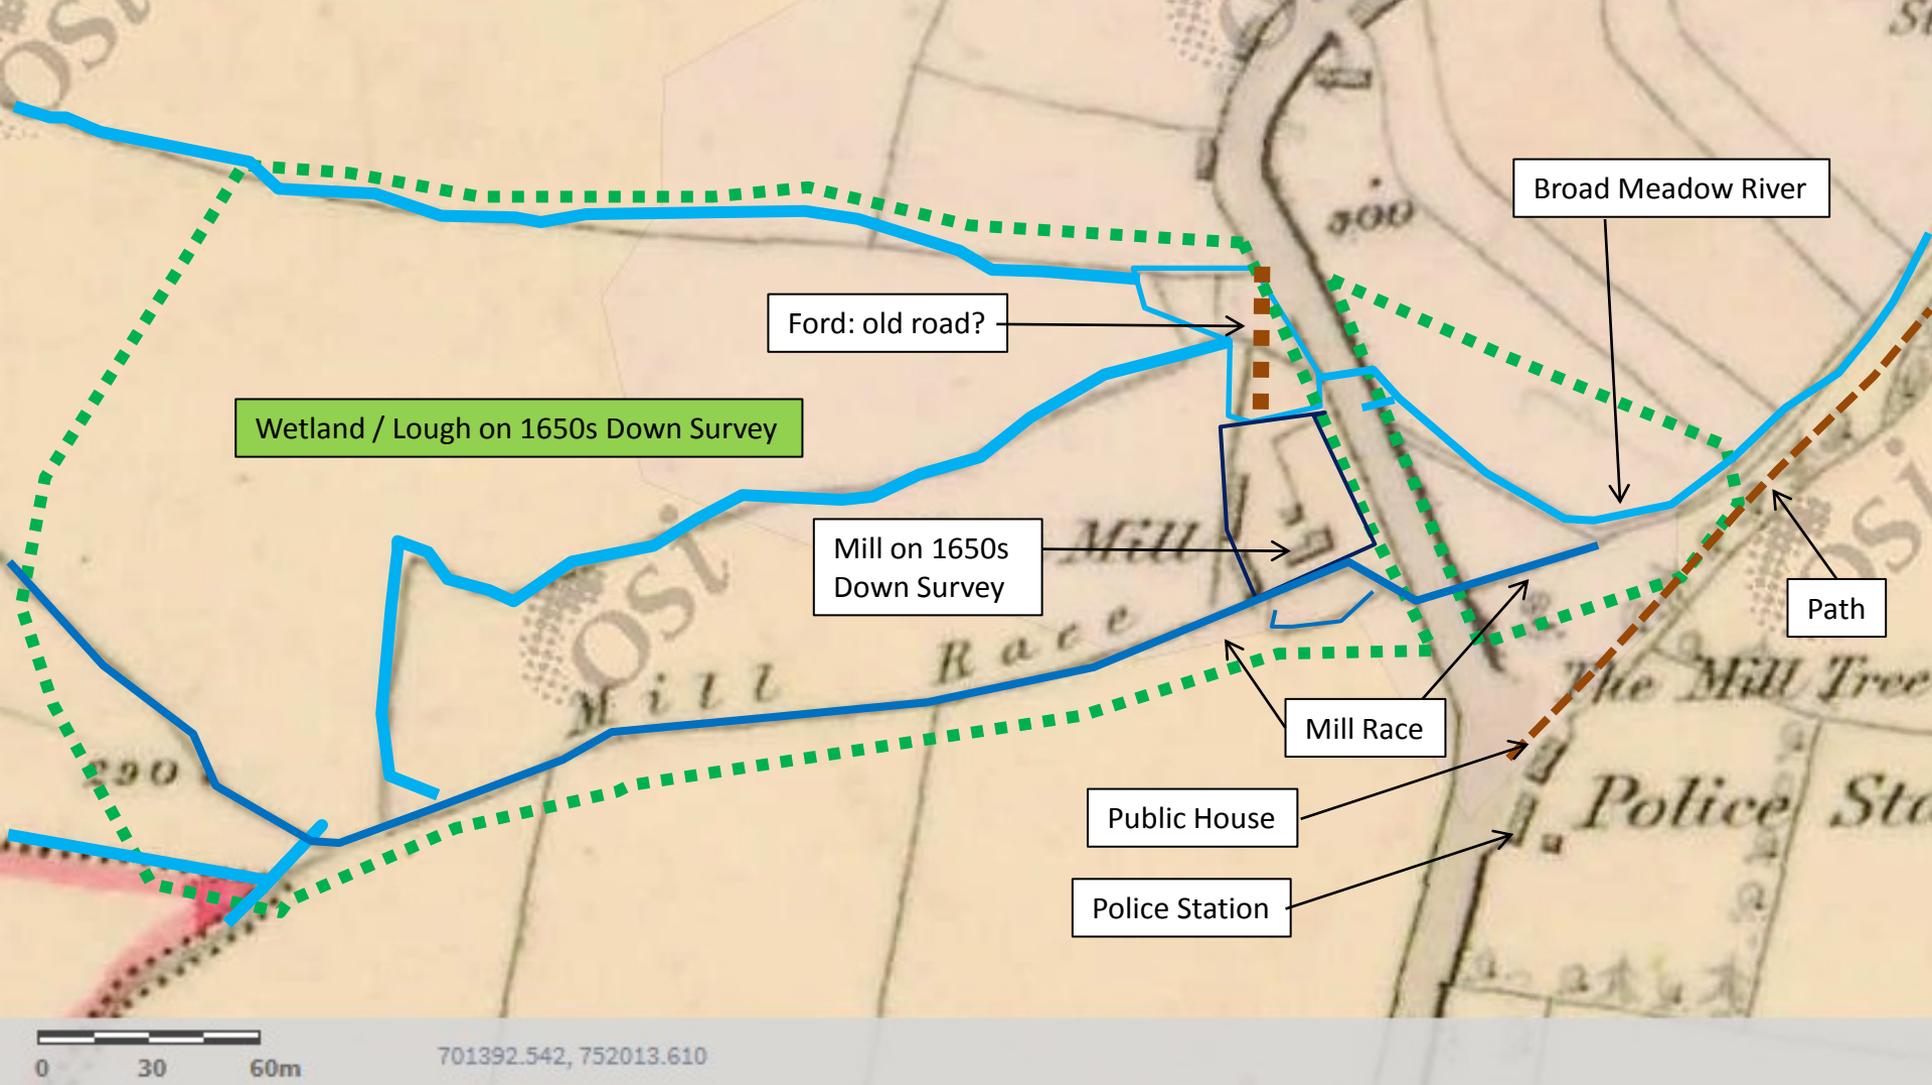
Fig 24: 1837 of area to west of Ratoath that was a lough or mill pond on the 1650s Down Survey

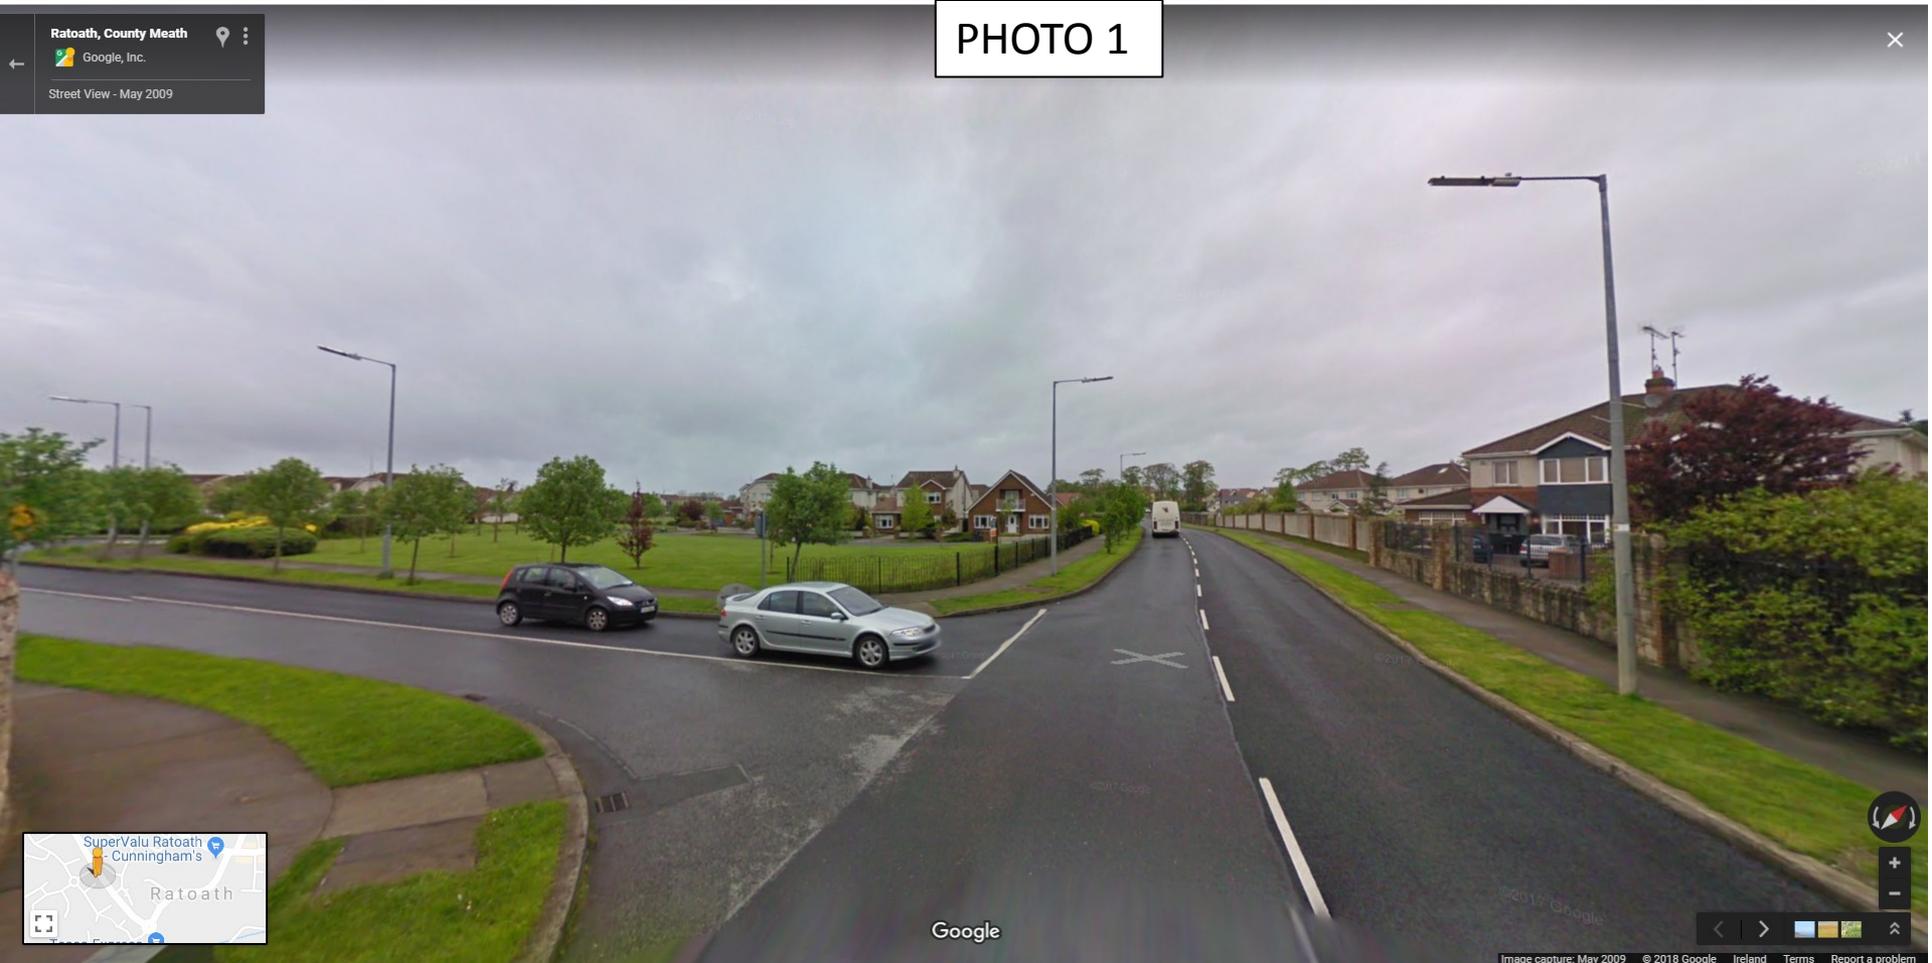
PHOTO 2

Discussion 802A

Typical view facing NW on Sean Eiffe Road showing condition as a housing estate (2009)

Discussion 802A (Fig 37, Photo 1)
