**Ratoath pedestrian and cycle scheme
Ratoath,
Co. Meath**

Desk Based Review and Assessment

Niall Roycroft

22nd November 2018

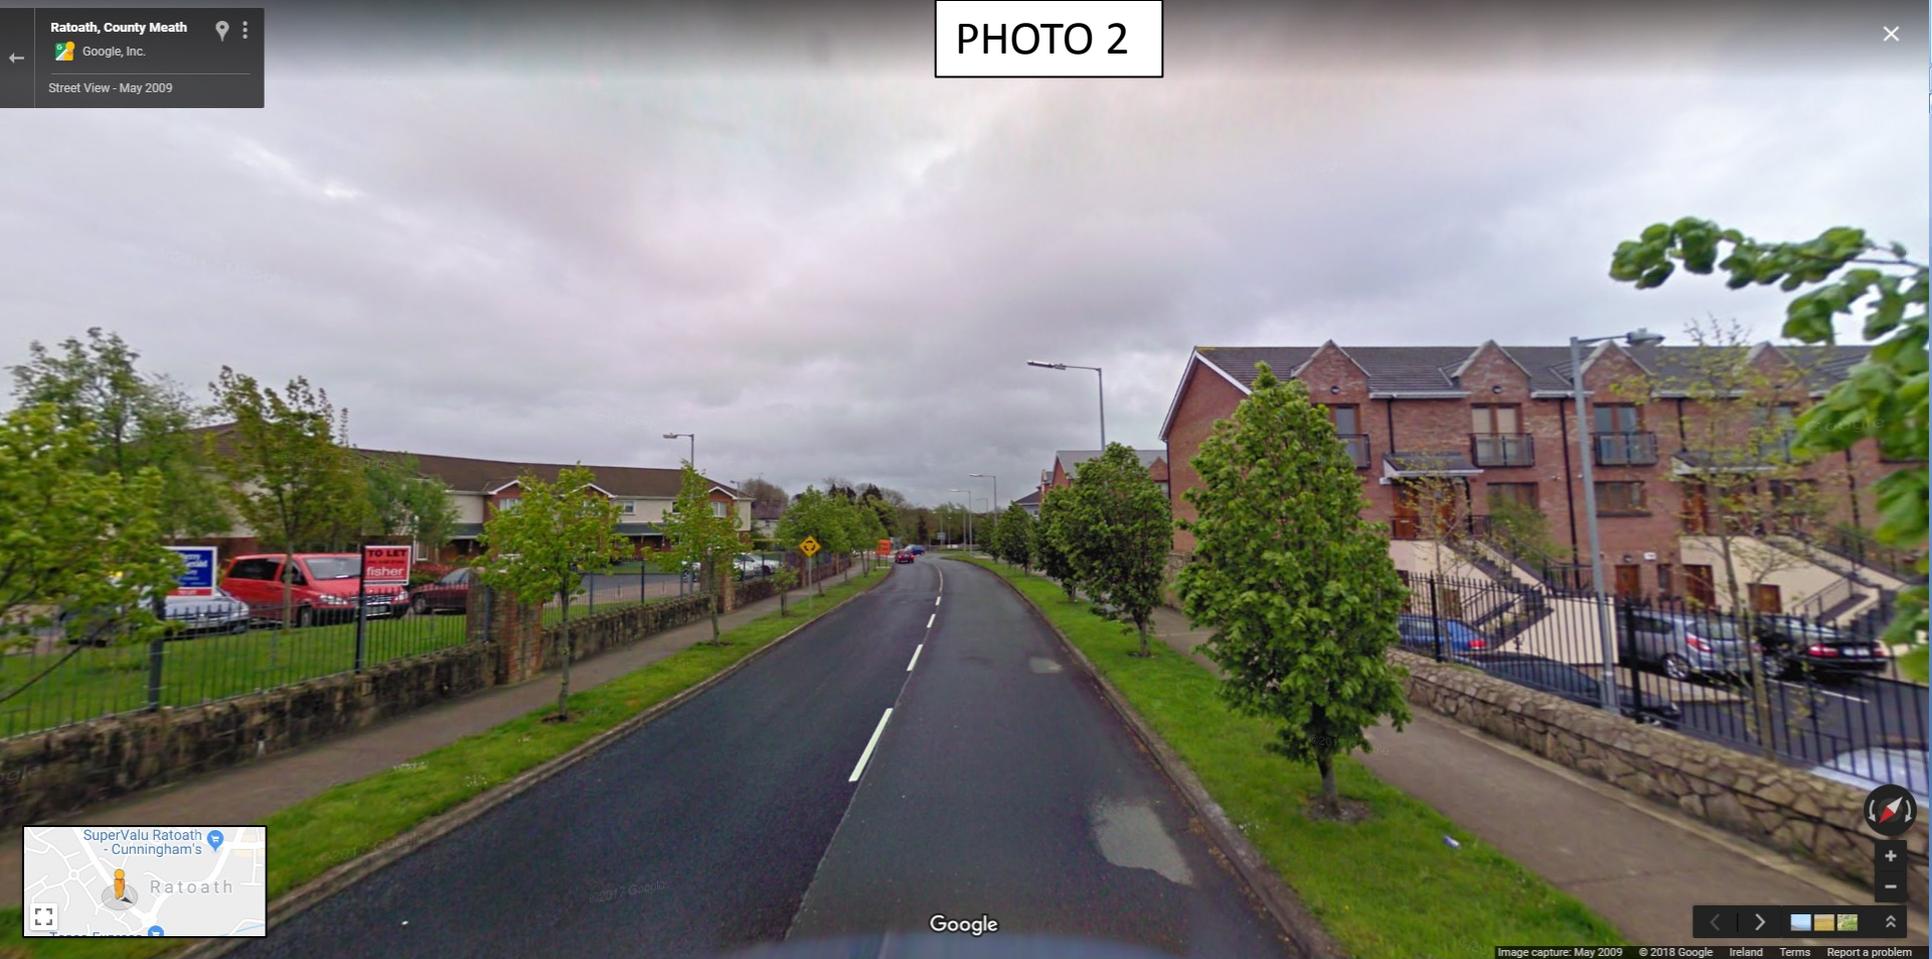
PHOTO 3

Discussion 802B

Typical view facing NW on Sean Eiffe Road showing condition as a housing estate (2009)

Discussion 802B (Fig 37, Photo 2)

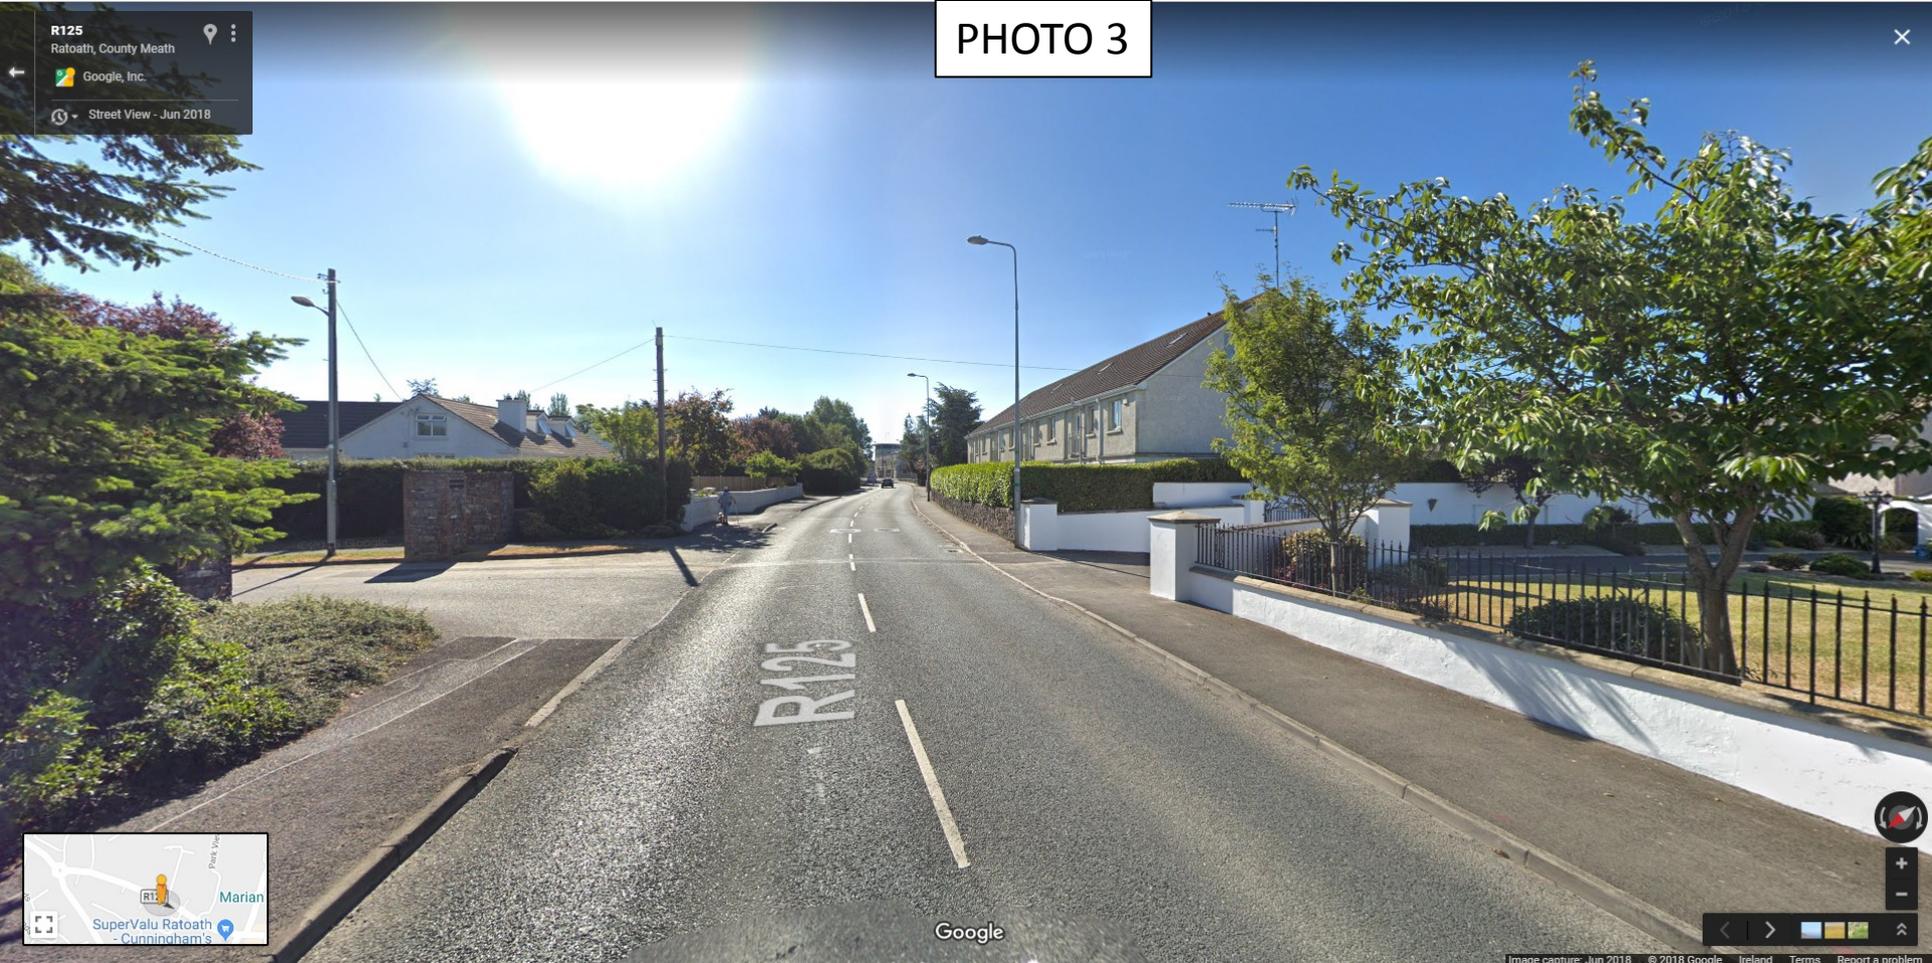
PHOTO 4

Discussion 803A

Typical view facing E on R125 showing built up condition (2018). Turning north to Streamstown estate on left

Discussion 803A (Fig 38, Photo 3)

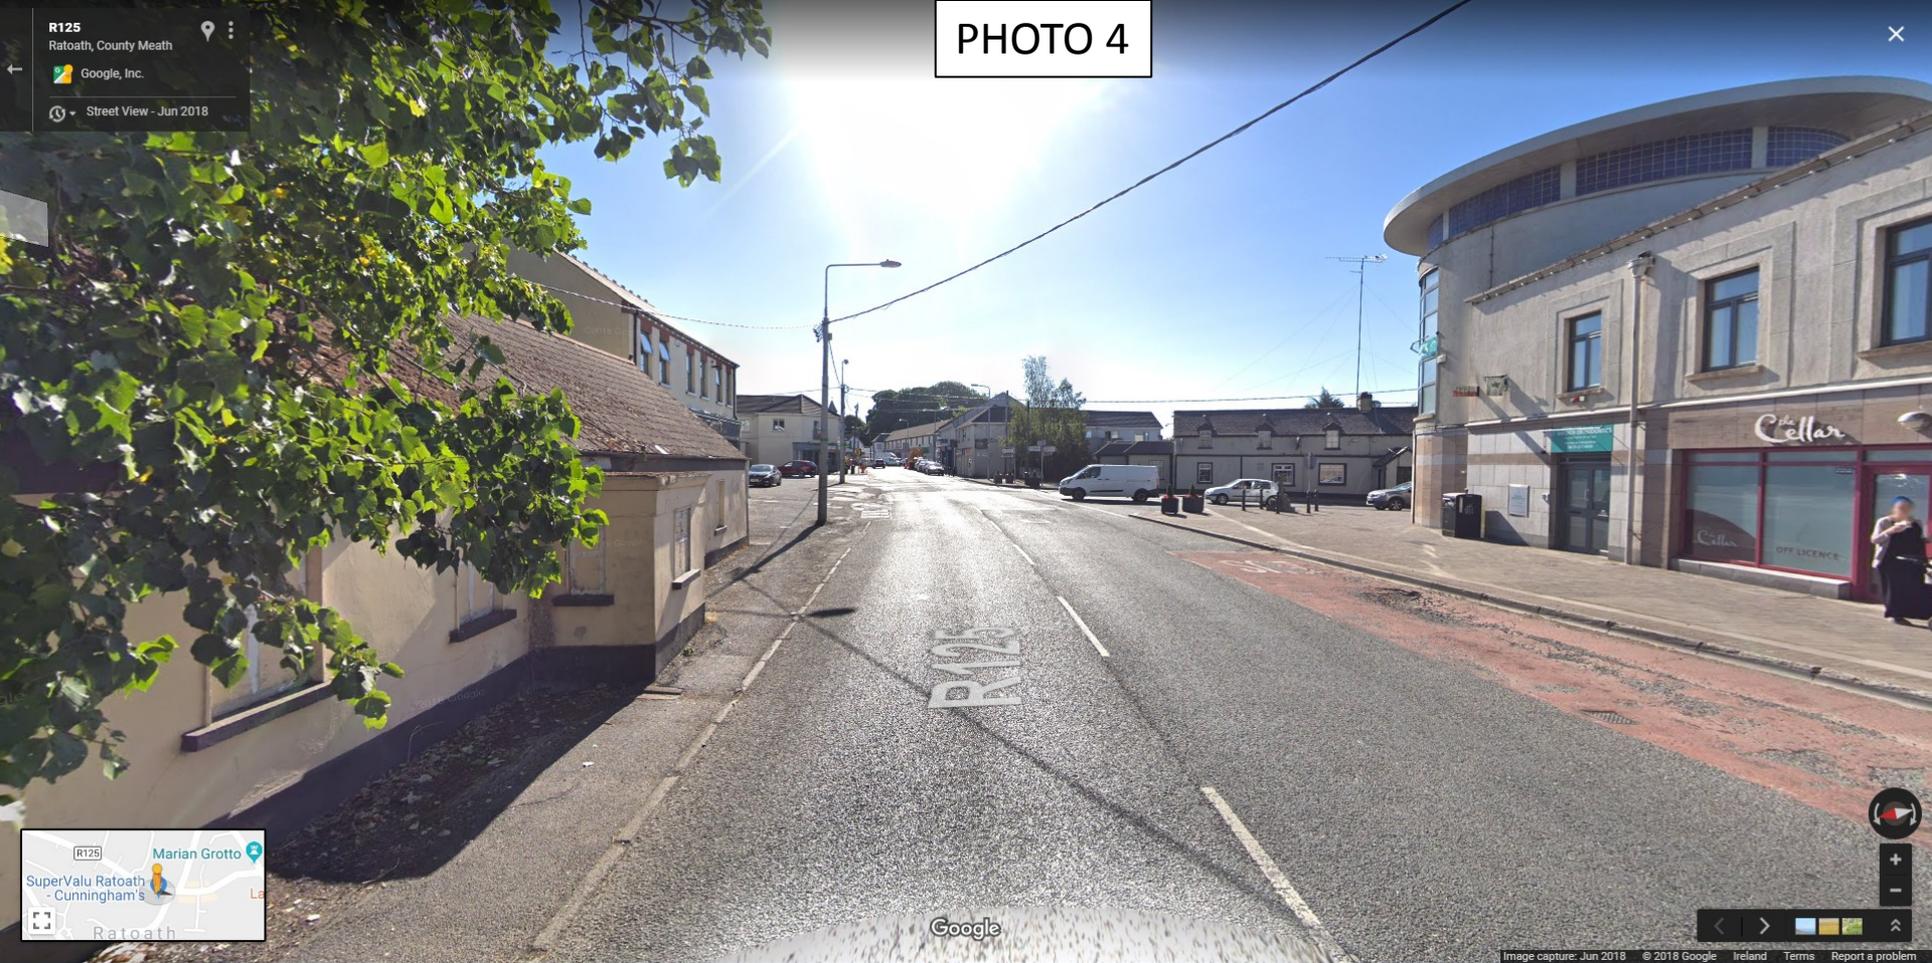
PHOTO 5

Discussion 804A + 804B

Typical view facing E on R125 –R155 junction showing built up condition (2018).

Discussion 804A (Fig 39, Photos 4, 5, 6)

Discussion 804B (Fig 39, Photos 4, 5, 6)

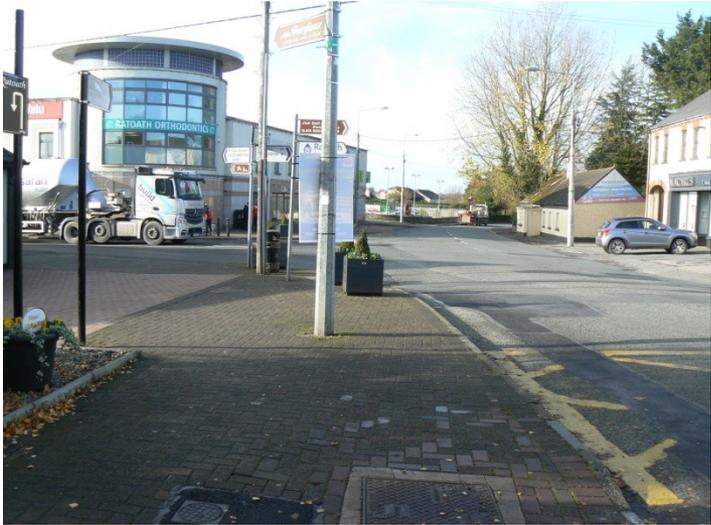
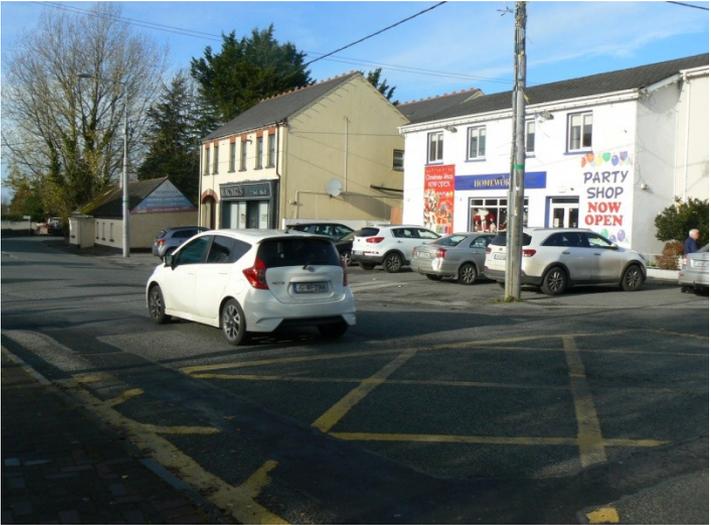
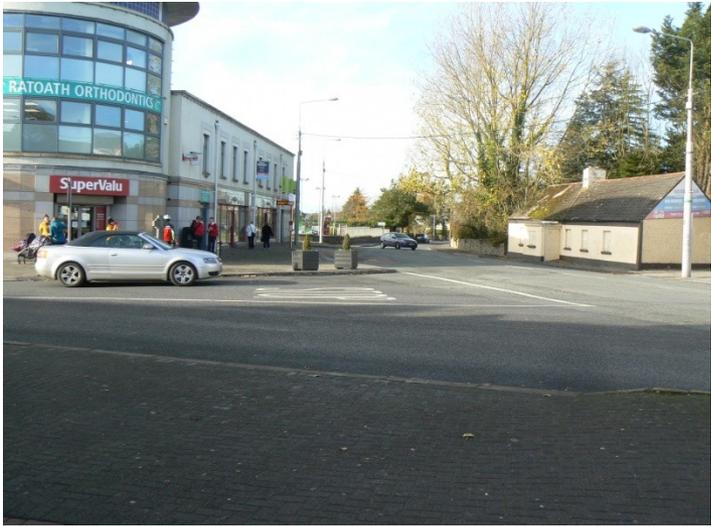
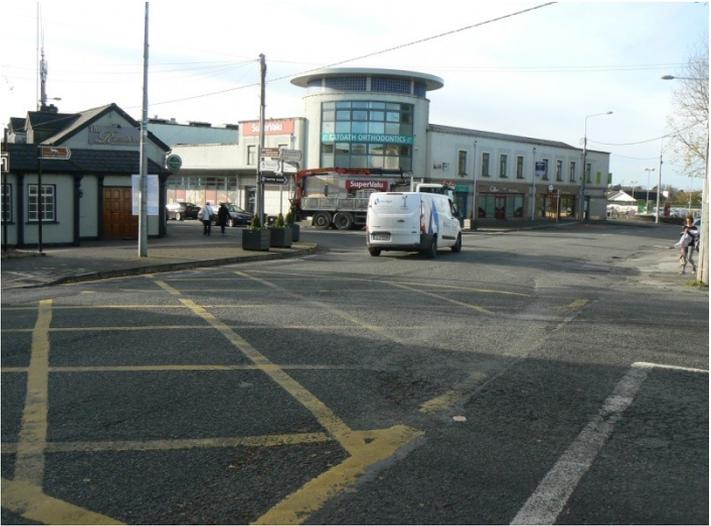
PHOTO 6

804B. Facing W. P1200485

804A. Facing W. P1200486

804B. Facing W. P1200487

804B. Facing W. P1200484

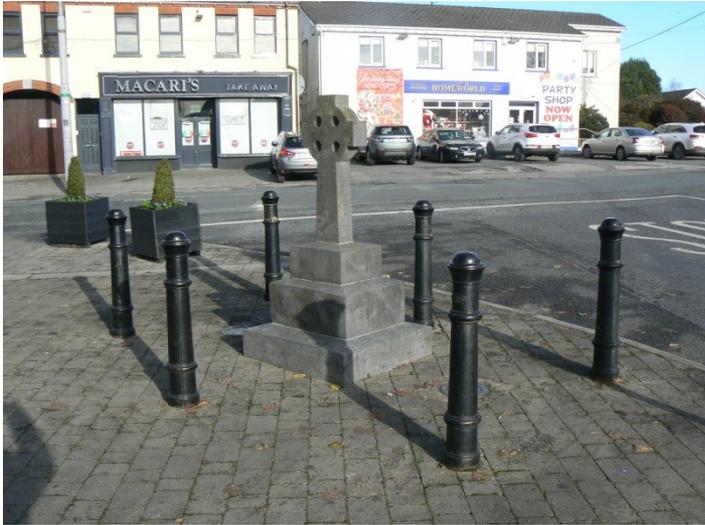
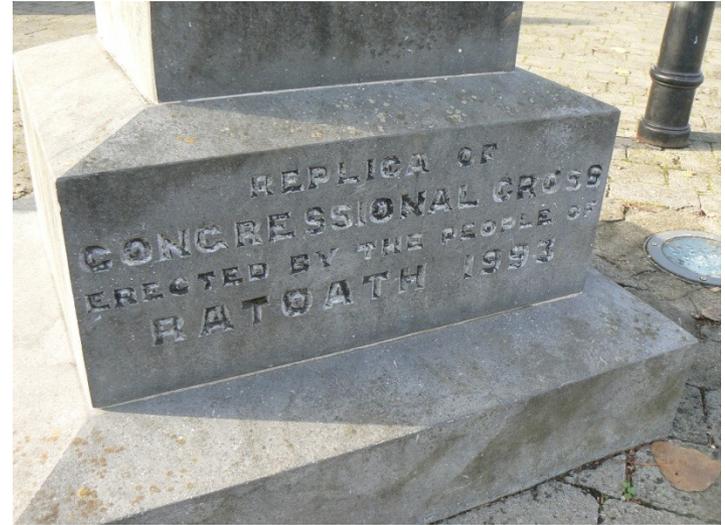
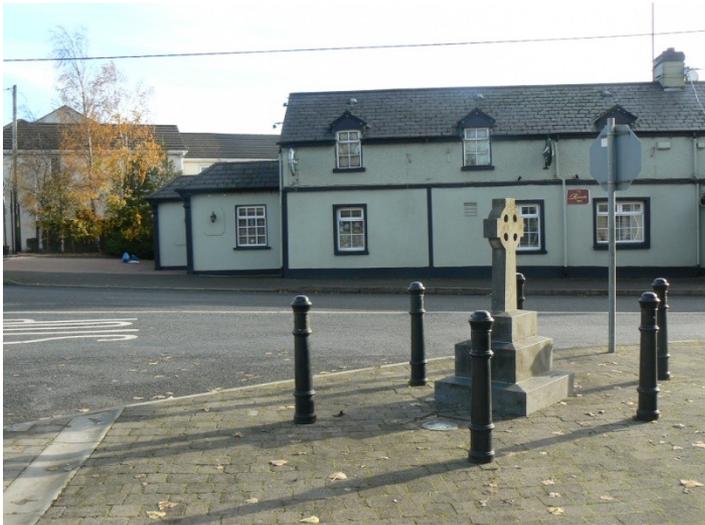
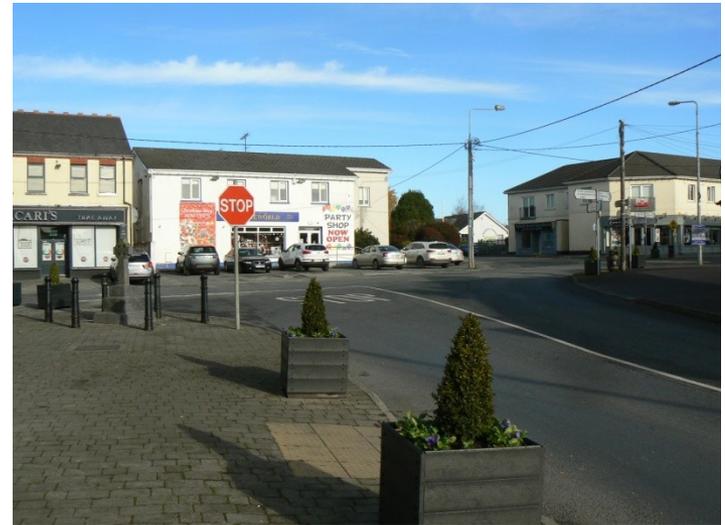
PHOTO 7

804B. Facing N. P1200489

804B. Facing W. P1200490

804B. Facing E. P1200491

804A+B. Facing W. P1200492

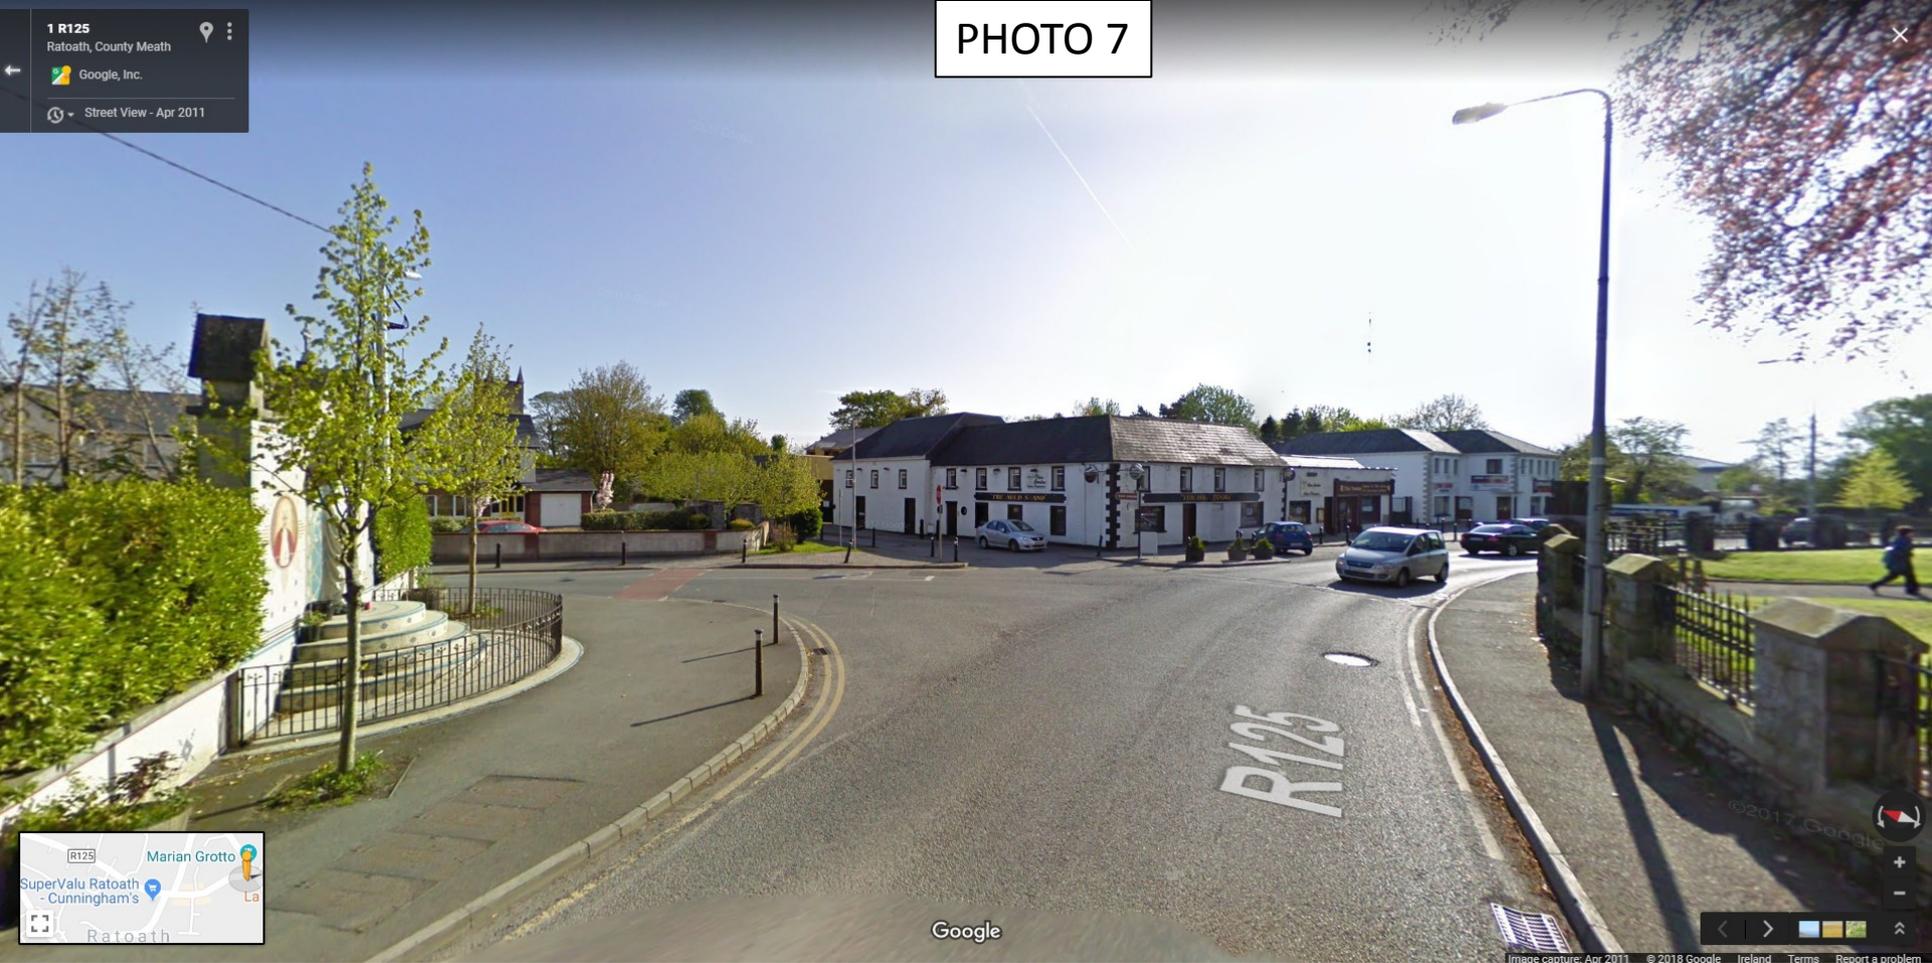
PHOTO 8

Discussion 804C

Typical view facing E on R125 Main Street Skryne Road (left) junction showing built up condition (2018). Facing E

Discussion 804C (Fig 39, Photos 7, 8, 9)

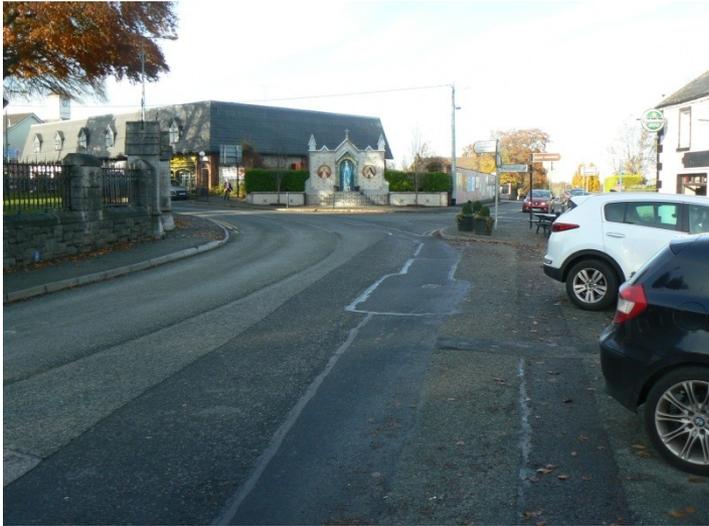
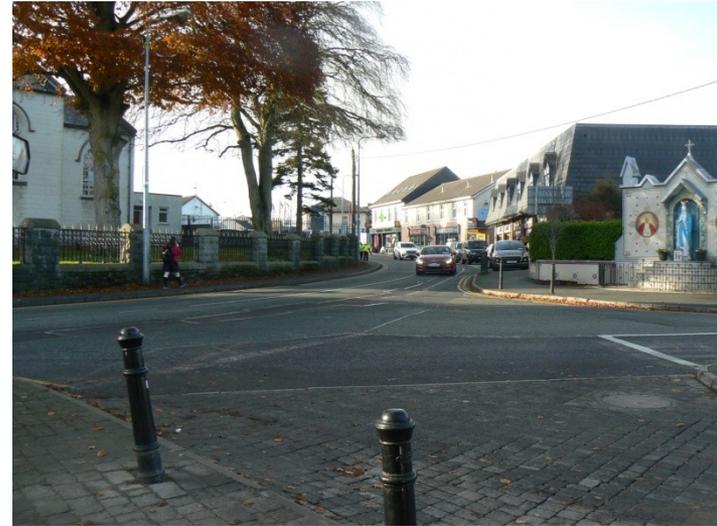
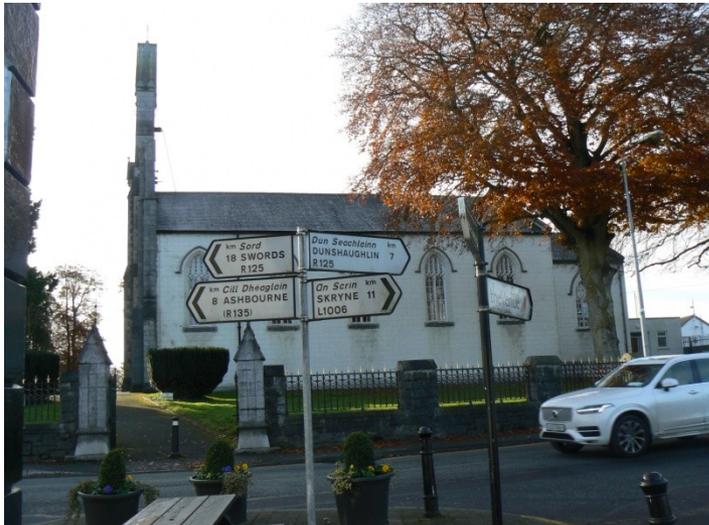
PHOTO 9

804C with grotto. Facing N with Skryne Road to right. P1200471

804C with grotto. Facing W. Ratoath Church on left. P1200472

804CRatoath Church and gate from Glebe Lane. Facing SW. P1200473

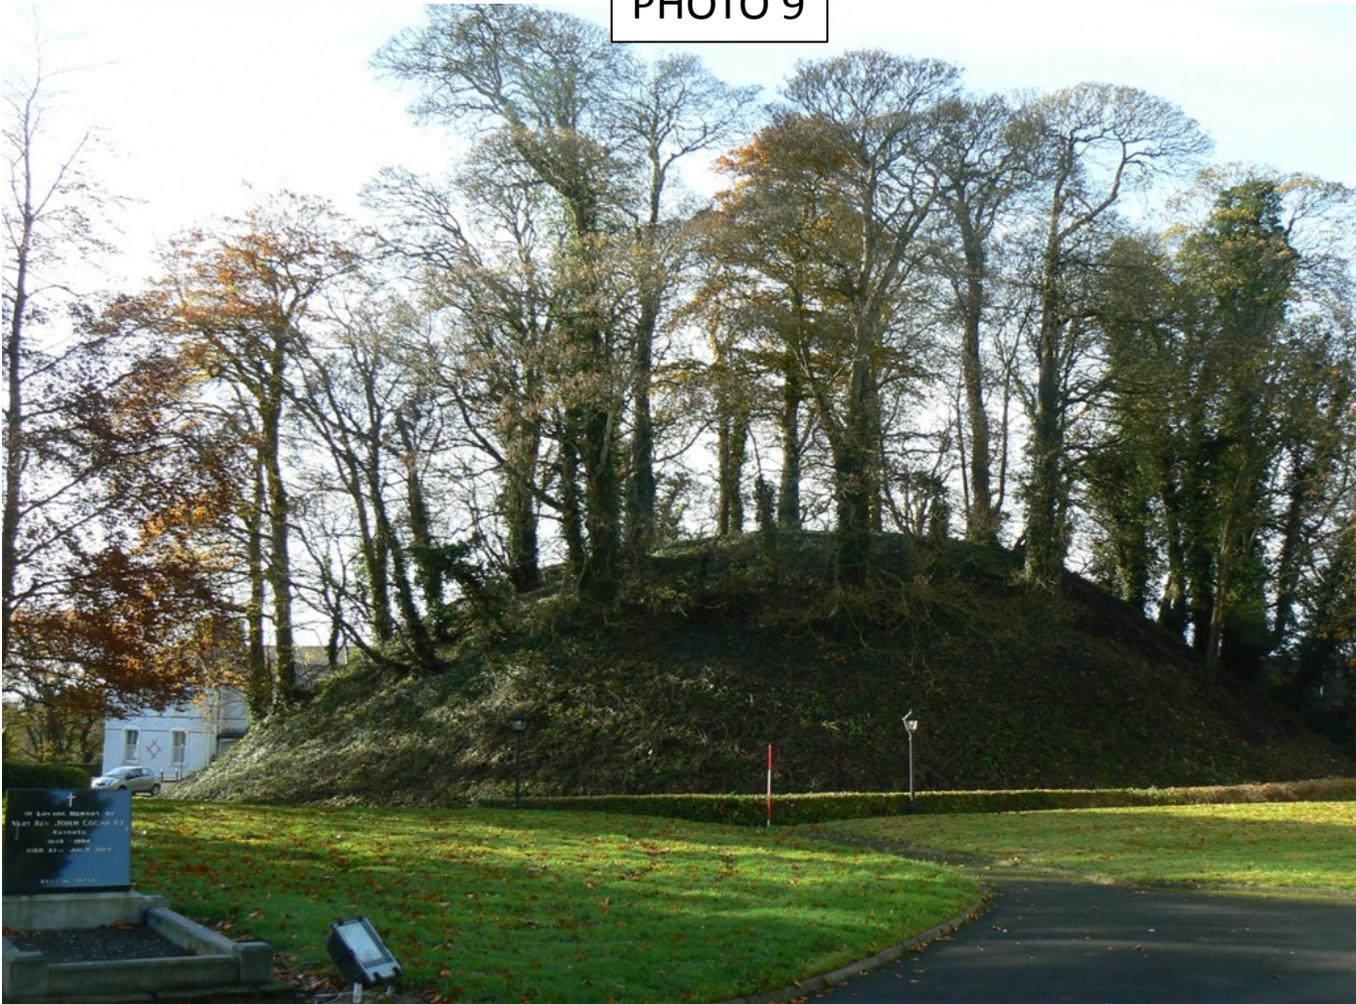
P1200468

Ratoath Motte. Facing SW

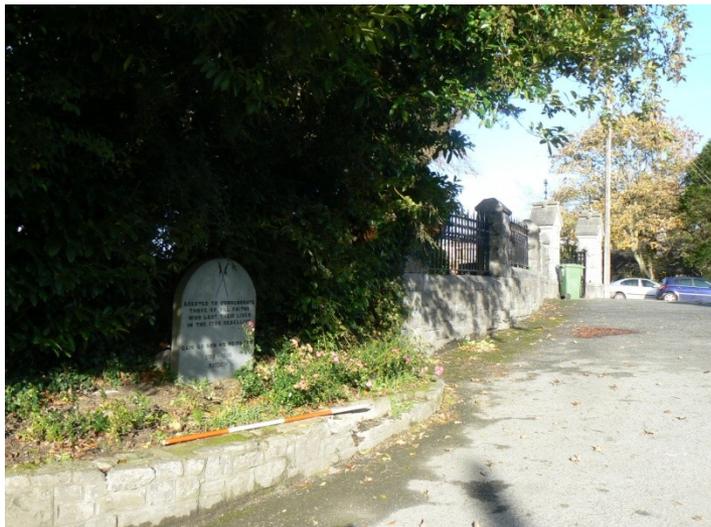
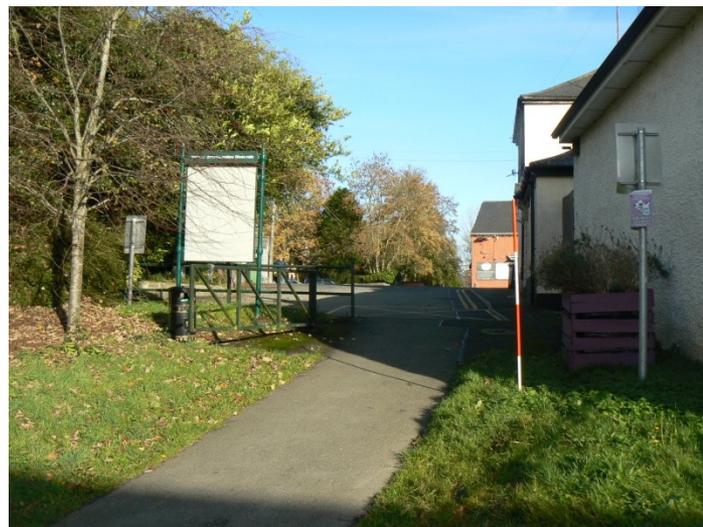
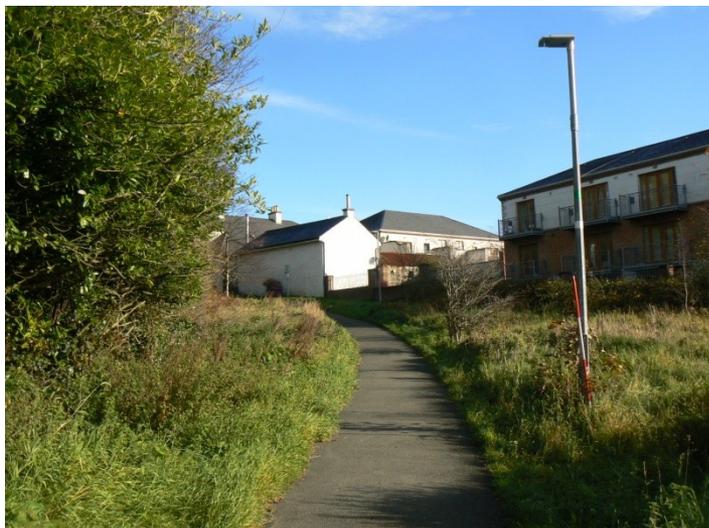
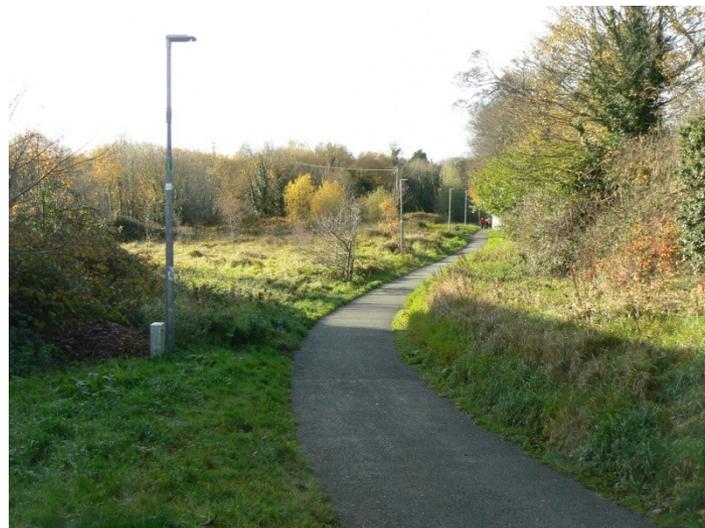
PHOTO 12

804D. Church end. Facing N. P1200464

804D. Church end. Facing N. P1200462

804D. Facing N. P1200461

804D. Facing S. P1200463

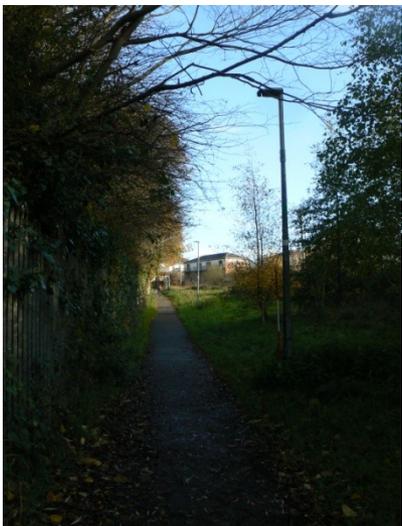
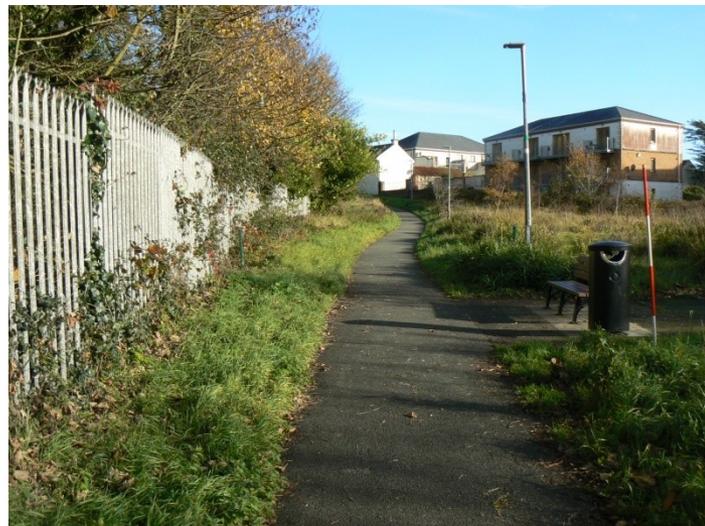
PHOTO 13

813F near to Bridge 1. Facing
NE. P1200459

813F facing NE. P1200460

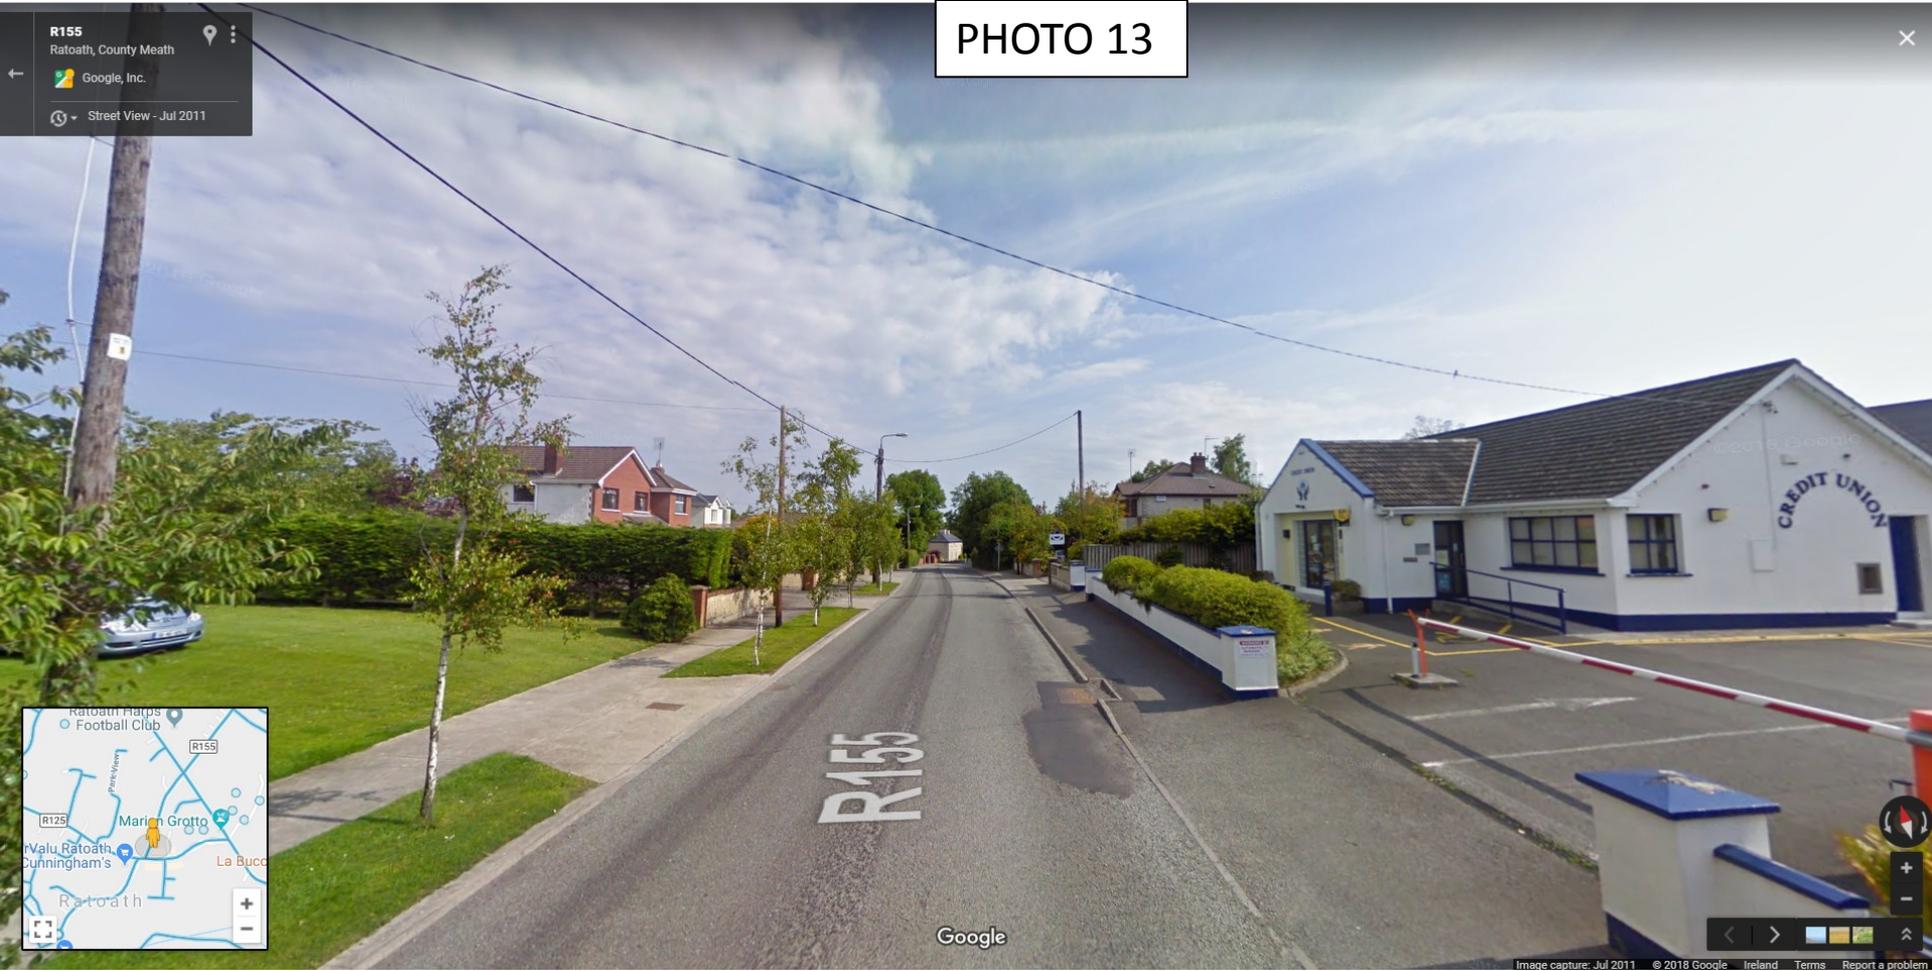
PHOTO 14

Discussion 804E

Typical view on R155 Well Road, Facing N (2018).

Discussion 804E (Fig 39, Photo 13)

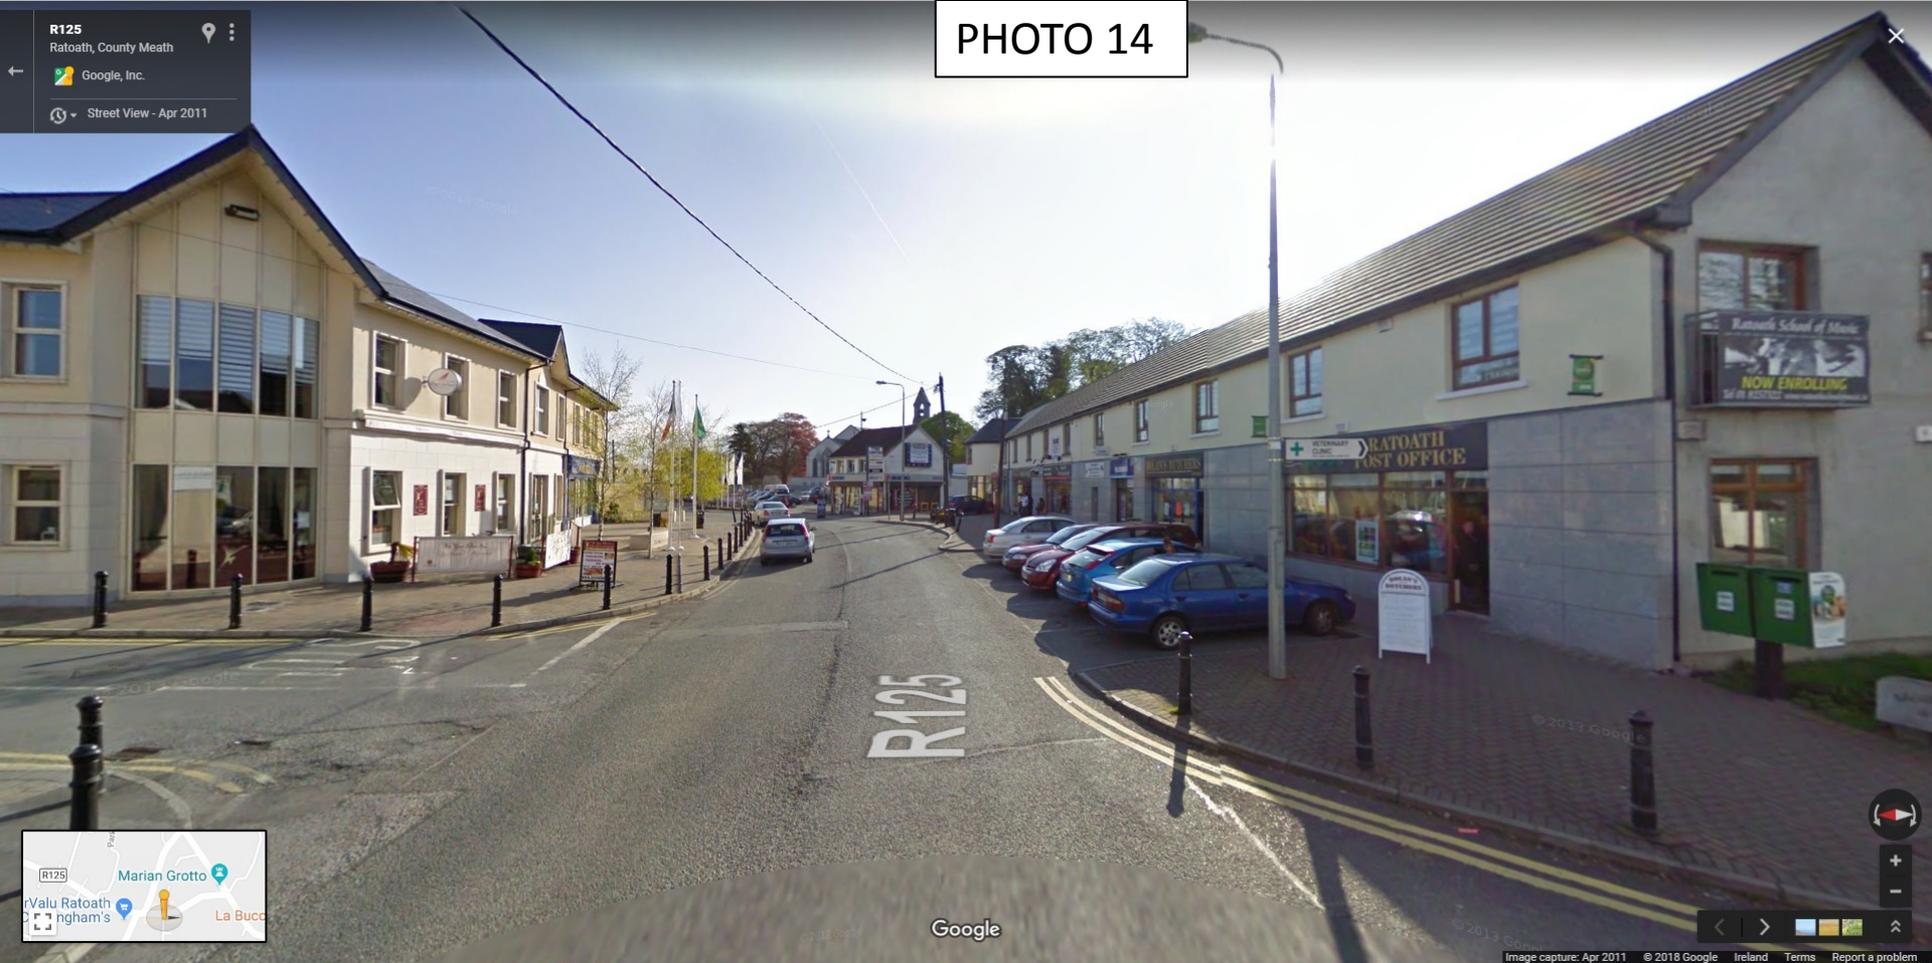
PHOTO 15

Discussion 804F

Typical view on R125 Main Street. Facing E (2018).

Discussion 804F (Fig 39, Photo 14)

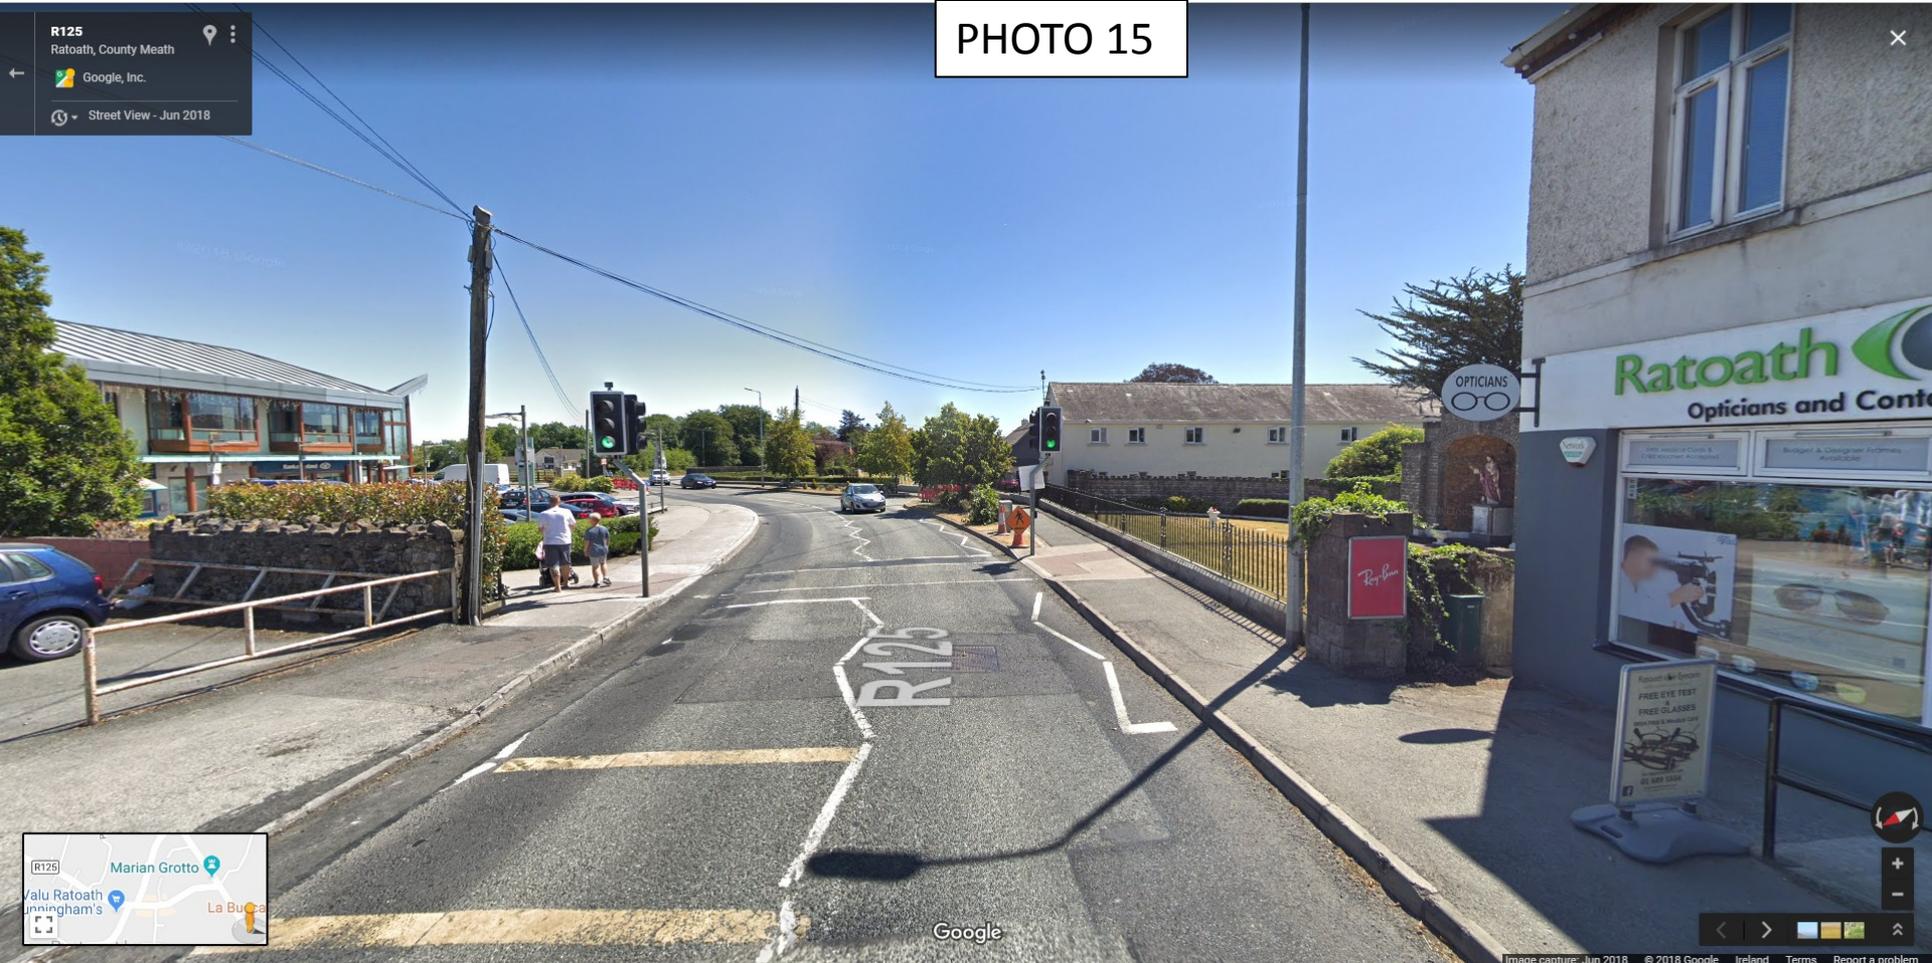
PHOTO 16

Discussion 805A

Typical view on R125 Main Street. Facing E (2018).

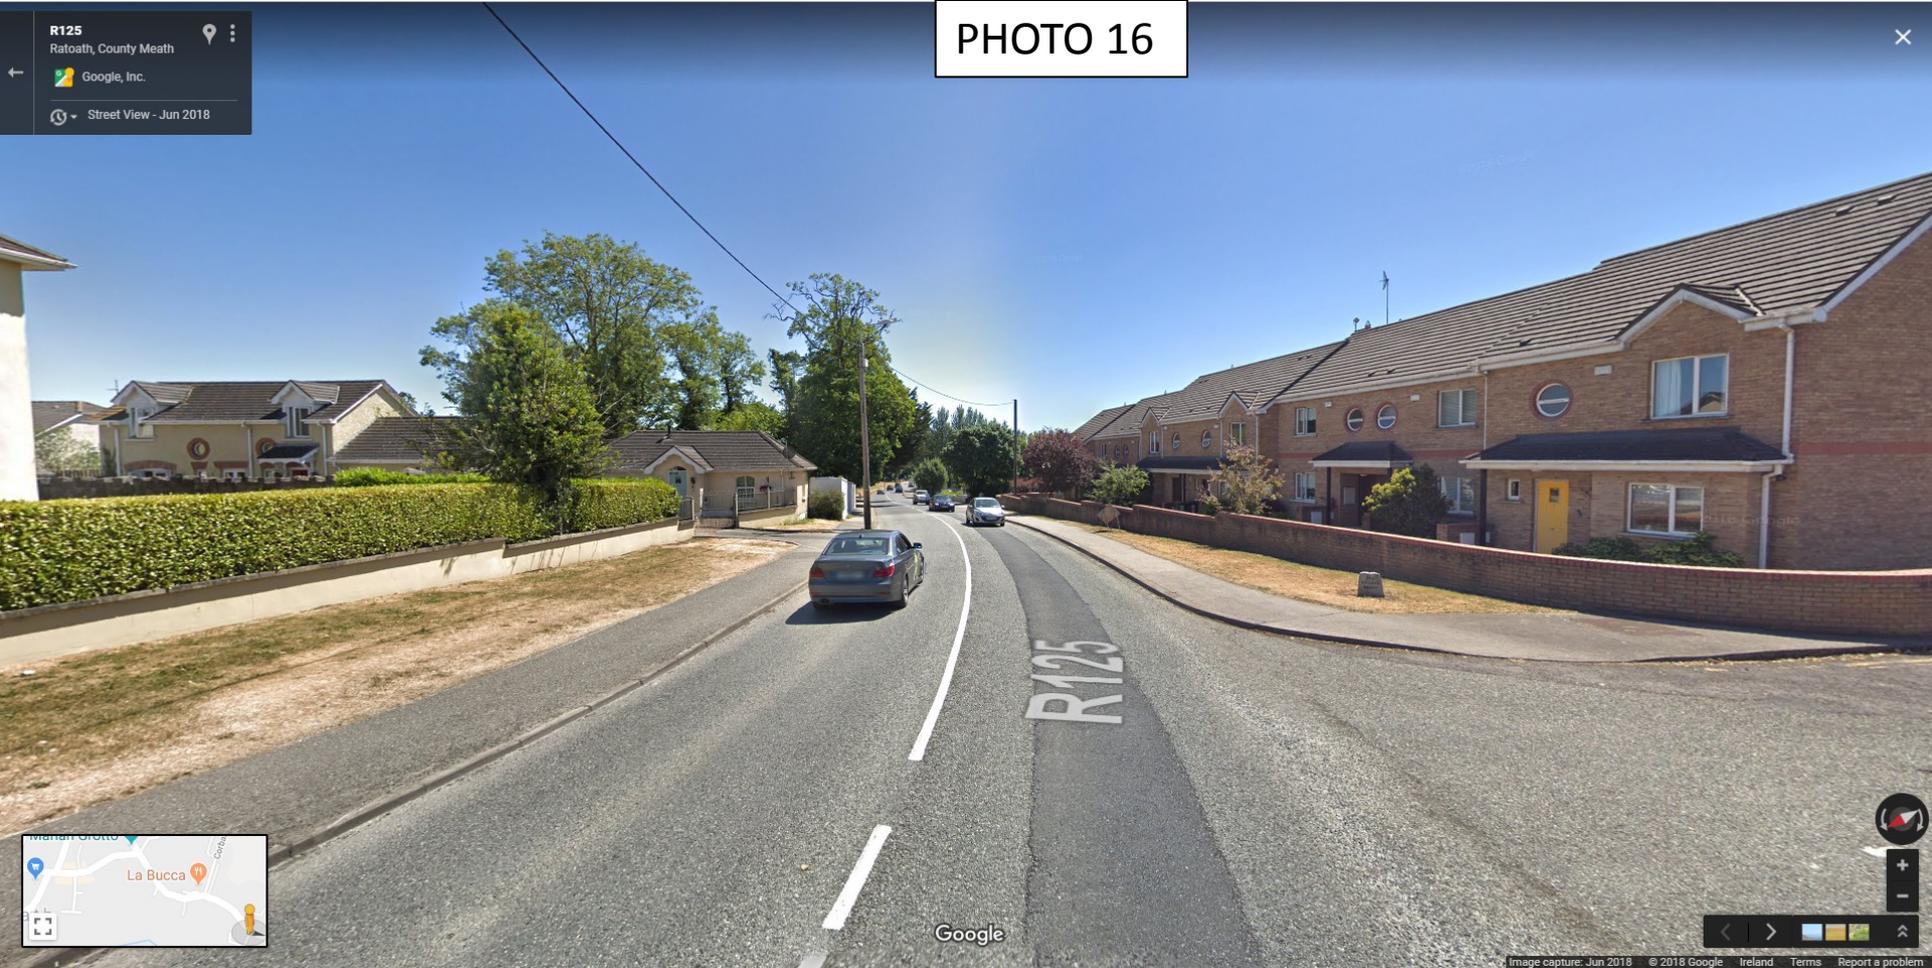
PHOTO 17

Discussion 805B

Typical view on R125 on E side of Ratoath. Facing E (2018).

Discussion 805B (Fig 40, Photo 16)
