**Ratoath pedestrian and cycle scheme
Ratoath,
Co. Meath**

Desk Based Review and Assessment

Niall Roycroft

22nd November 2018

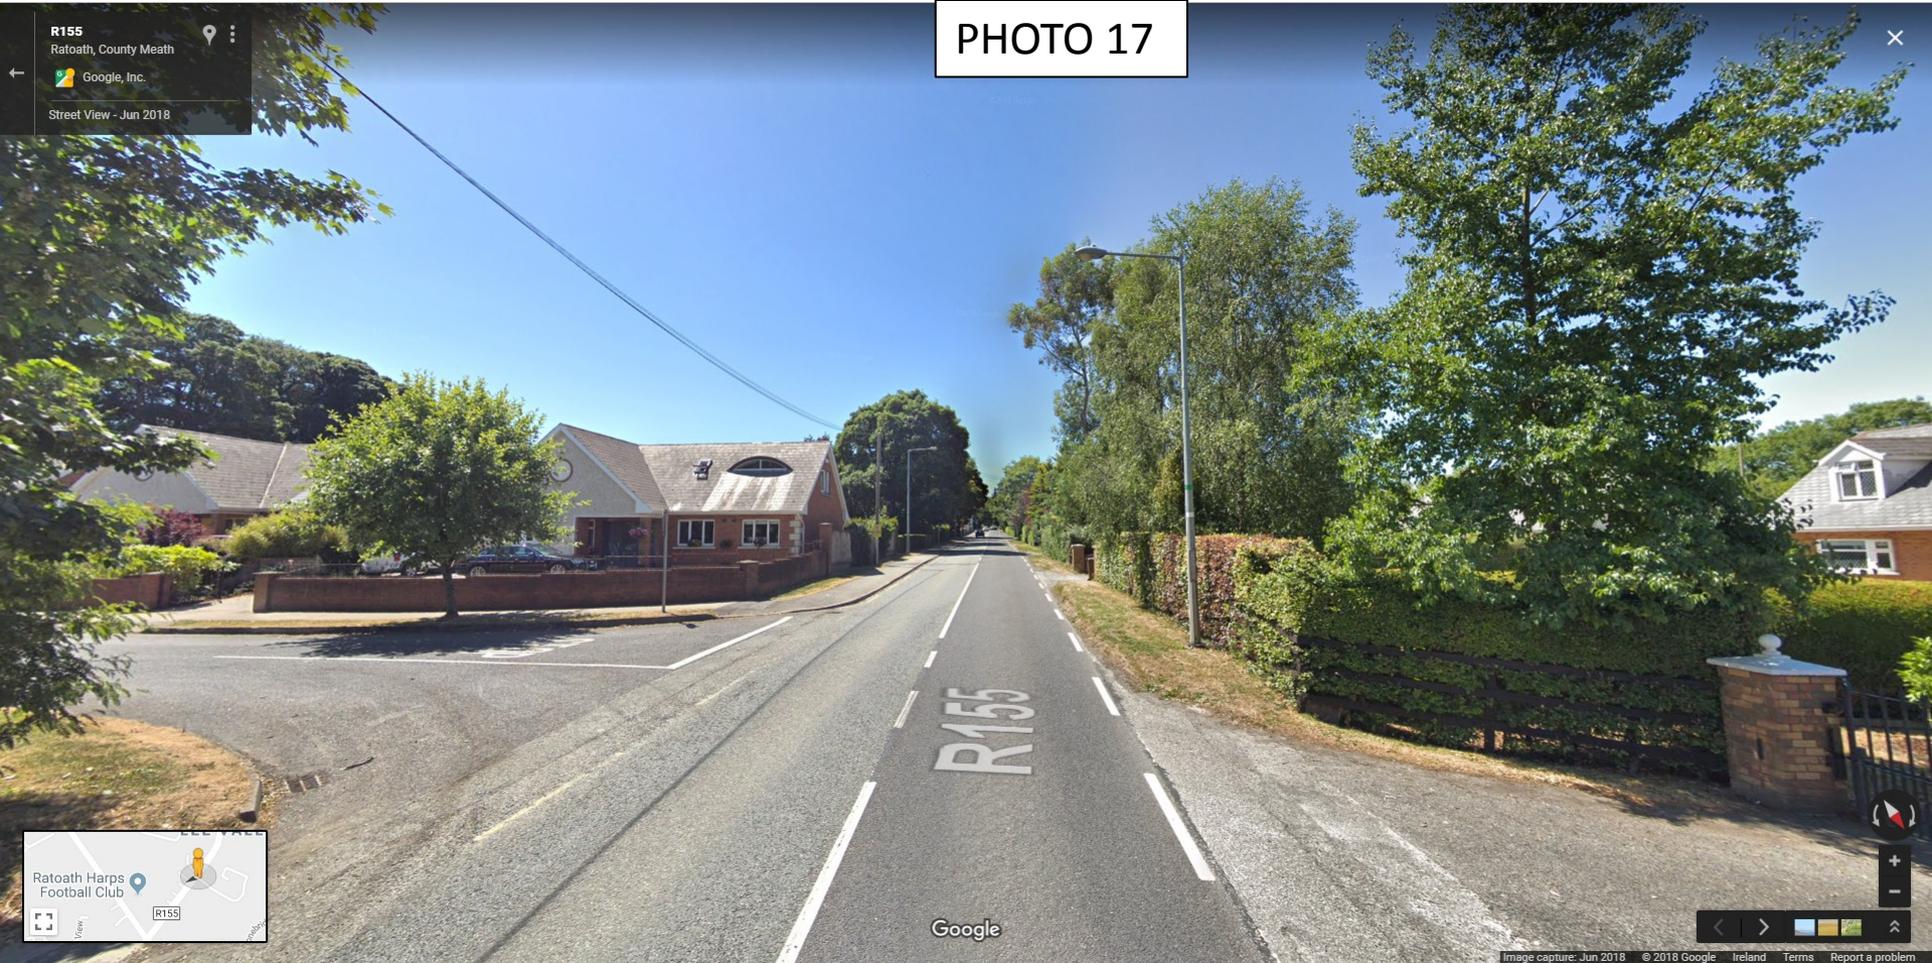
Discussion 808A

Typical view on R155 Curragha Road on NE side of Ratoath. Facing SW (2018).

Discussion 808A (Fig 41, Photo 17)

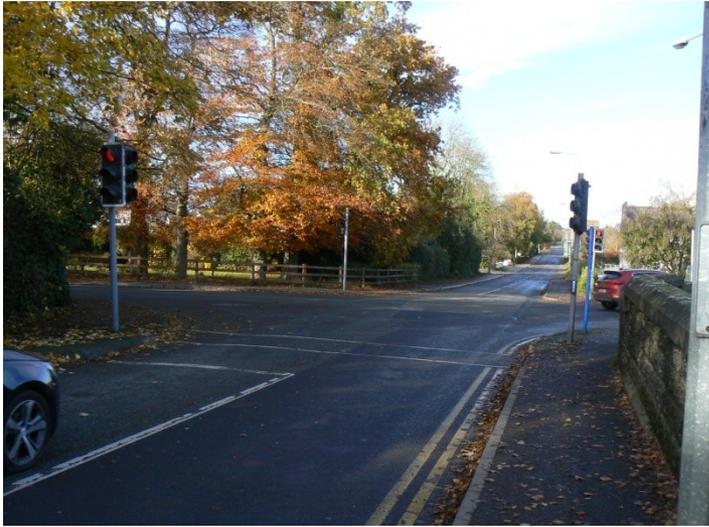
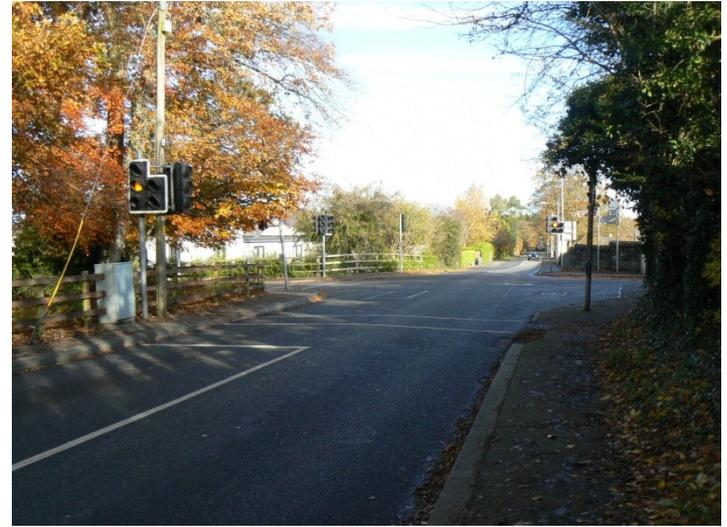
808B. Skryne Road with graveyard wall on right. Facing N. P1200482

808B. R155 Well Road facing NE to junction with Skryne Road. P1200483

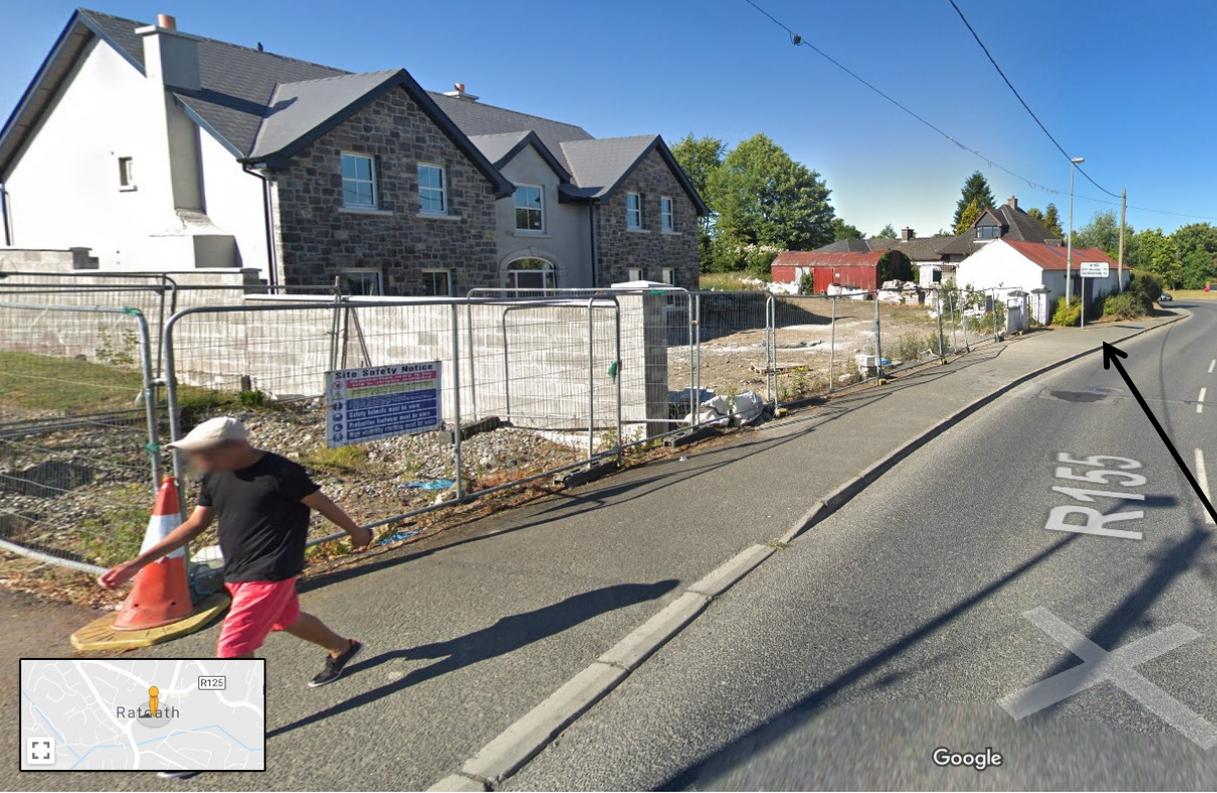
PHOTO 21

Typical view on R155 Fairyhouse Road on SW side of Ratoath. Facing SW (2018). Previous smithy (arrowed)

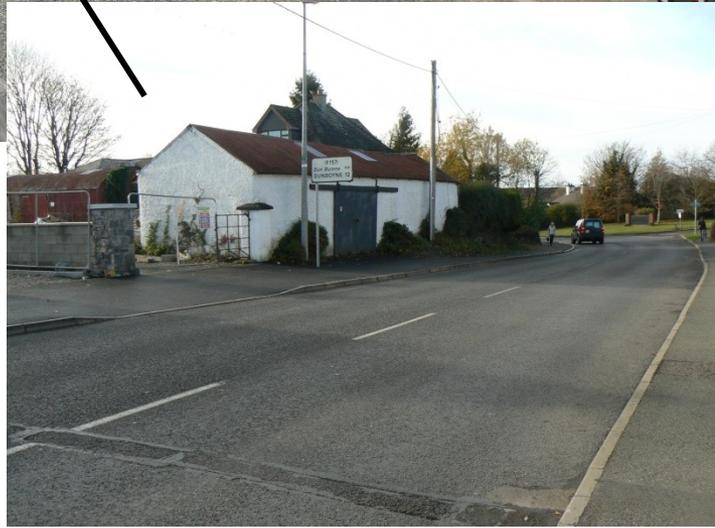
Discussion 810A

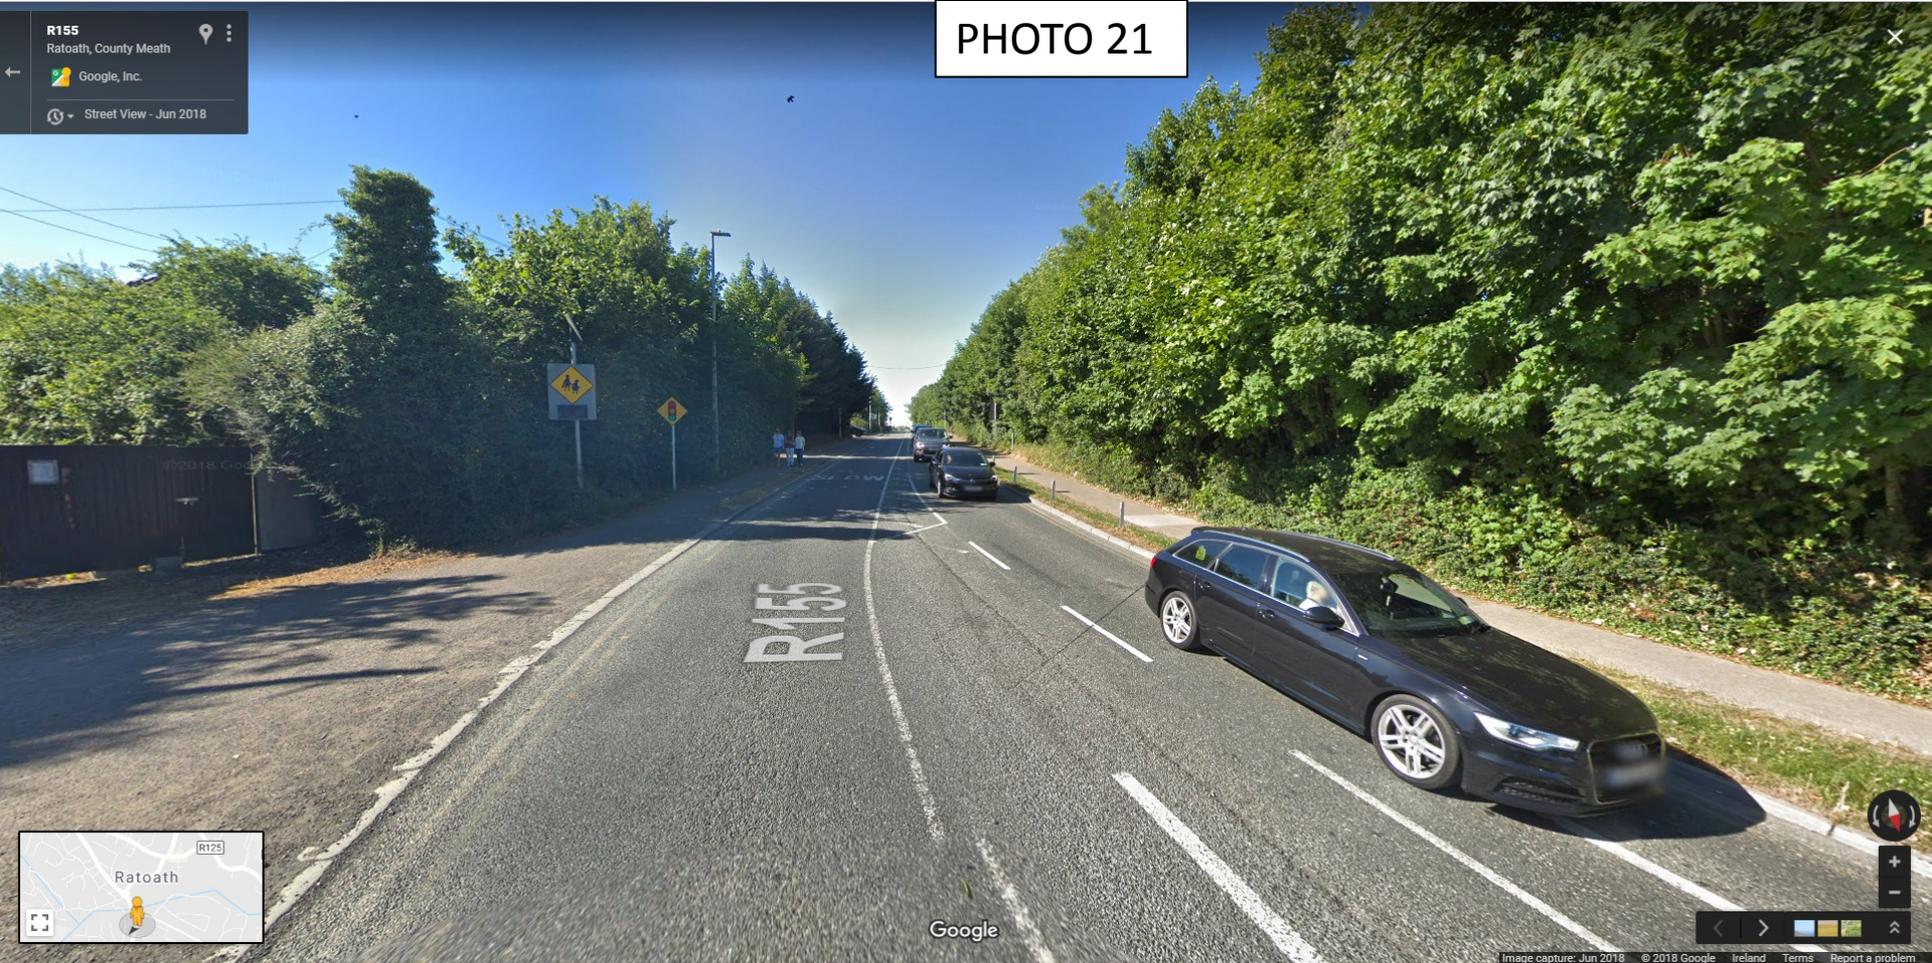
PHOTO 22

Discussion 811A

Typical view from northern end of 808A, R155 Fairyhouse Road on SW side of Ratoath. Facing S (2018).

Discussion 811A (Fig 43, Photos 21, 22)

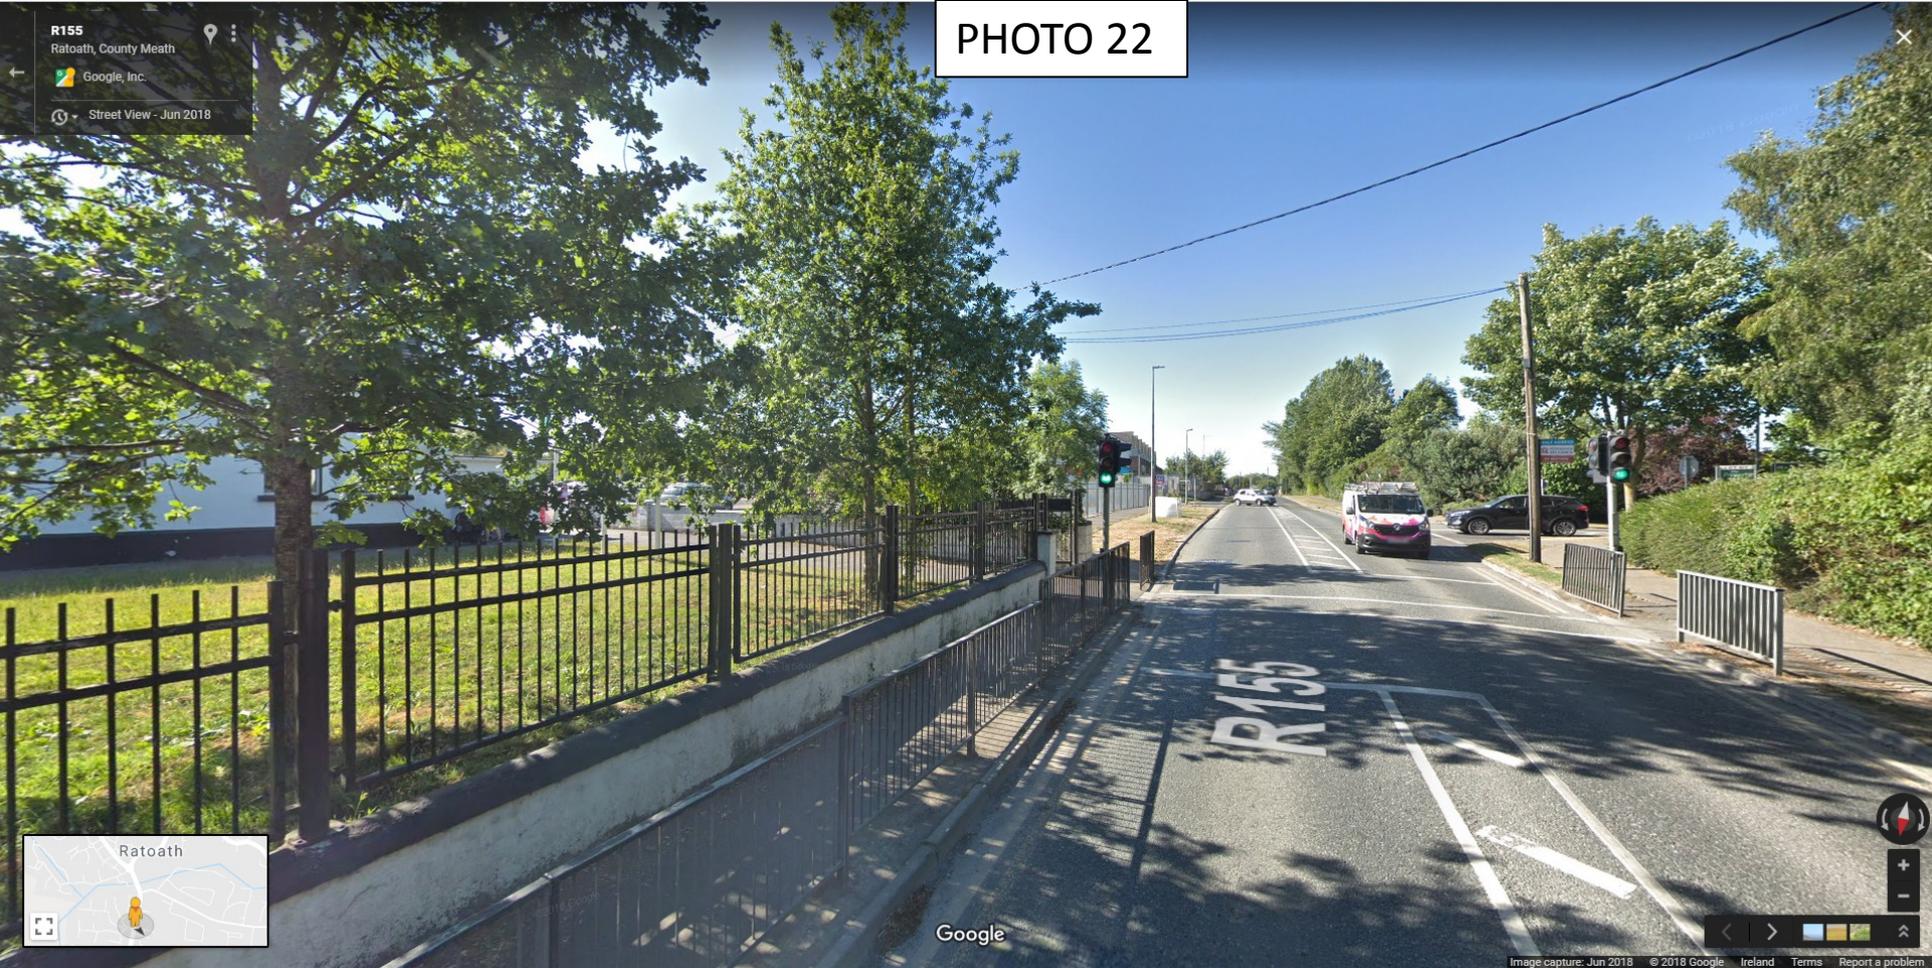
Discussion 811A

Typical view of R155 Fairyhouse Road outside Ratoath National School. Facing S (2018).

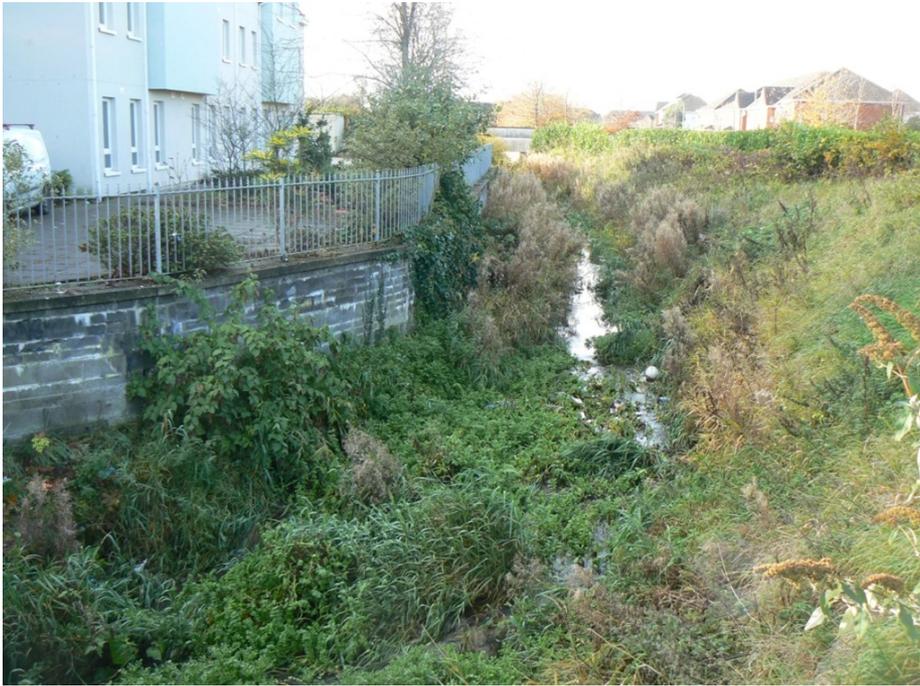
Broad Meadow River to W of R155. Facing W. P1200500

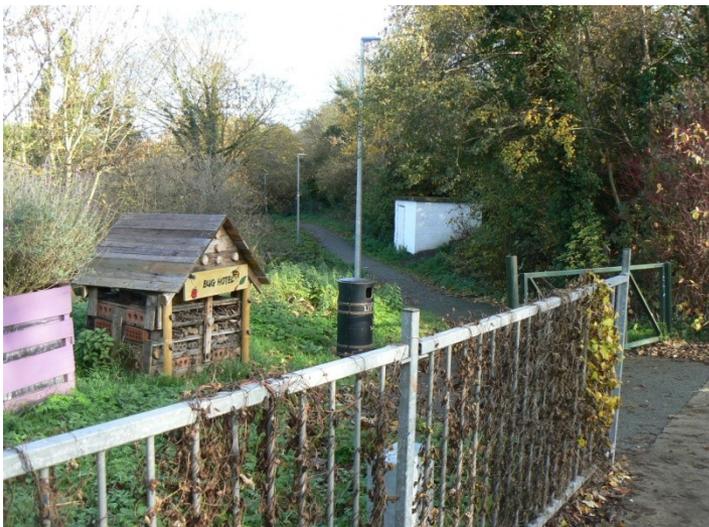
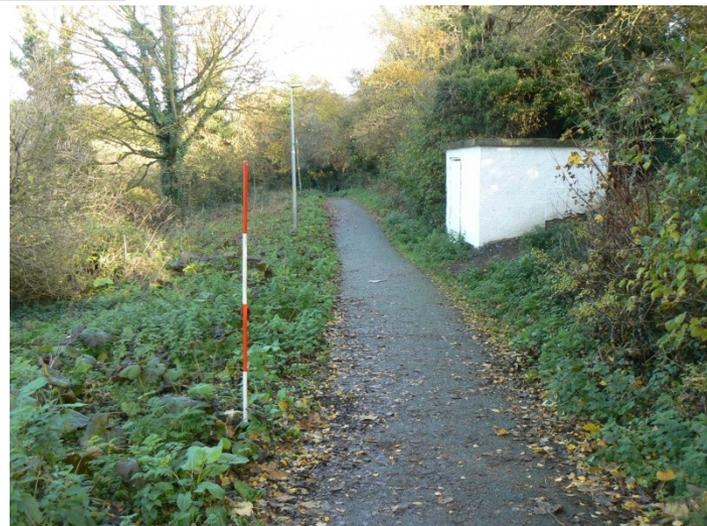
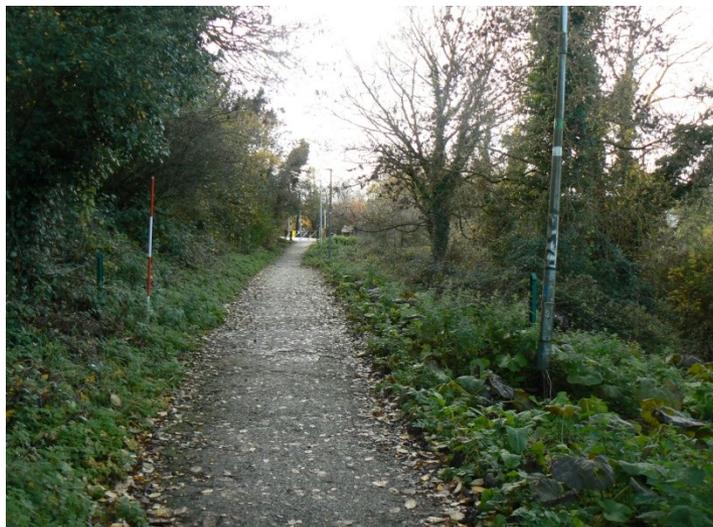
813A. W end (start) of riverside walkway.
Facing E. P1200503

813A. W end (start) of riverside walkway.
Facing E. P1200504

813A. W end (start) of riverside walkway.
Facing W. P1200521

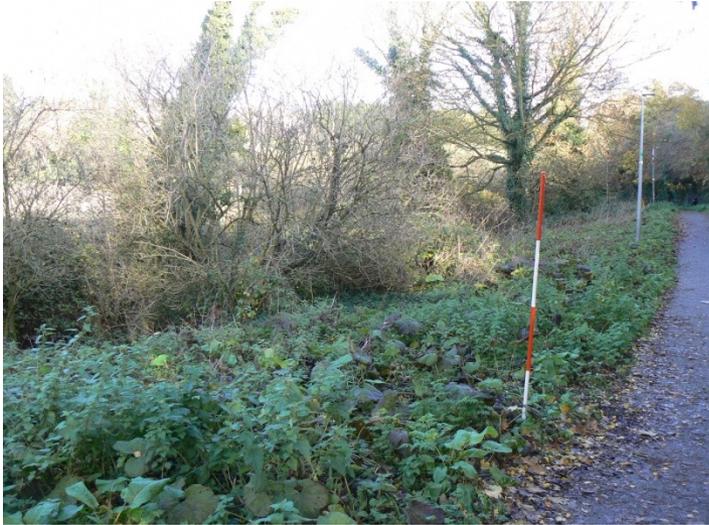
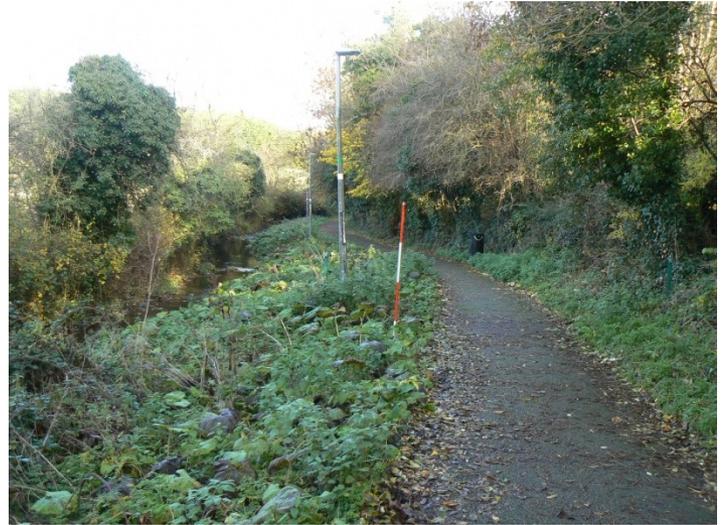
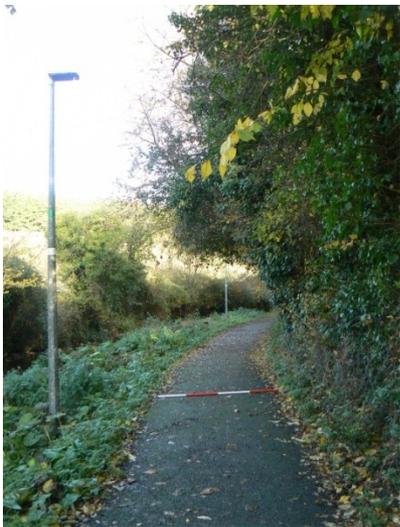
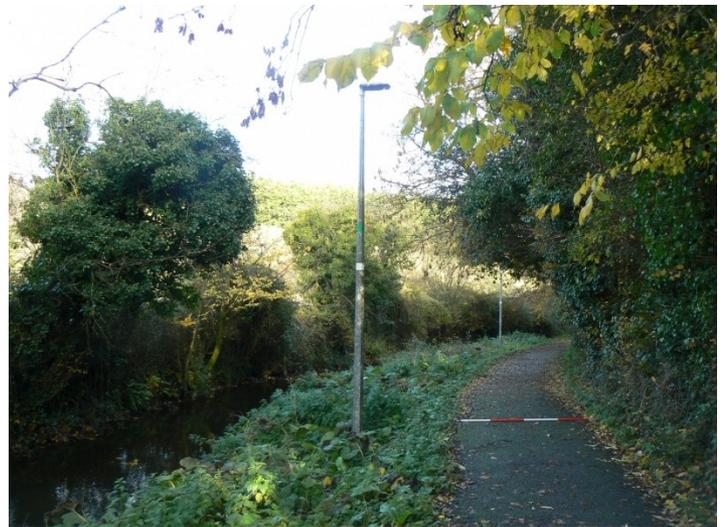
813B. Facing E. P1200505

813B. Facing E. P1200506

813B. Facing E. P1200507

813B. Facing E. P1200508

Verge to left of footpath is area of previous mill race

Discussion 813B (Fig 44, Photo 26, 27, 28, 29)

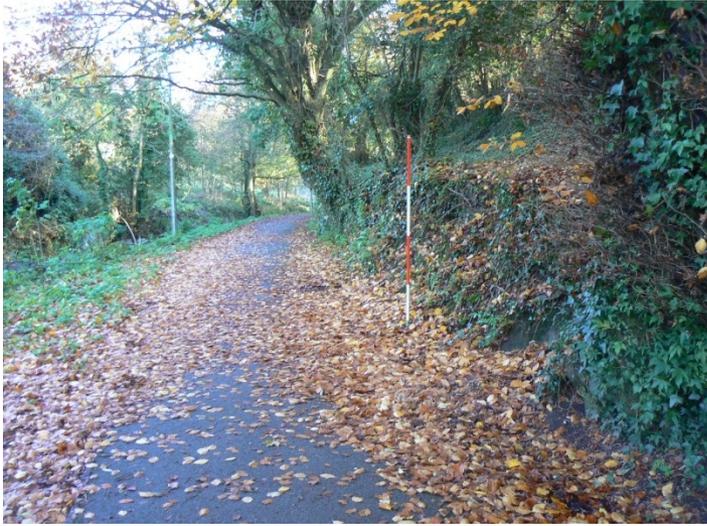
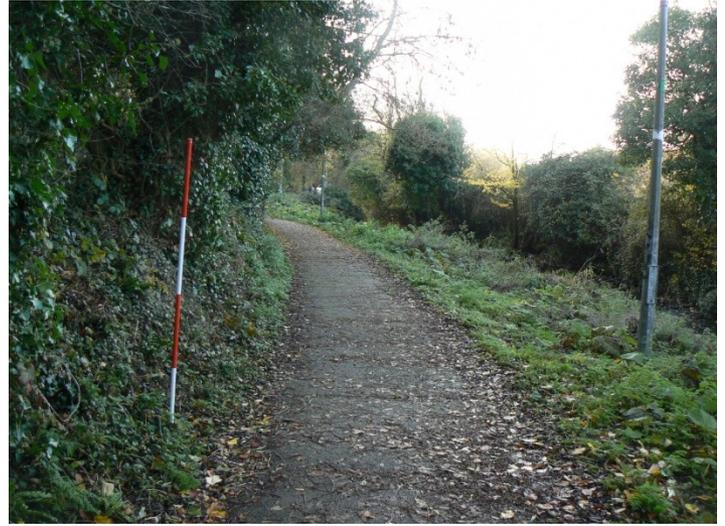
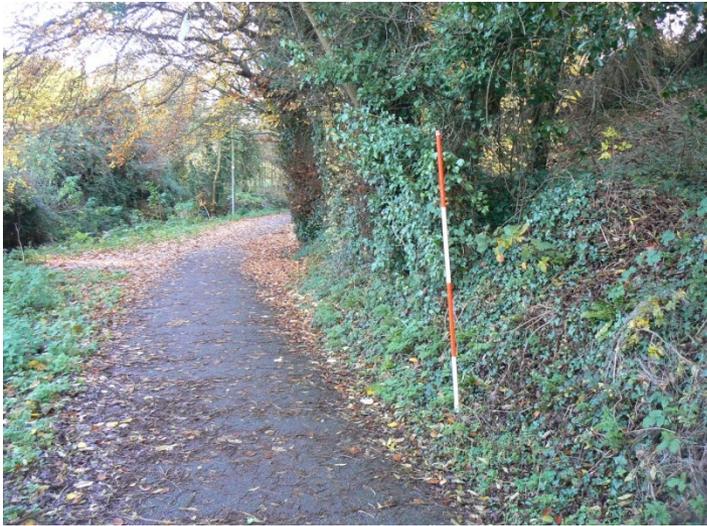
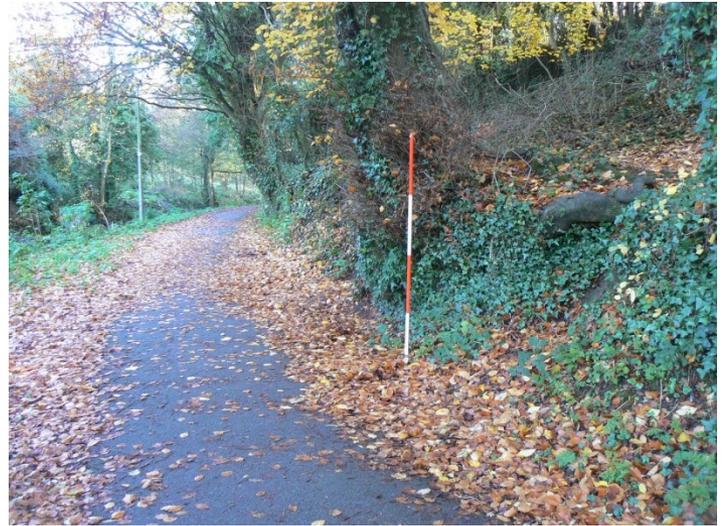
813B. Facing E. P1200509

813B. Facing W. P1200510

813B. Facing E. P1200511

813B. Facing E. P1200512

Bank to right of footpath in E facing photos is the side of a previous mill race

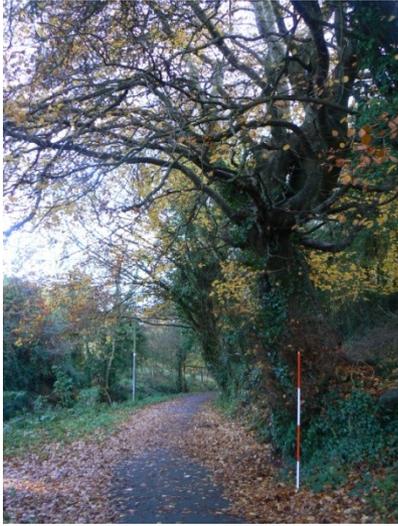
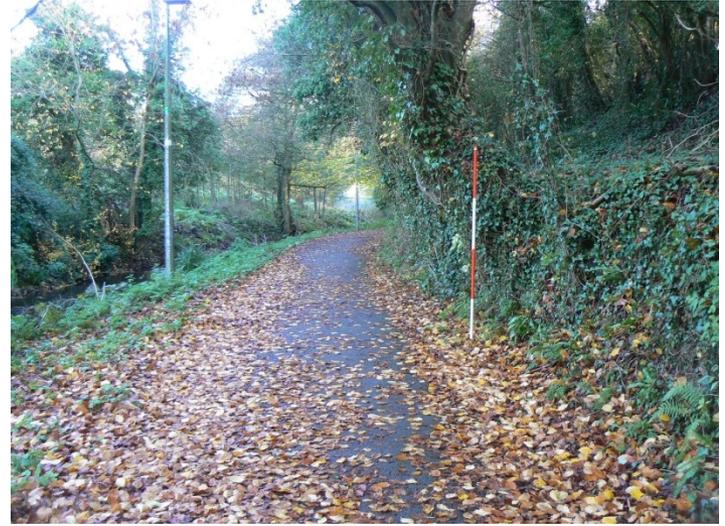
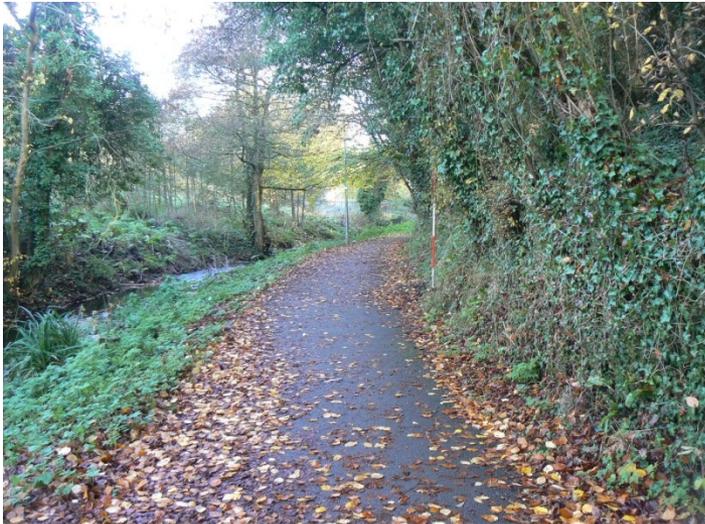
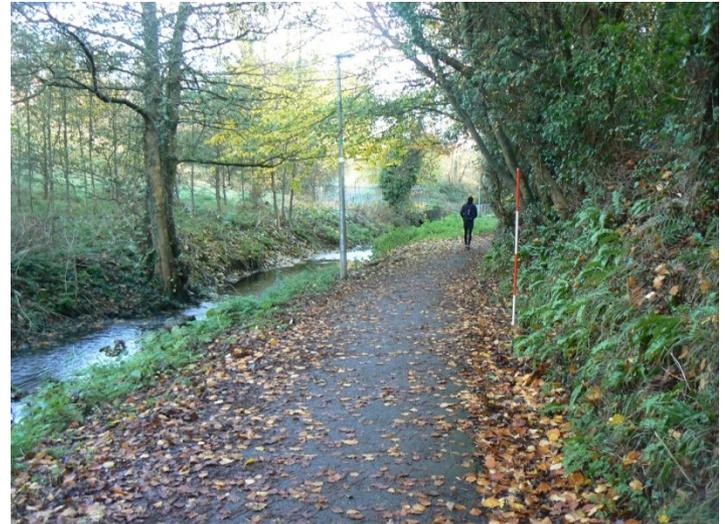
813B. Facing E. P1200513

813B. Facing E. P1200514

813B. Facing E. P1200515

813B. Facing E. P1200516

Bank to right of footpath is the side of a previous mill race

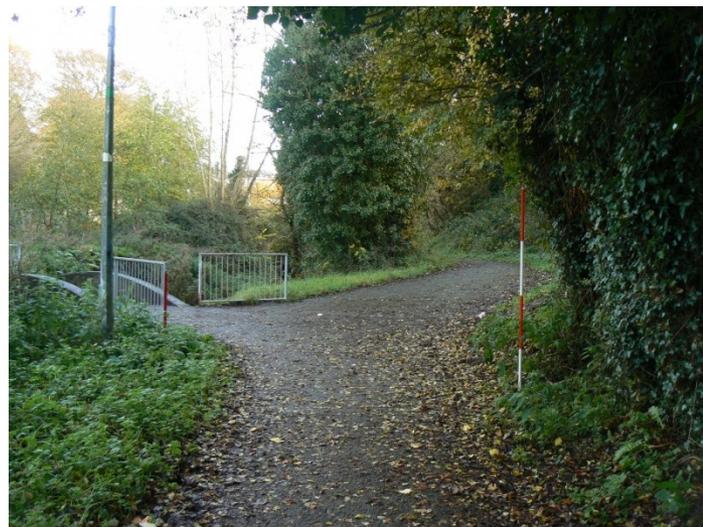
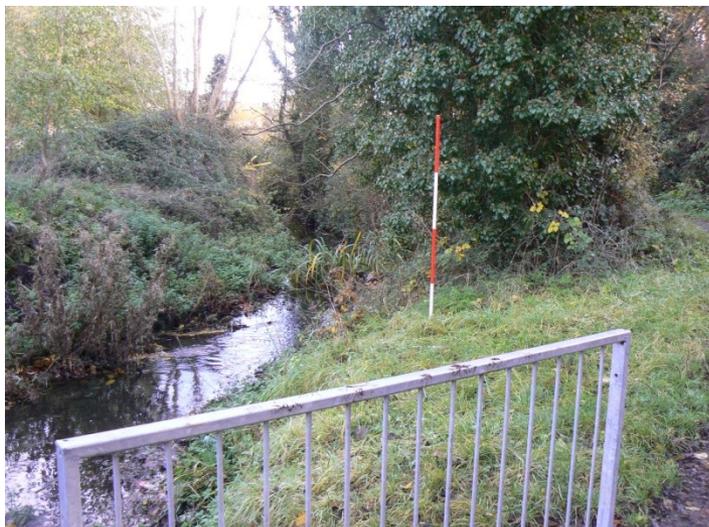
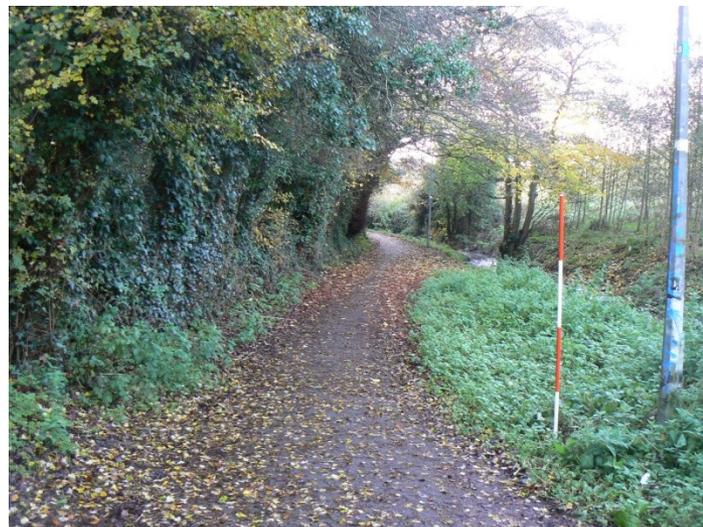
813B and 813D. Facing E. P1200518

813B. Facing E. P1200519

813B. Facing W. P1200520

Bank to right of footpath in E facing photos is the side of a previous mill race

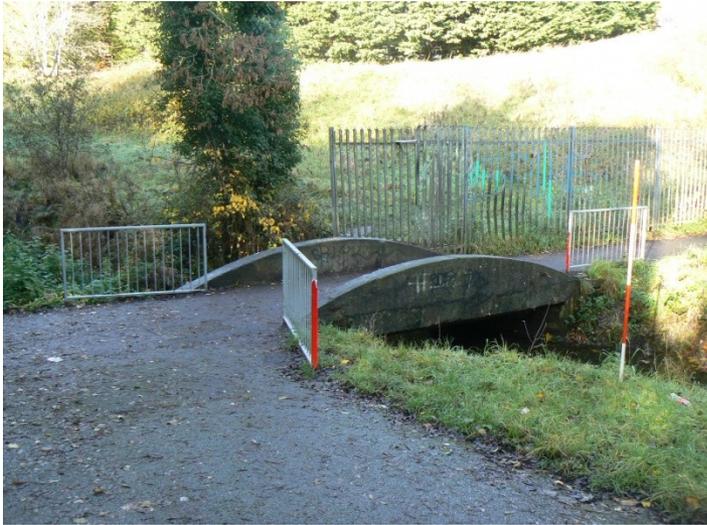
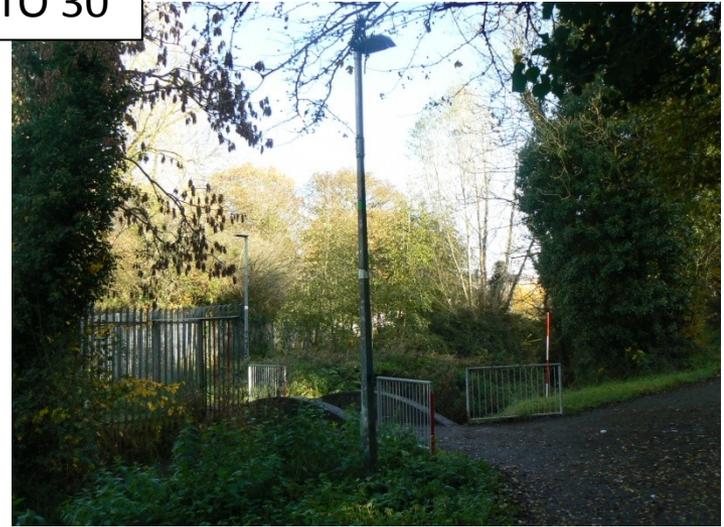
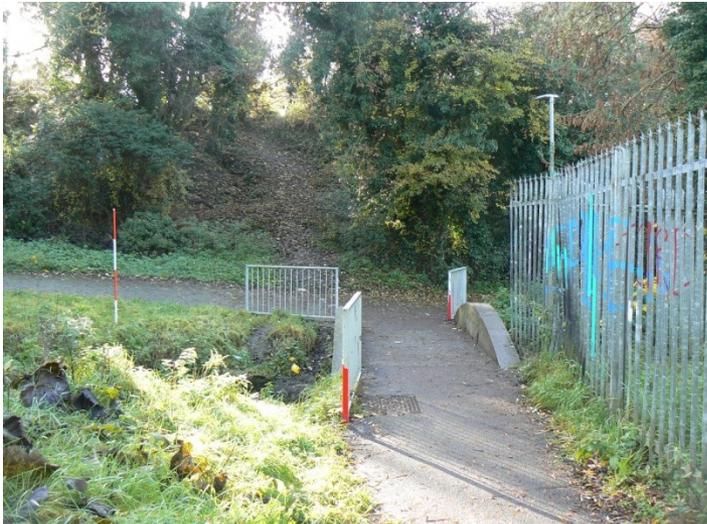
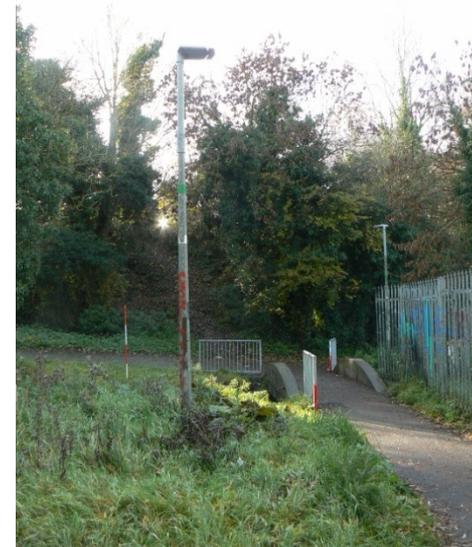
813D. Facing NW. P1200453

813D. Facing SE. P1200454

813C (to rear) and 813D (bridge). Facing S.
P1200455

813C (to rear) and 813D
(bridge). Facing S. P1200457

There is a path implied here on the 1837 OS and shown in this general area on the 1913 OS. The present unmade slippy path has eroded any surfacing it once had but probably survives in a roughly similar condition to the original layout. The path and stepping stones seem to cut through the Mill Race 1 tail race but these elements might all be contemporary. In any case the path forms part of an old crossing point of the Broad Meadow River.

This is an ancient crossing point of the Broad Meadow River. It is approached by two old routeways from the south and two from the north. The crossing point lies directly below Ratoath Motte ME044-034001 and as a crossing point, may well pre-date the motte. Medieval river crossing points usually focus on broad, shallow parts of a river and it is clear that the Broad Meadow River has here been embanked on both sides. The 1837 OS shows a ‘Stepping Stones’ crossing at this location and by the 1913 OS these have been replaced by a bridge. The present crossing bridge here is a modern concrete replacement to the 1913 OS bridge.

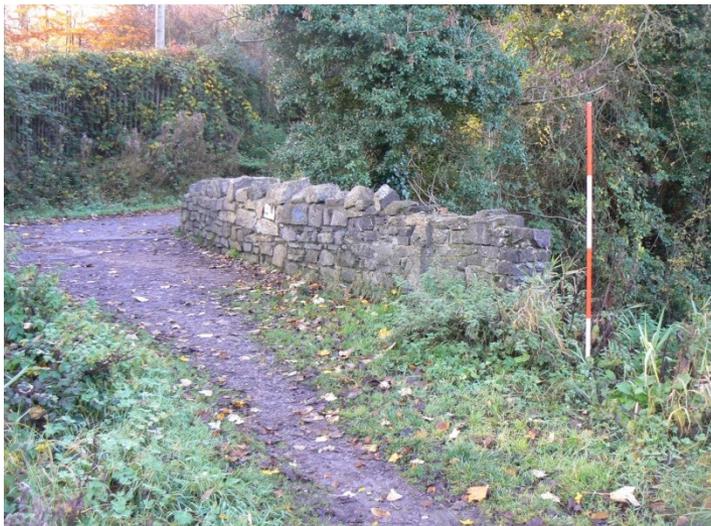
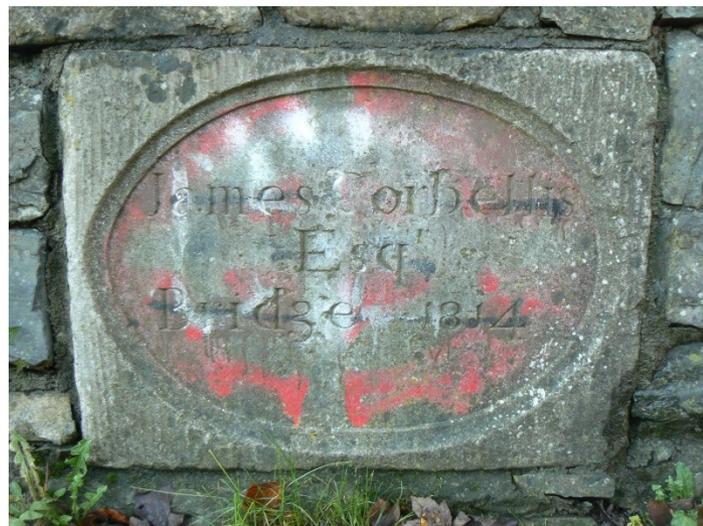
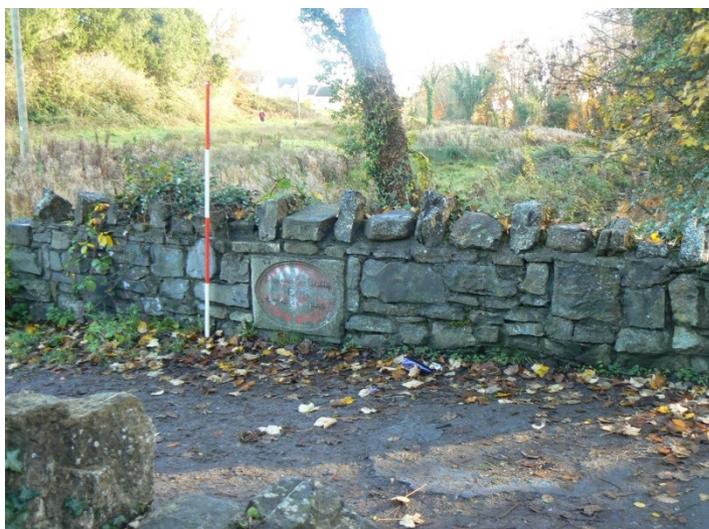
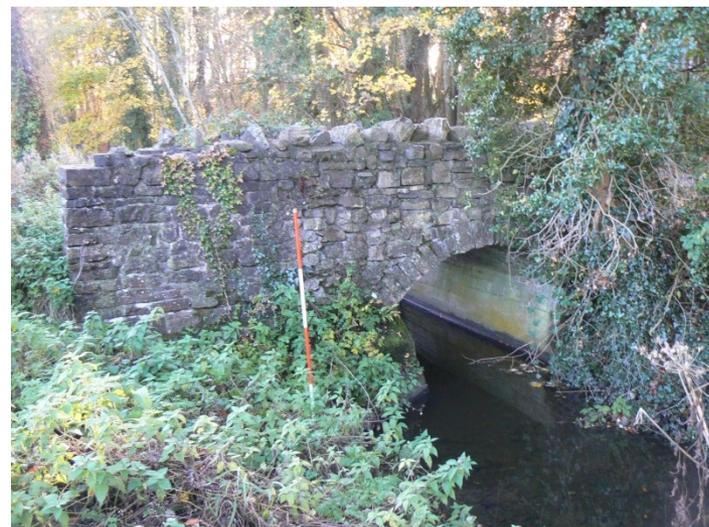
814C. Facing SW. P1200440

814C. Plaque on E parapet. P1200442

814C. Facing E. P1200441

814C. Facing E. P1200443

The main element here is a single arched, masonry bridge over the Broad Meadow River. The bridge (Bridge 3) appears to have a three-centre arch (similar to the bridges over the Boyne Navigation) with well cut voussoirs and rusticated abutment quoins. The bridge is slightly skewed NE-SW and has very low parapets with a cow-and-calf soldier course. A modern wooden paling fence on iron supports has been built to raise the parapet heights and there is a concrete bollard at the northern end to prevent vehicle traffic crossing. There is no bridge shown here on the 1837 OS but one is shown on the 1913 OS, leading to Jamestown House (demolished) to the south. The 1913 OS shows a previous fording point on the Broad Meadow River approximately 60m to the east and there may well have been a previous ford in the area of the present Bridge 3. The crossing point is shown as a townland boundary on the 1837 OS, but this boundary is moved eastwards when the Bridge 3 was built (or the 1837 is slightly inaccurate at this point). The present riverbanks have clearly been raised and formalised since the 1913 OS, but there is perhaps some rock armouring of the southern bank of the river channel that is probably older. The southern river bank is a quasi-vertical 'build' that perhaps reflects the location of a riverside road here.

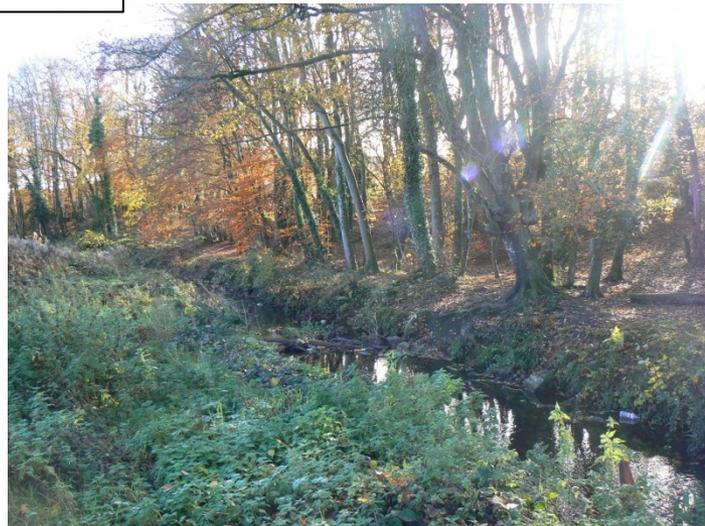
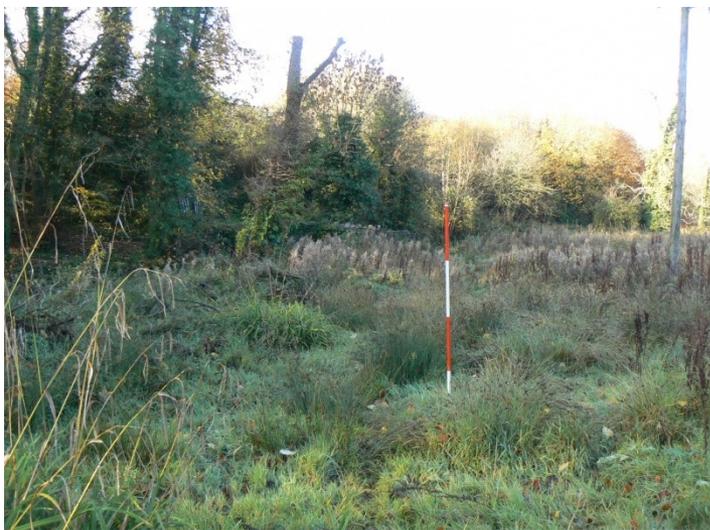
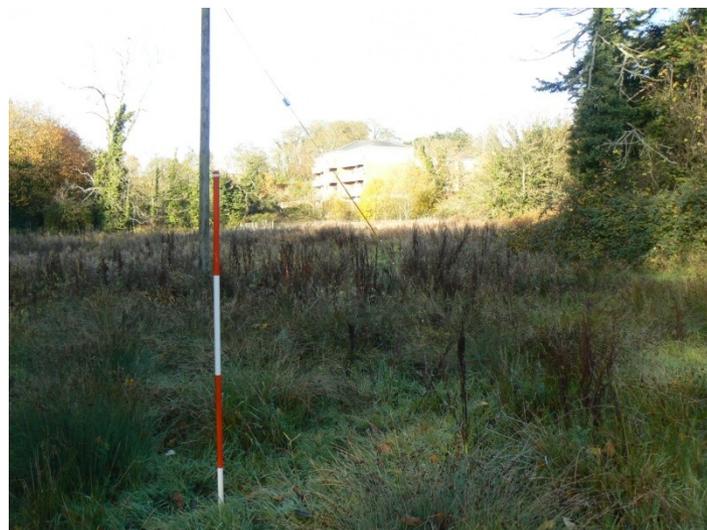
PHOTO 36

814D. W End. Facing E with 814F on right.
P1200435

814D W end facing E. P1200434

814D W end facing NE. P1200433

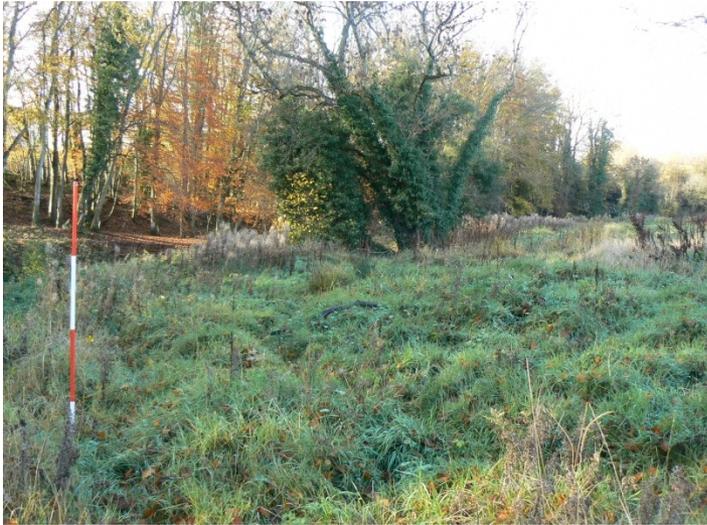
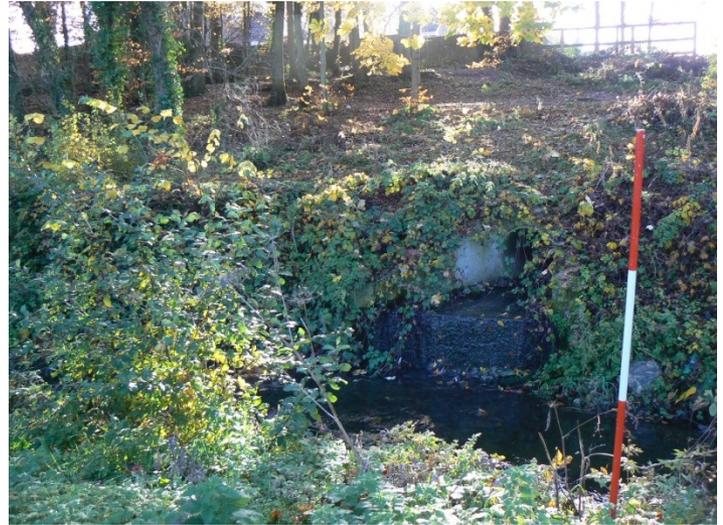
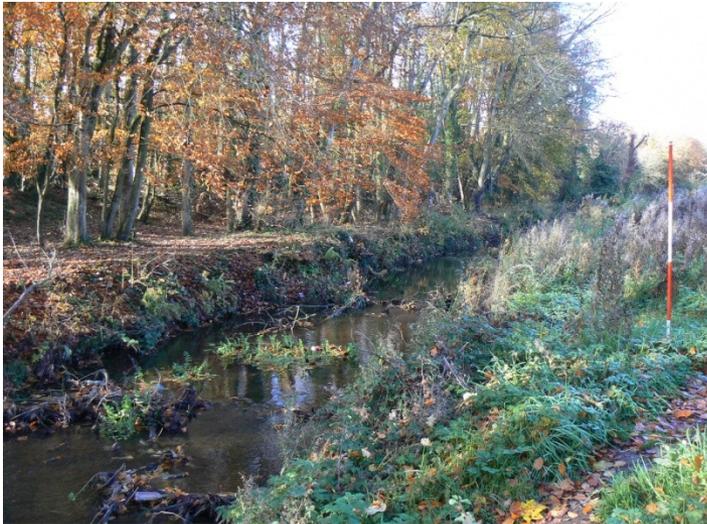
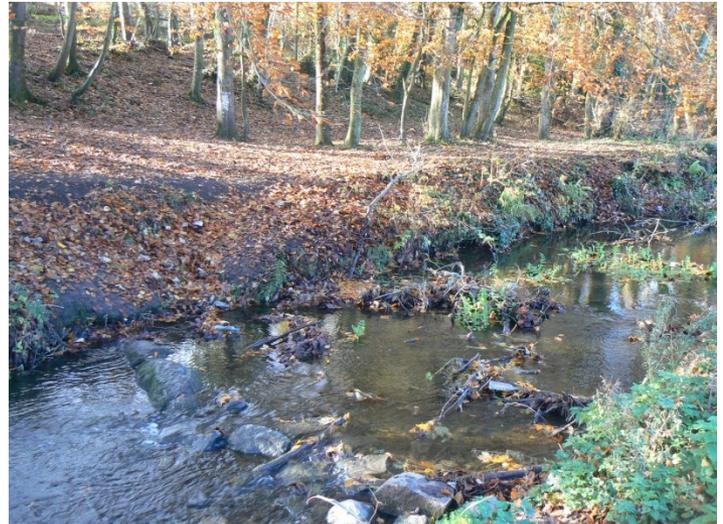
PHOTO 37

814D. E End. Facing E with 814F on right.
P1200429

814D. E End. Facing E with 814F with culvert
to rear. P1200430

814D. E End. Facing W with 814F on left.
P1200431

814D. E End. Facing S with stepping stones to
814F. P1200432

Discussion 814E (Fig 45, Photo 37)

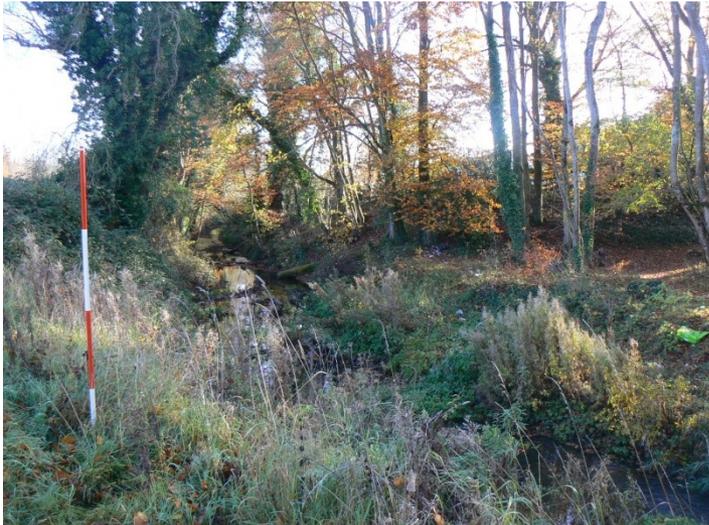
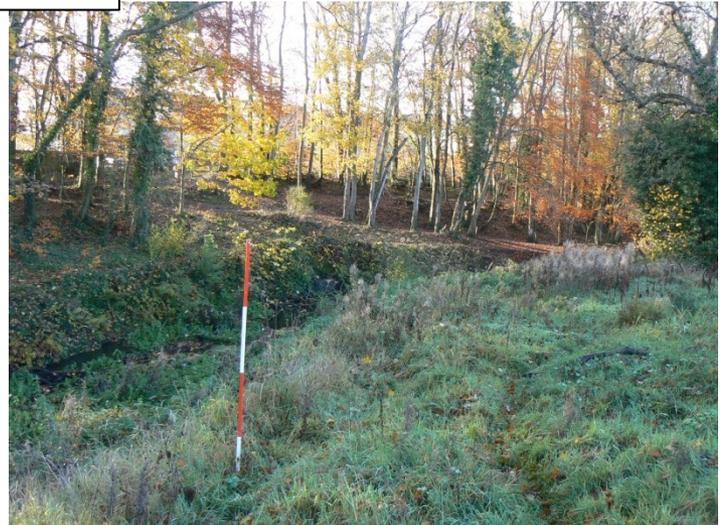
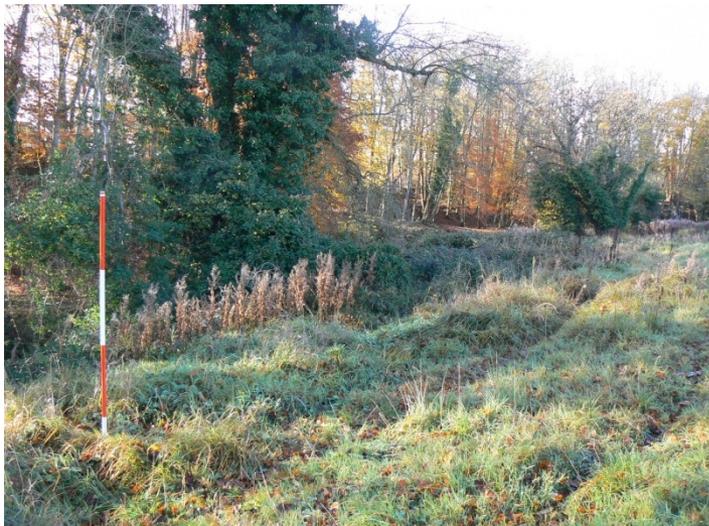
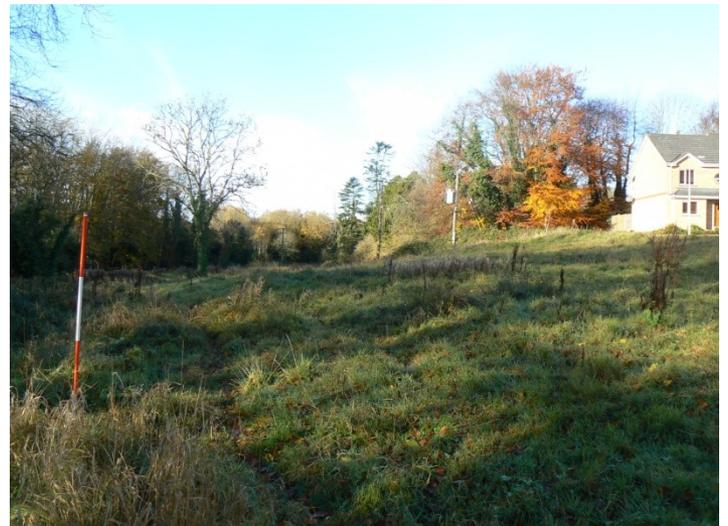
PHOTO 38

814E. E end. Facing E with 814F on right
P1200427

814E. E End. Facing SW with 814F to rear.
P1200428

814E. Middle. Facing W. P1200425

814E. Middle . Facing W. P1200426
