**Ratoath pedestrian and cycle scheme
Ratoath,
Co. Meath**

Desk Based Review and Assessment

Niall Roycroft

22nd November 2018

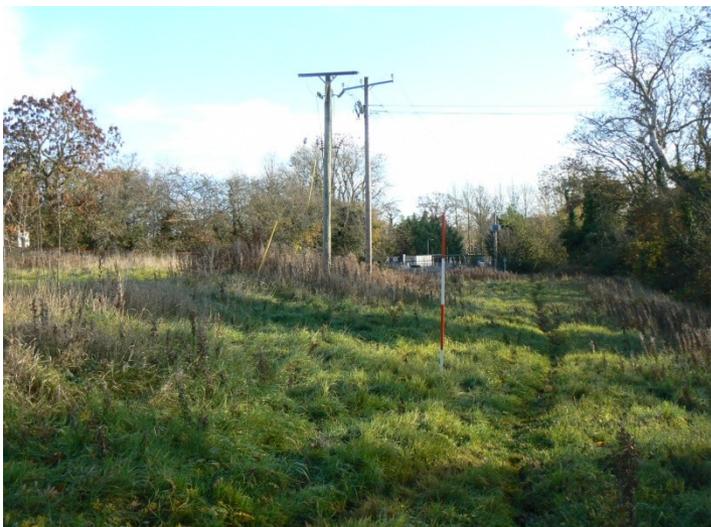
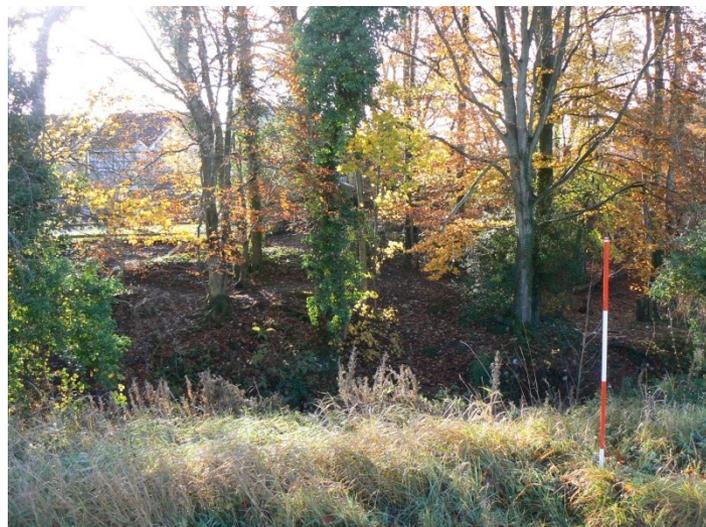
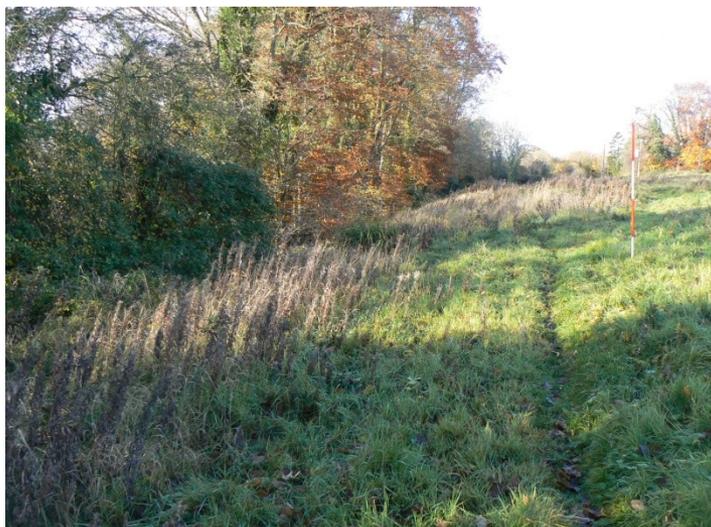
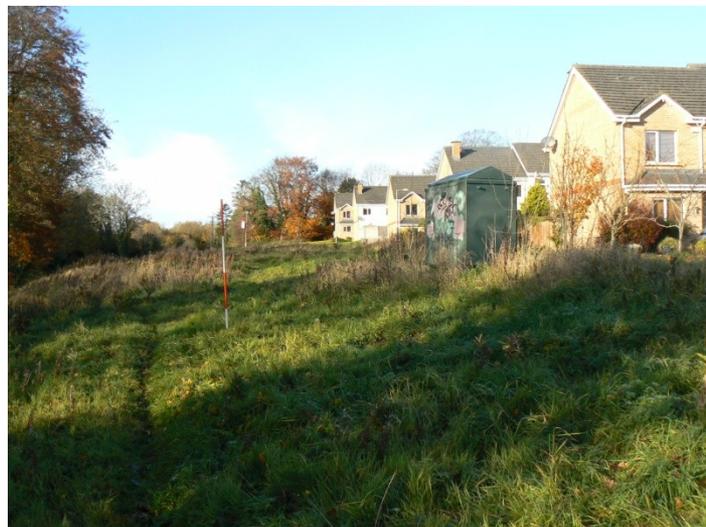
PHOTO 39

815A. Facing E. P1200423

815A. Middle . Facing S to 817F E end.
P1200424

815A. W end. Facing W. P1200422

815A. W end. Facing W. P1200421

Discussion 815A (Fig 46, Photo 39)

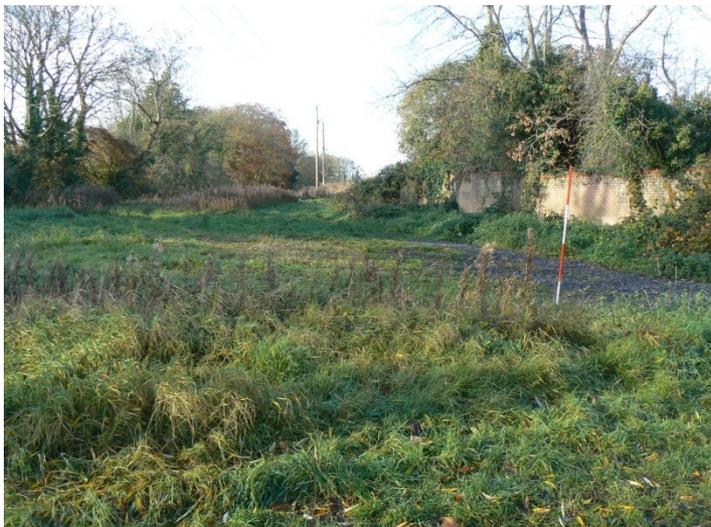
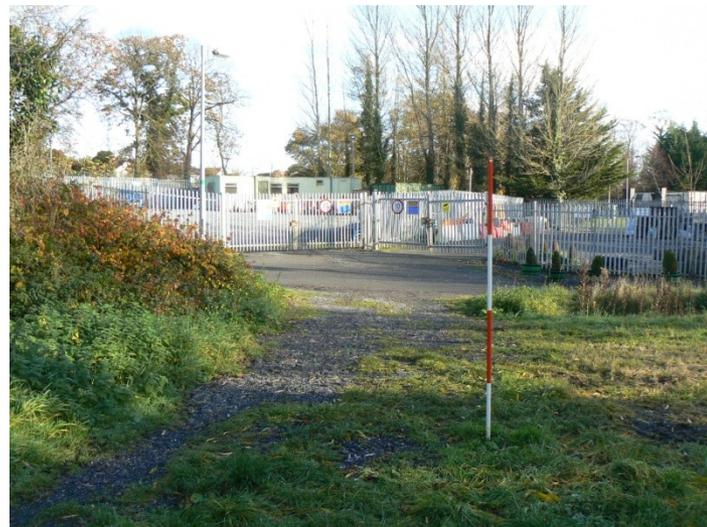
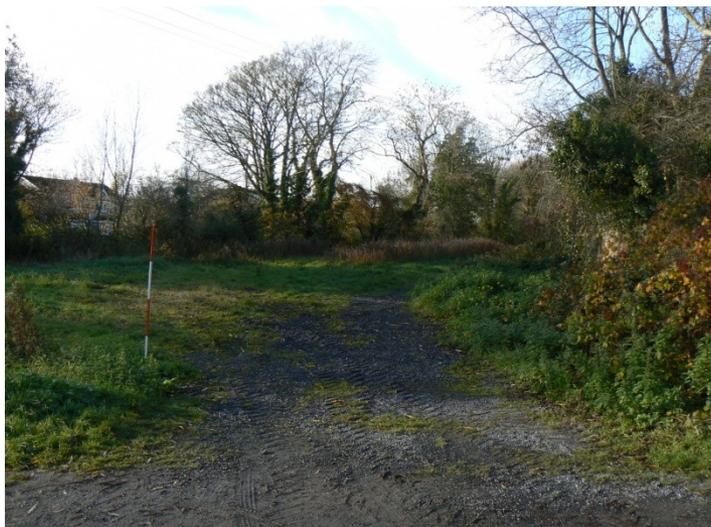
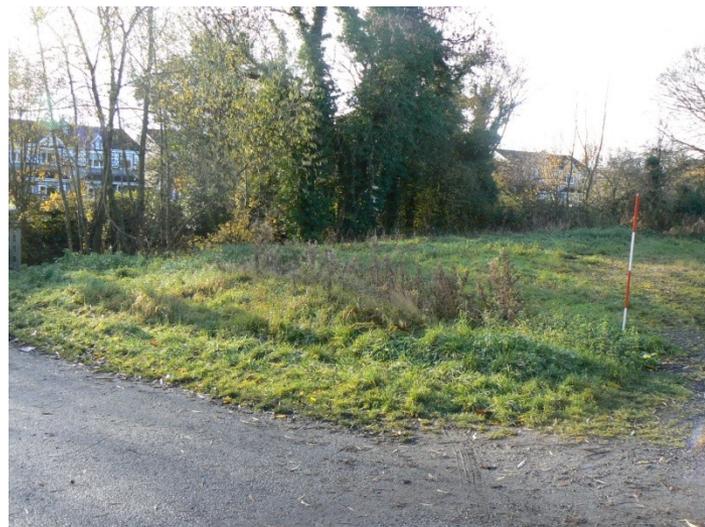
PHOTO 40

815A. E end. Facing W. P1200419

815A. E end. Facing E. P1200420

815A. E end. Facing W. P1200417

815A. E end. Facing SW. P1200418

Discussion 815B (Fig 46, Photos 40, 41)

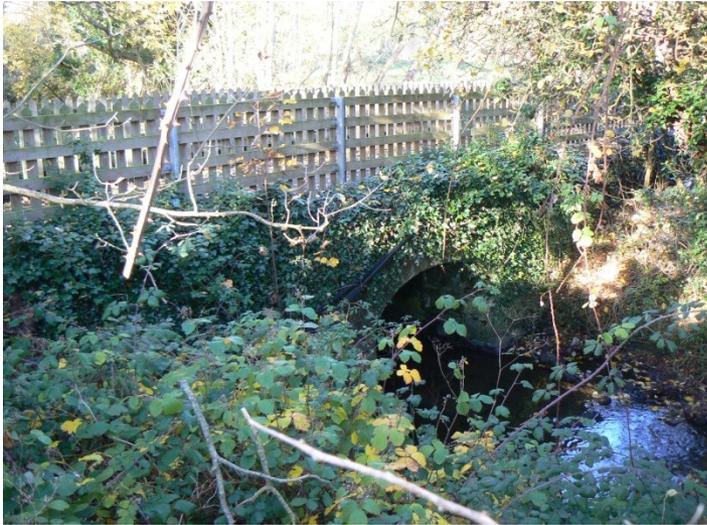
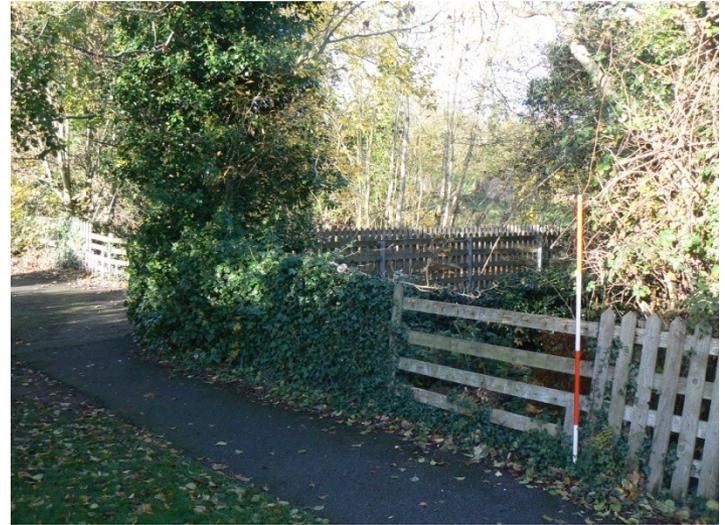
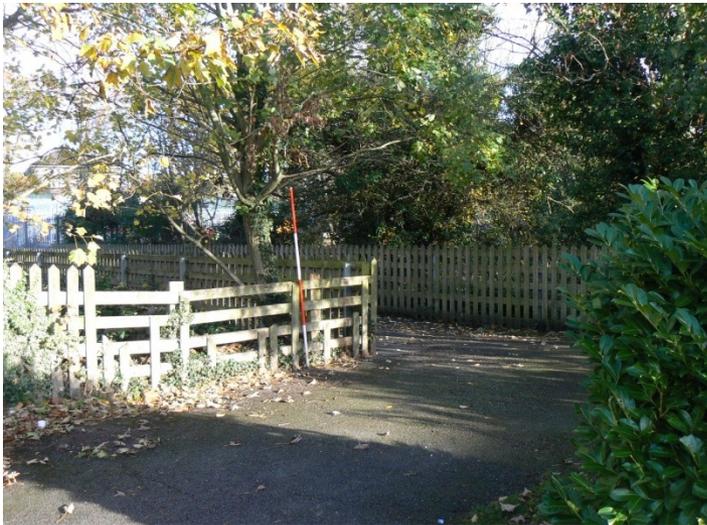
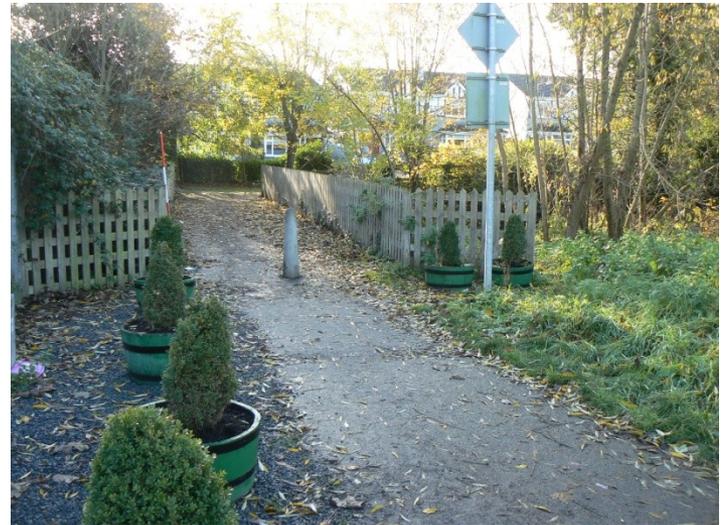
PHOTO 41

815B. Bridge E face. Facing W. P1200409

815B. Facing W from 815D. P1200410

815D. Facing E from 814C. P1200411

815D. Facing S from 815A. P1200412

The main element here is a single arched, masonry bridge over the Broad Meadow River. The bridge (Bridge 3) appears to have a three-centre arch (similar to the bridges over the Boyne Navigation) with well cut voussoirs and rusticated abutment quoins. The bridge is slightly skewed NE-SW and has very low parapets with a cow-and-calf soldier course. A modern wooden paling fence on iron supports has been built to raise the parapet heights and there is a concrete bollard at the northern end to prevent vehicle traffic crossing. There is no bridge shown here on the 1837 OS but one is shown on the 1913 OS, leading to Jamestown House (demolished) to the south. The 1913 OS shows a previous fording point on the Broad Meadow River approximately 60m to the east and there may well have been a previous ford in the area of the present Bridge 3. The crossing point is shown as a townland boundary on the 1837 OS, but this boundary is moved eastwards when the Bridge 3 was built (or the 1837 is slightly inaccurate at this point). The present riverbanks have clearly been raised and formalised since the 1913 OS, but there is perhaps some rock armouring of the southern bank of the river channel that is probably older. The southern river bank is a quasi-vertical 'build' that perhaps reflects the location of a riverside road here.

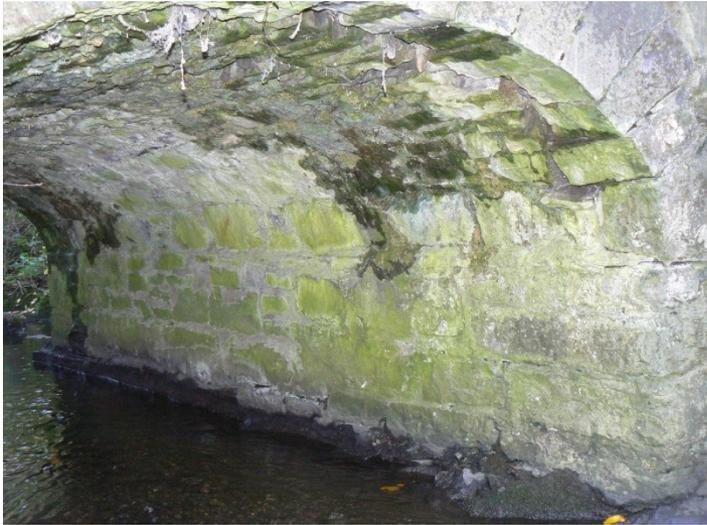
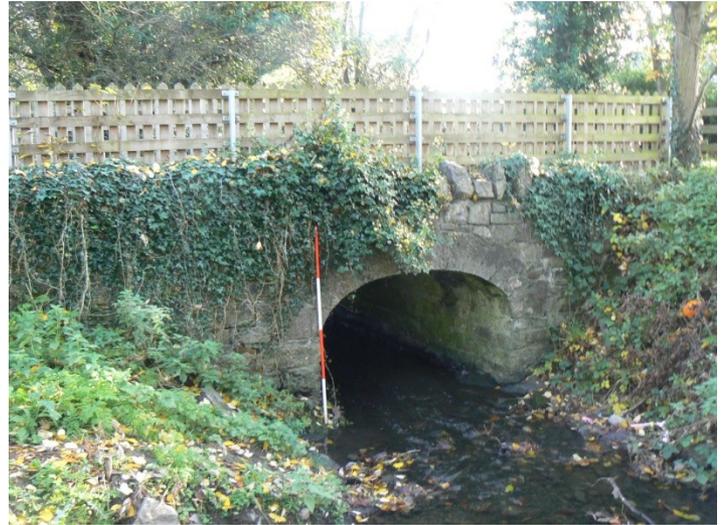
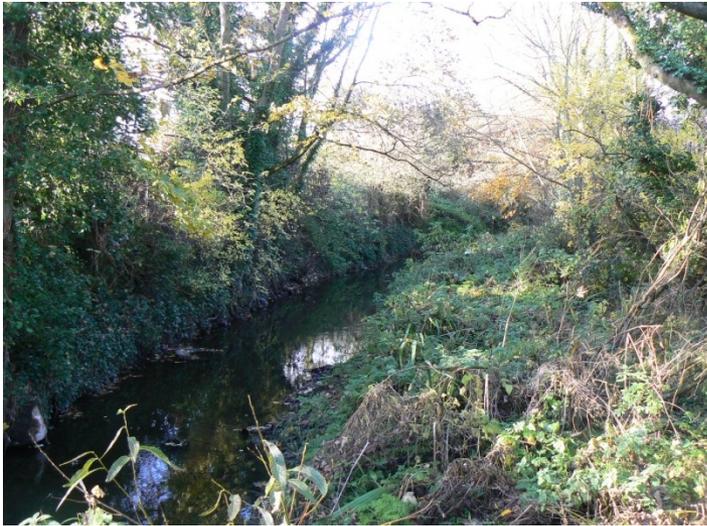
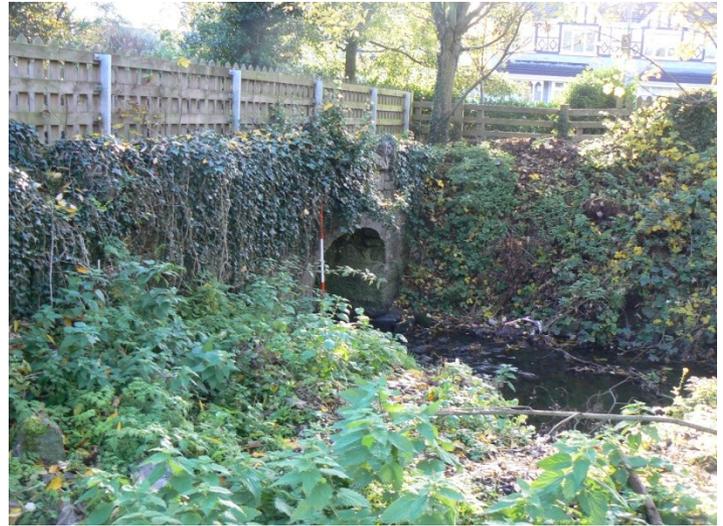
PHOTO 42

815B. Soffit under arch. P1200413

815B. Bridge W face. Facing E. P1200414

815C River to old fording point. Facing W.
P1200415

815B. Bridge W face. Facing SE. P1200416

Discussion 815C (Fig 46, Photos 42, 43)

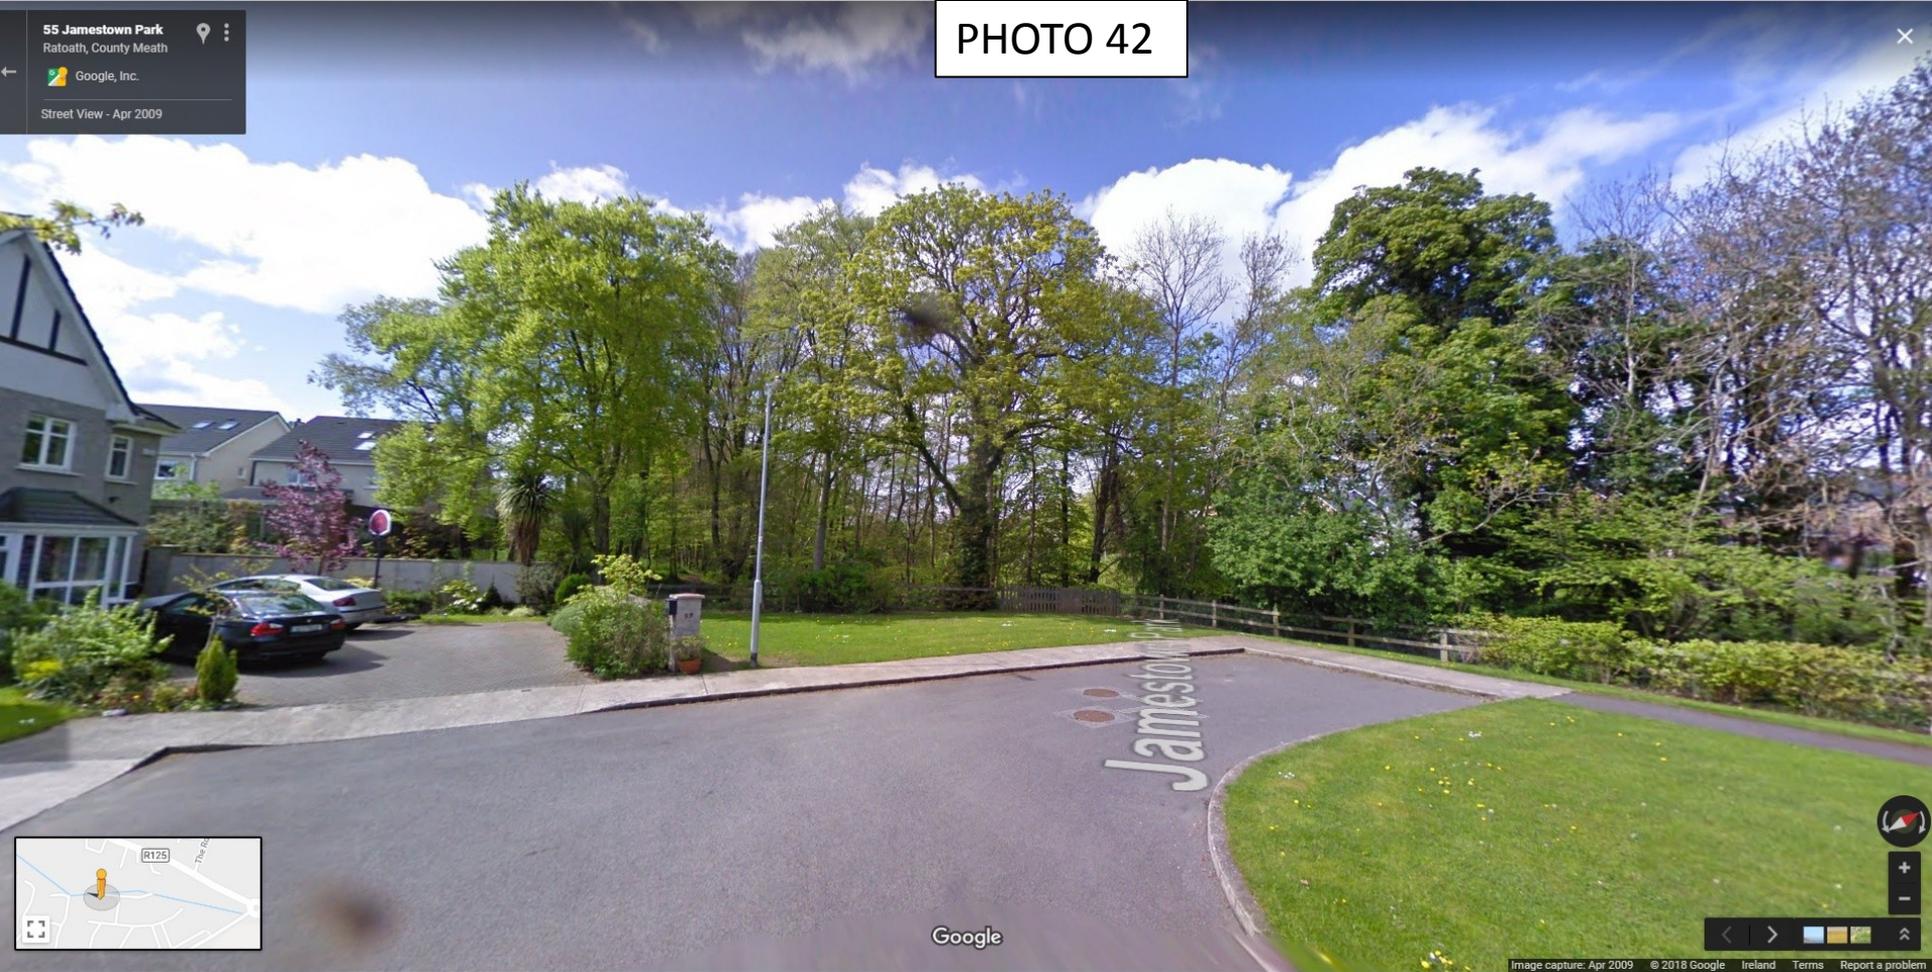
PHOTO 43

Discussion 814F to 815C

Transition zone from 814F (trees to middle-left) to 815C (landscaped housing estate with river in trees to middle-right). Facing W. (2009)

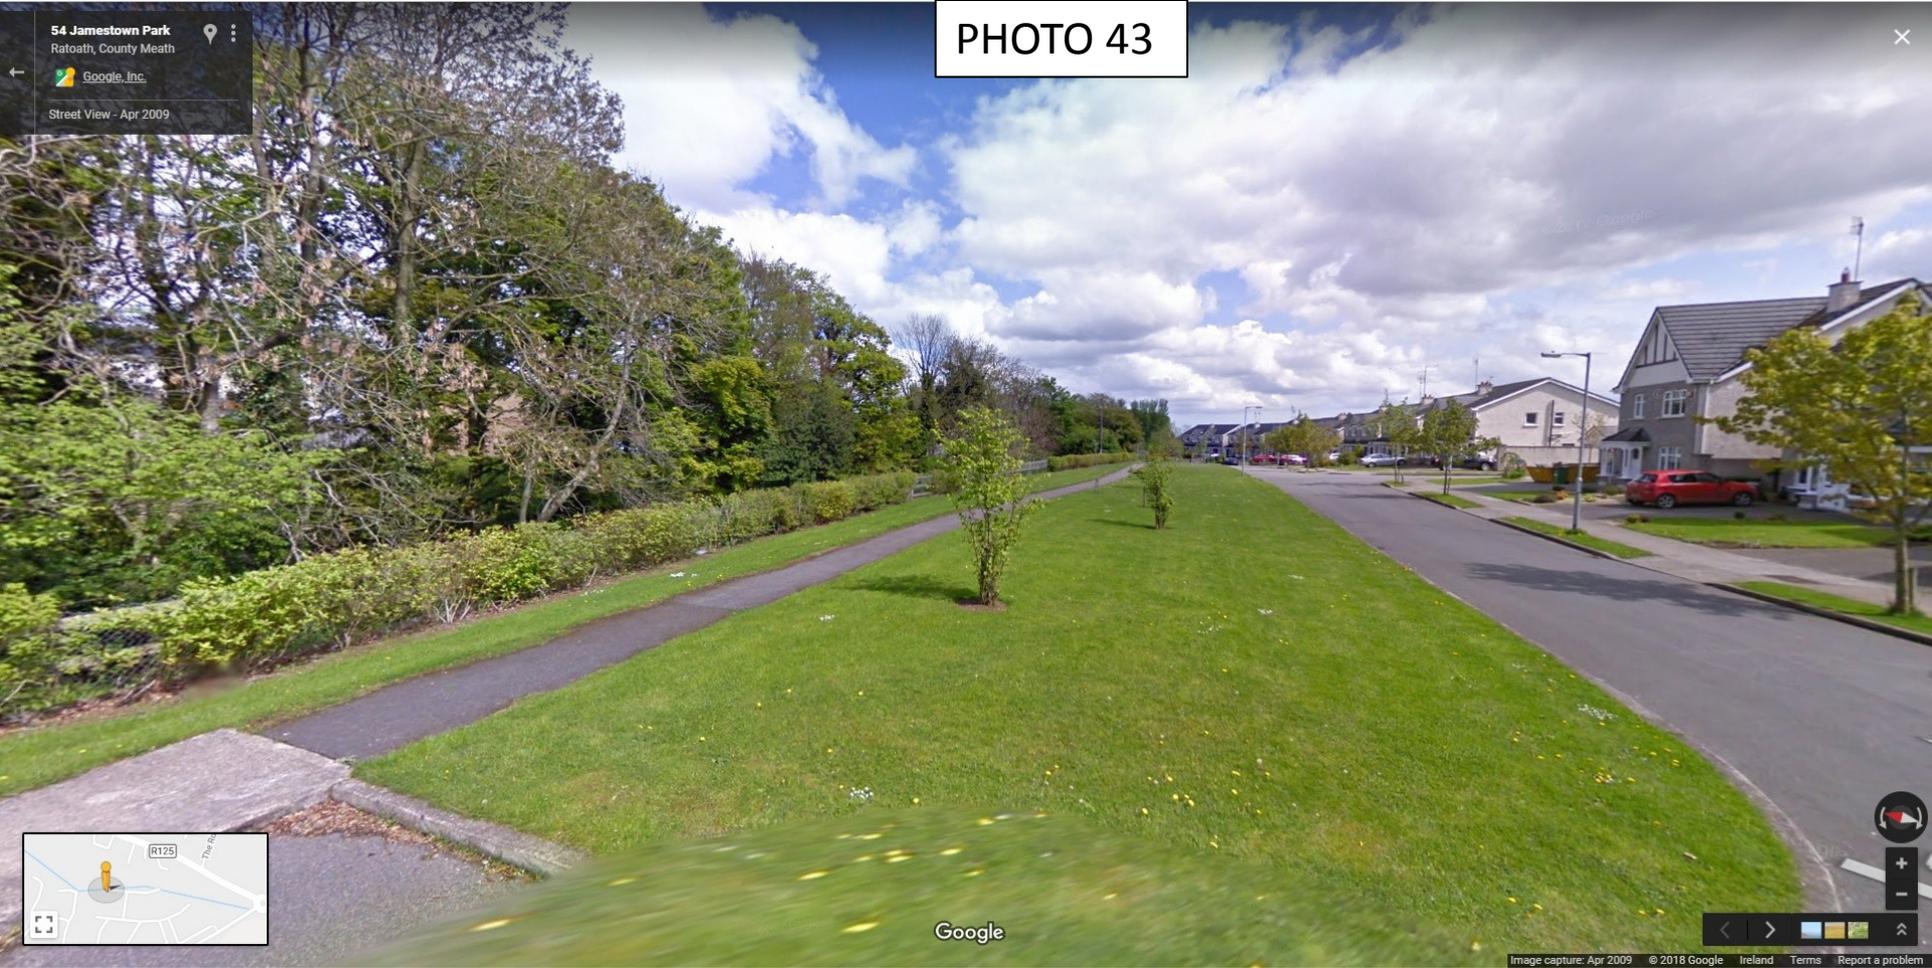
PHOTO 44

Discussion 815C

Typical view of landscaped area alongside River (to left) at Jamestown Park. Facing E (2009).

Discussion 815D (Fig 46, Photo 44)

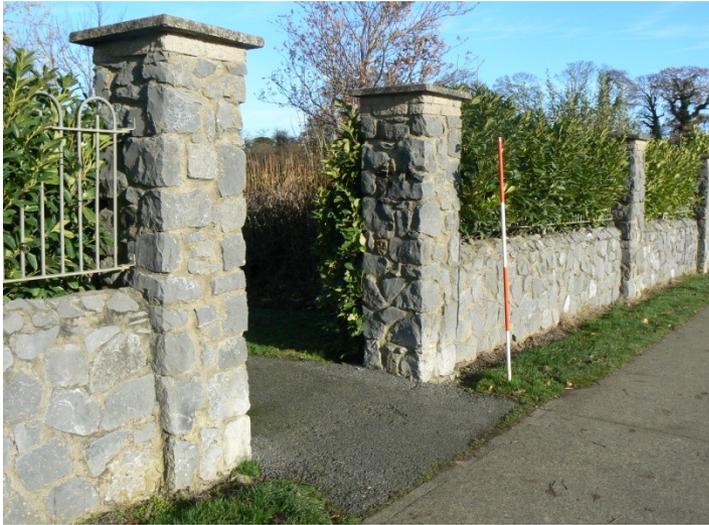
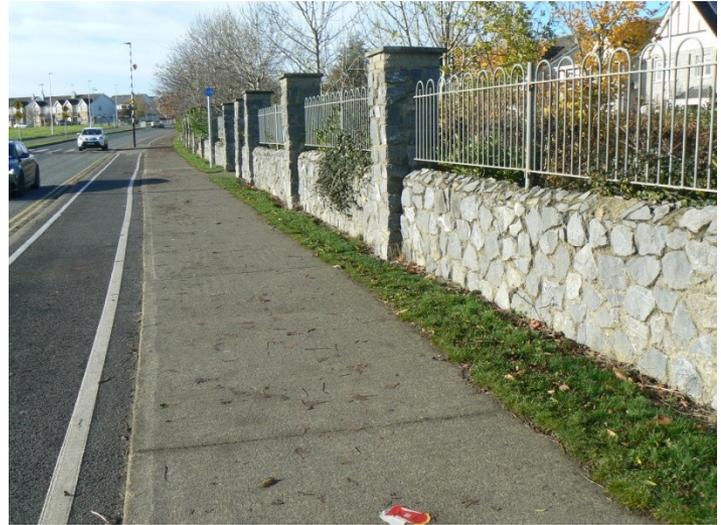
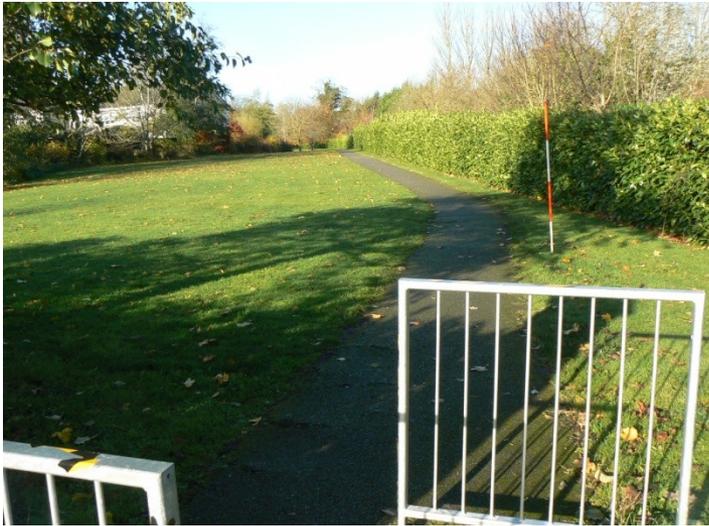
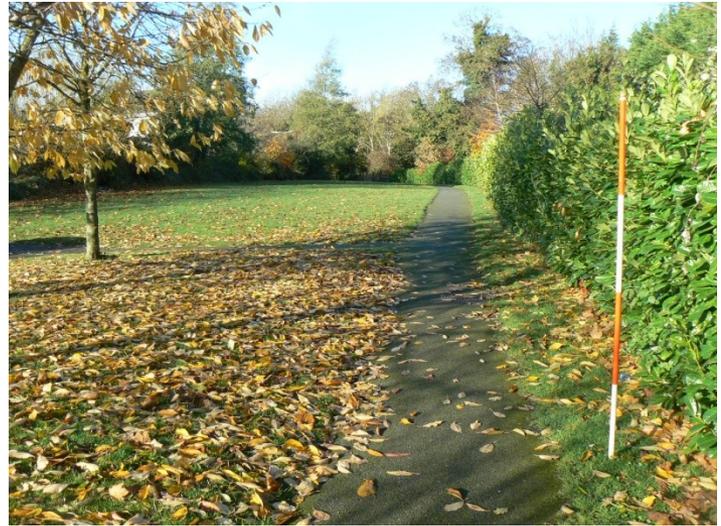
815D; Gates to The Avenue. Facing N.
P1200405

815D; Gates to The Avenue. Facing SW.
P1200406

815D. Existing landscaped footpath. Facing
NW. P1200407

815D. Existing landscaped footpath. Facing NW.
P1200408
