# **Pedestrian/Cycle Bridge, New Bridge, Navan, Co. Meath**

## **Options Evaluation Report**

**Client: Meath County Council**

**Date: April 2017**

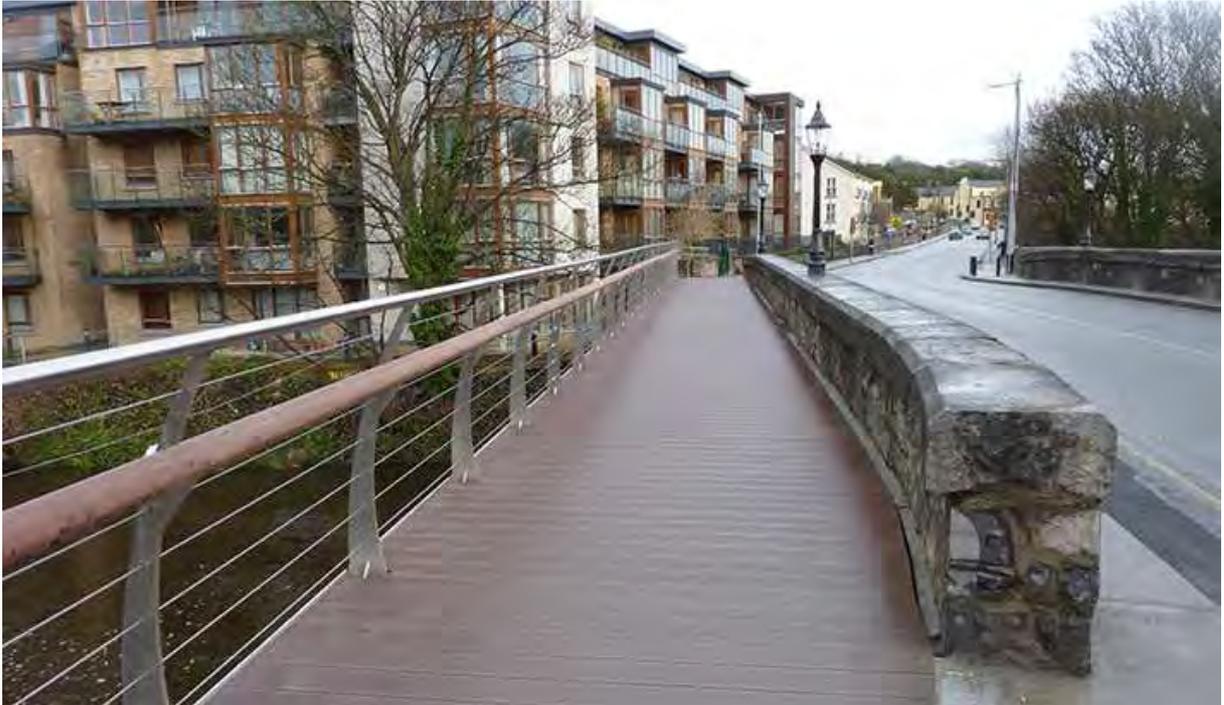
*Figure 2 – Anna Livia Bridge, Chapelizod; Northern Deck Finishes*

The exact colour/orientation for the deck panels can be agreed with Meath County Council Architect's and Heritage Officer in due course.

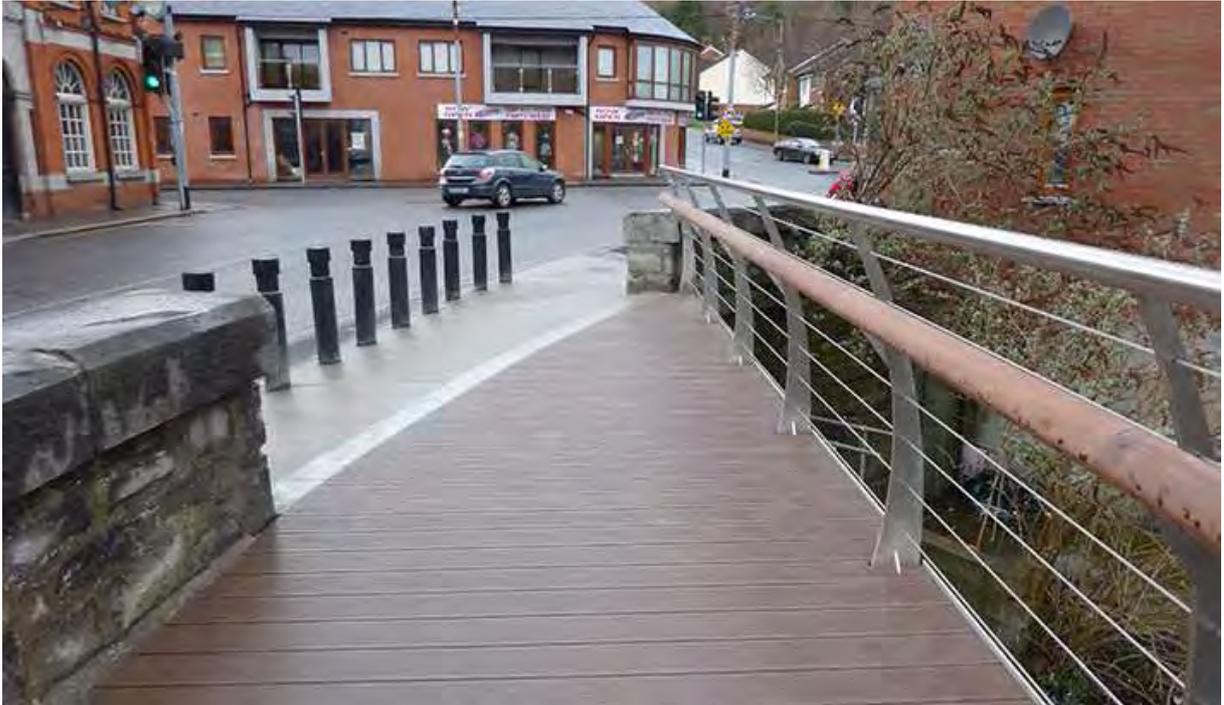
*Figure 3 – Anna Livia Bridge, Chapelizod; Western Interaction with Existing Bridge*

The above image illustrates the envisaged detail for the shared surface to the Navan-side of the proposed bridge showing the existing upstand wall cut and repaired with salvaged masonry.

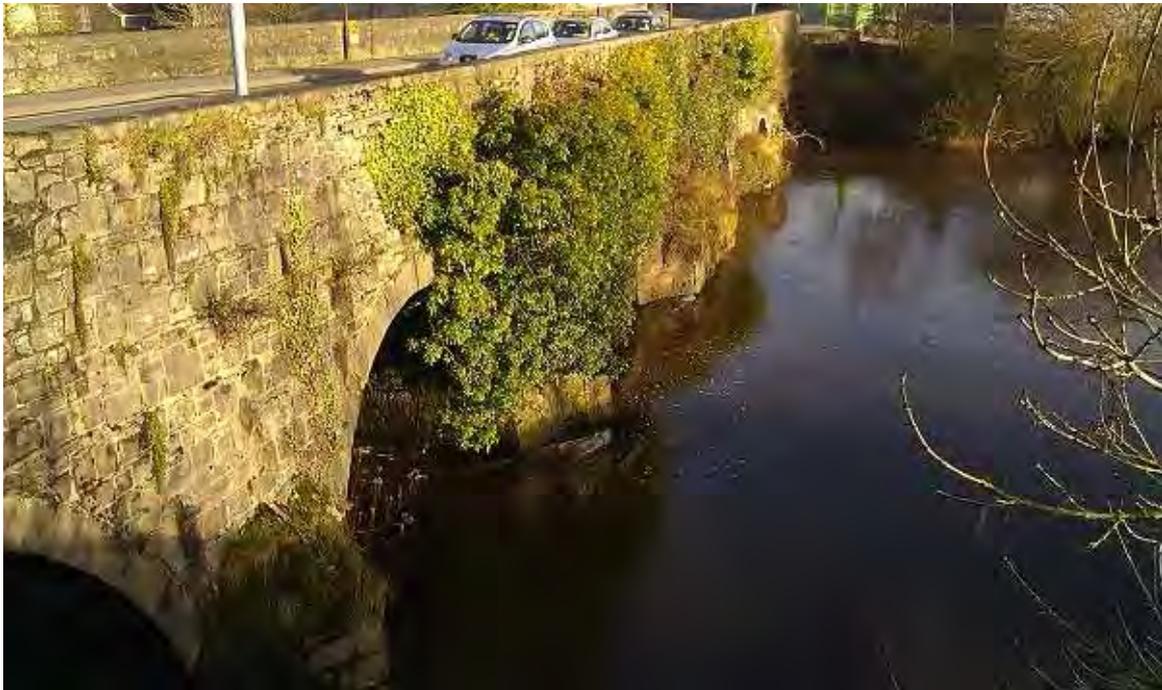
**Plate 1:** New Bridge with old stone walls (upstream view). The pedestrian bridge is proposed for this south facing side of the bridge (photo taken in 2013 prior to ivy removal and bridge cleaning in 2015).

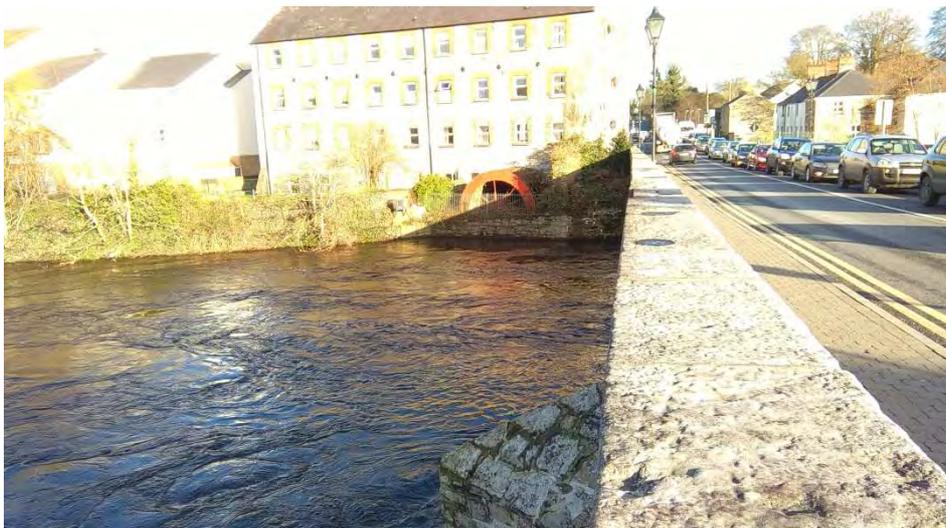
**Plate 3:** New Bridge with old stone walls (downstream view). Photograph taken in February 2016.

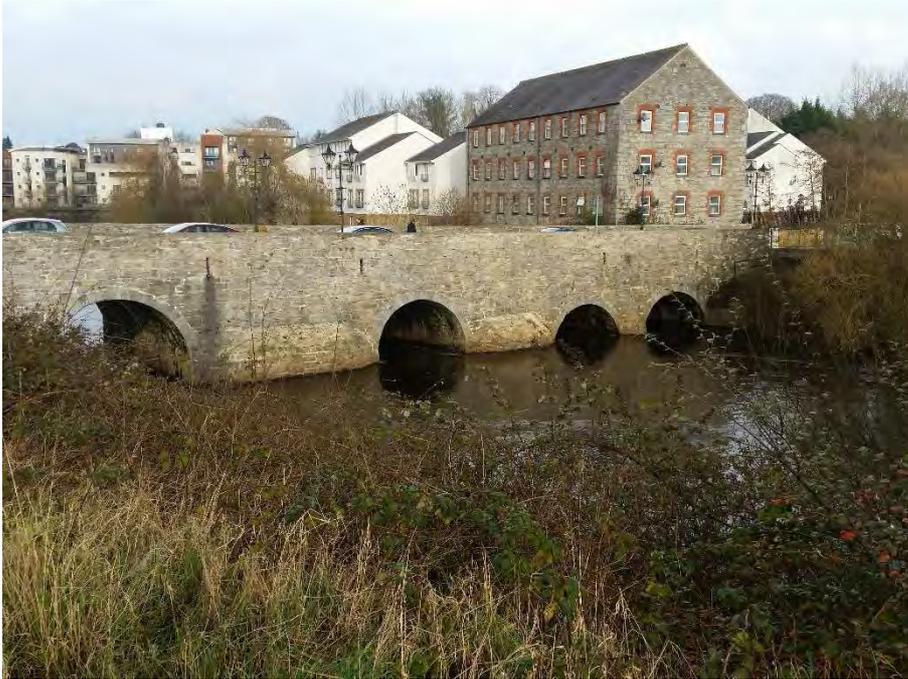
*Figure 2: Upstream View to 'New Bridge'*

The existing 'New Bridge', a protected structure constructed in 1756, is a 7-span masonry arch bridge connecting Athlumney on the east bank of the River Boyne with Navan town centre on the west bank. Six of the arches are clearly visible and are located within the existing river channel; a seventh arch is located on the eastern side of the river and has been filled in on its southern elevation to facilitate a public park area.

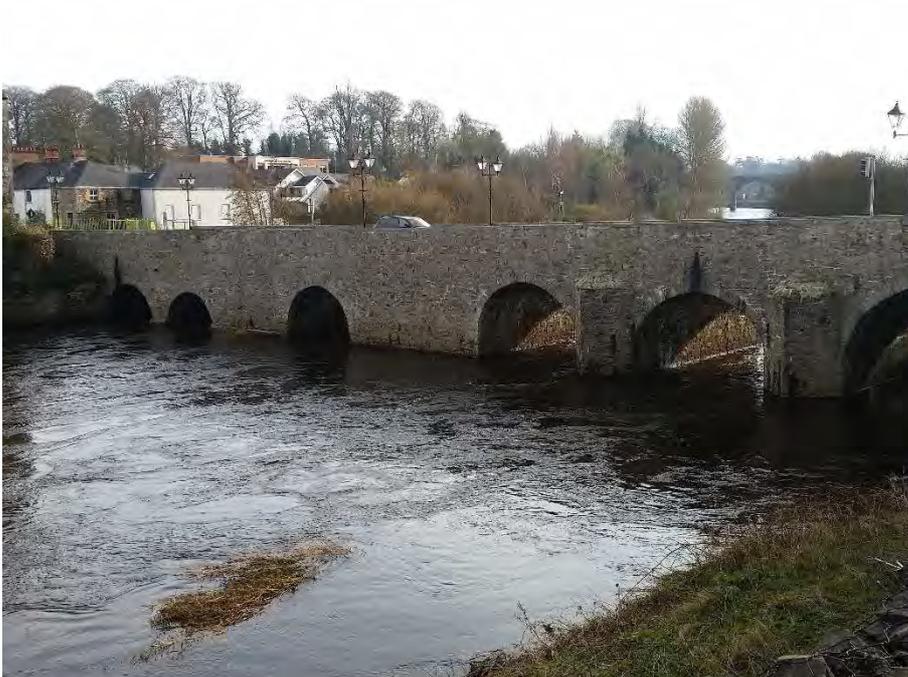
*Figure 3: Downstream View to 'New Bridge'*

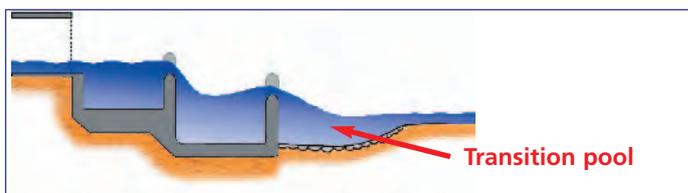
1. To conform to the principles set out above, culverts always need to be oversized and, generally, laid below the river-bed grade level by about 500 mm.
2. Where the bed gradient is too steep for full backwatering, the best option for achieving low velocity and adequate fishway is to provide a fish-pass at the downstream end, as shown in Figure 3.

**Fig. 3. Fish pass and transition pool at downstream end of culvert**

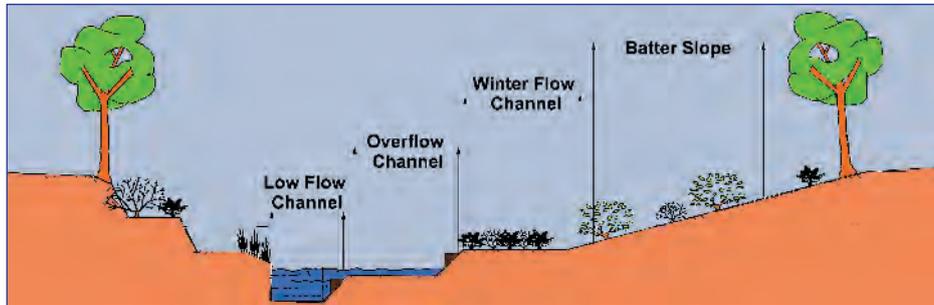
While permanent diversions are not encouraged, in limited circumstances they will be permitted. The new channel should display hydraulic and morphological characteristics fulfilling the requirements of fisheries habitats. Bed and bank work should be executed in natural materials.

Fig. 4. Example of realignment design

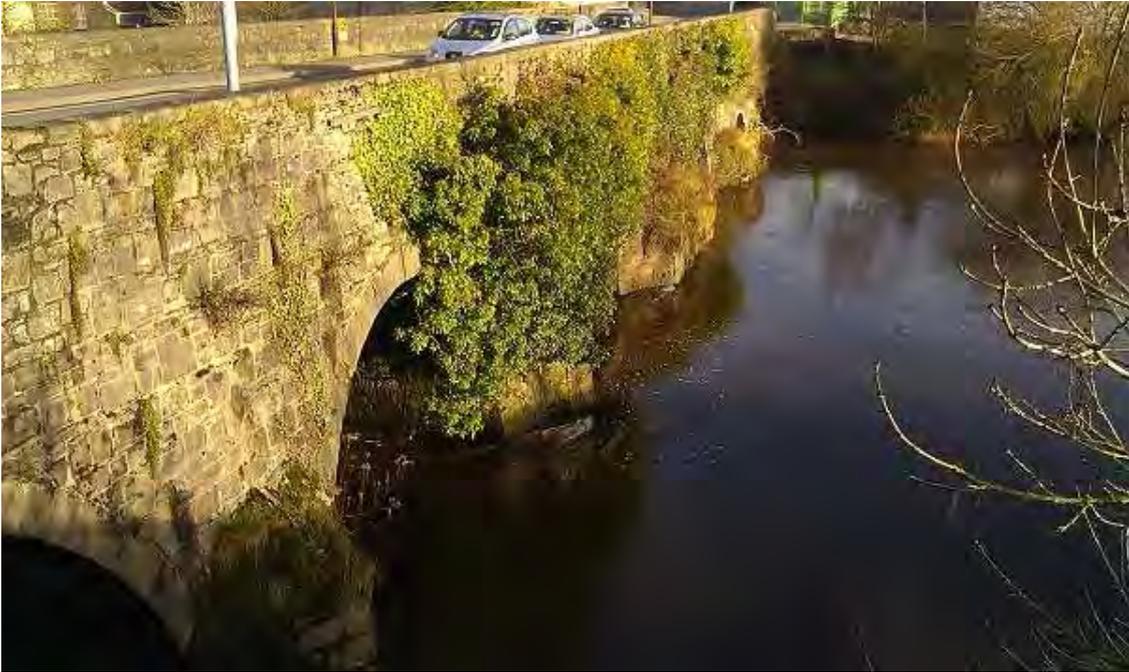
**Figure 6:** New Bridge with old stone walls (BL1), ivy and other species are found here. The pedestrian bridge is proposed for this south facing side of the bridge. The bridge was cleaned after this photograph was taken in 2013 and as at March 2016 there was no ivy present.

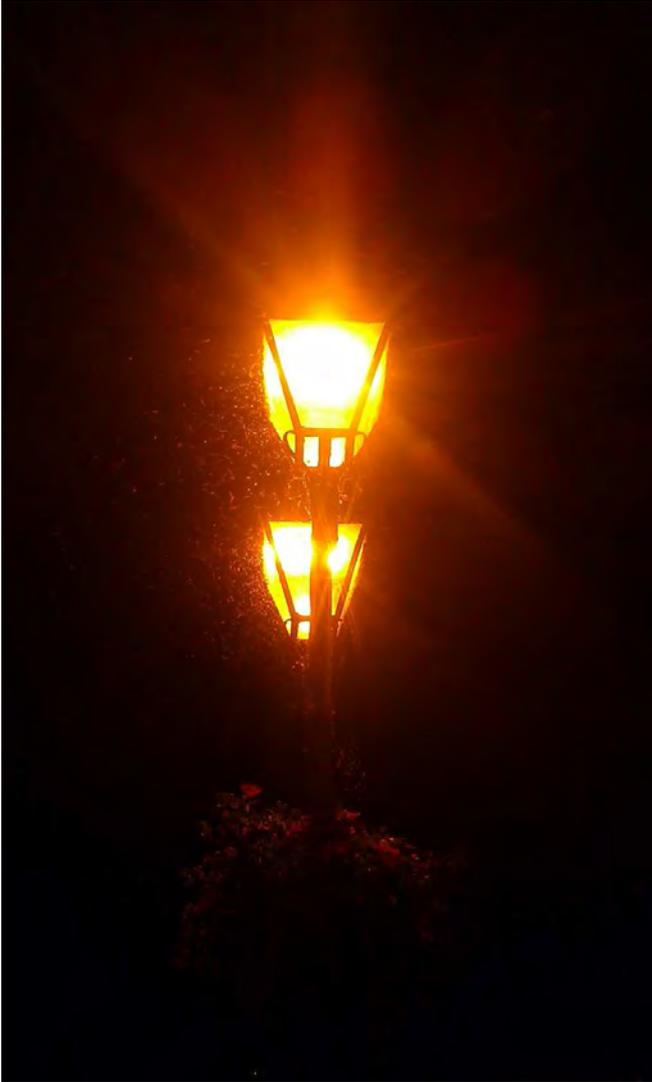
Figure 10: Insects swarming at yellow (high pressure sodium) street lights on the deck of New Bridge, Navan, Co. Meath, July 2013.

On the night of the survey large swarms of emerging aquatic insects were observed swarming around artificial yellow (high pressure sodium) night lights at and around the bridge (see Figure 10).

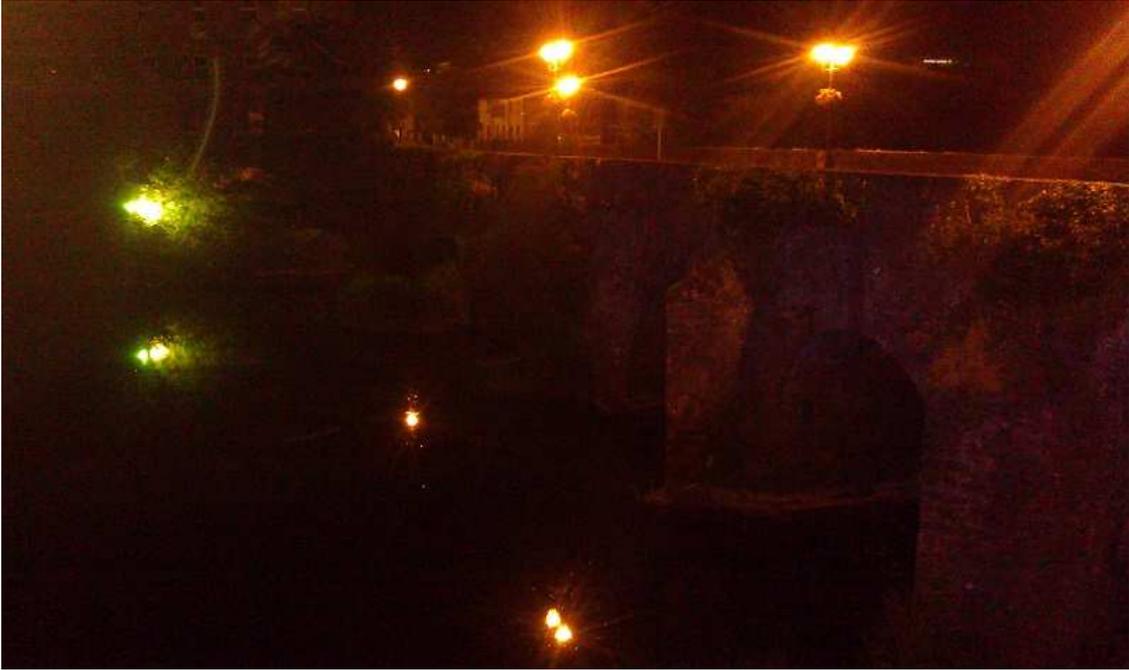
Figure 11: New Bridge (north facing façade) and the River Boyne, lit at night by direct, diffuse and reflected artificial lighting.

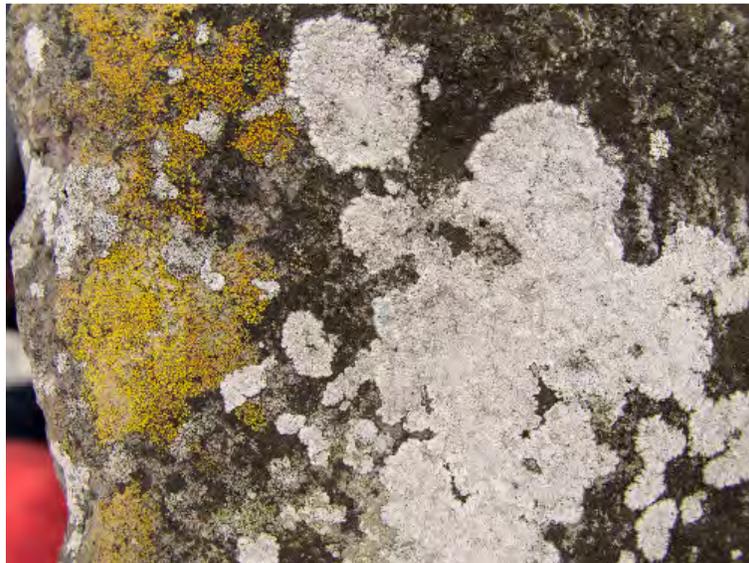
**Figure 1: Main species on the bridge limestone blocks are species from the groups *Caloplaca* (yellow), *Verrucaria* (brown) and *Aspicilia* (white).**

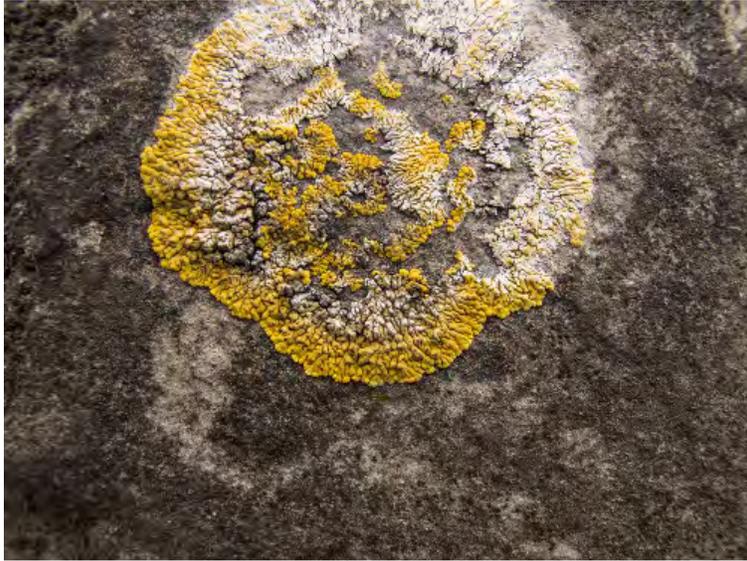
**Figure 2:** Few and poorly developed *Caloplaca flavescens* on the vertical aspect of the bridge walls. Normally a lot more of this species would be expected.

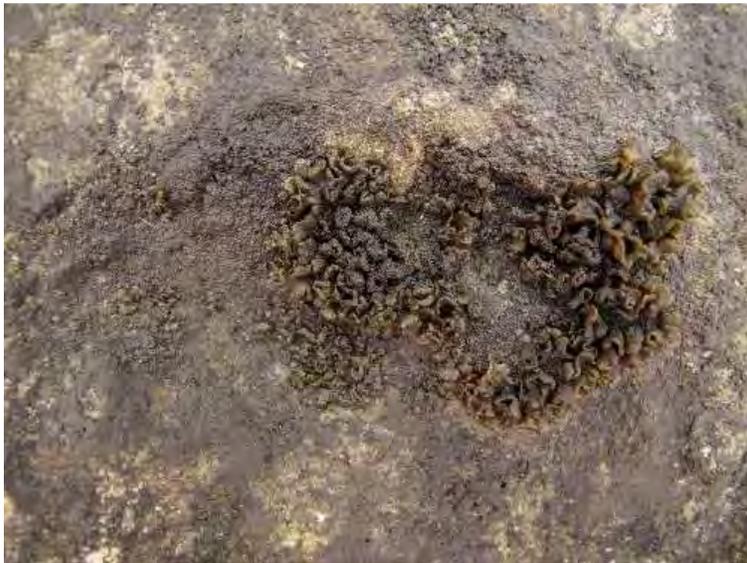
**Figure 3:** *Collema* species are rare on the bridge. Again, more of this group should be present if mortar had not been replaced by cement.

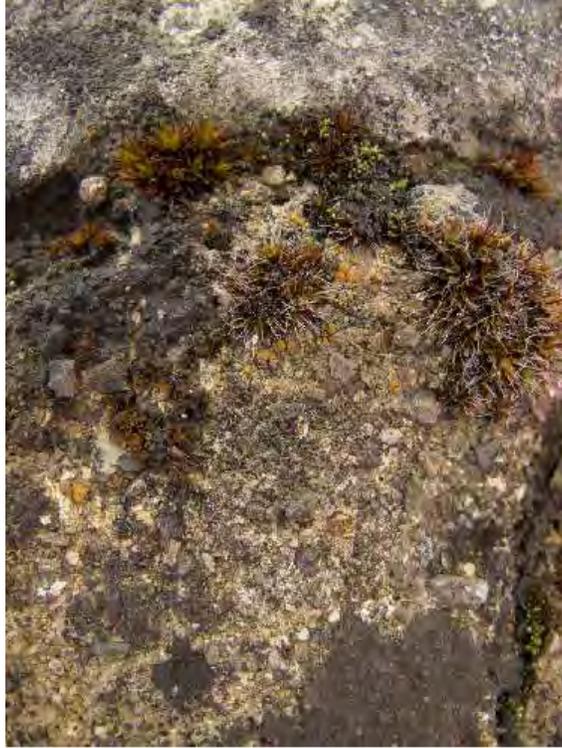
**Figure 4: *Protobastina rupestris* (orange dots) on poor cement pointing.**

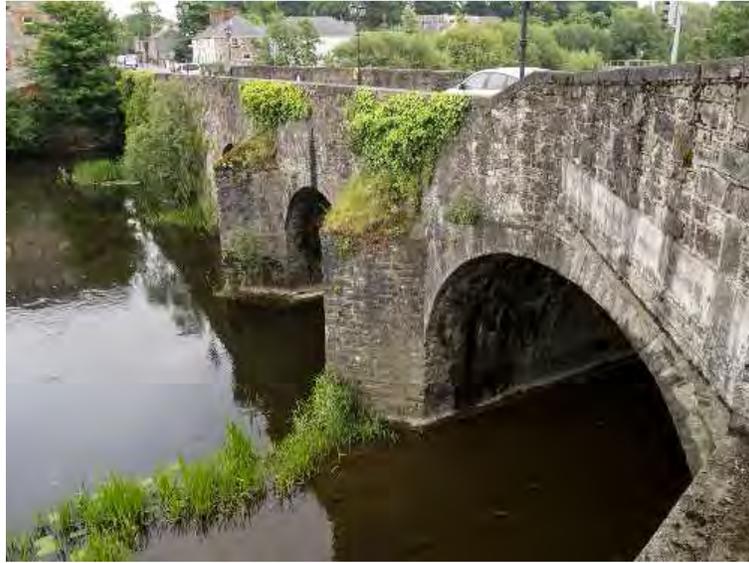
**Figure 5: North-facing aspect of the bridge showing large growths of *Aspicilia* and *Verrucaria*.**

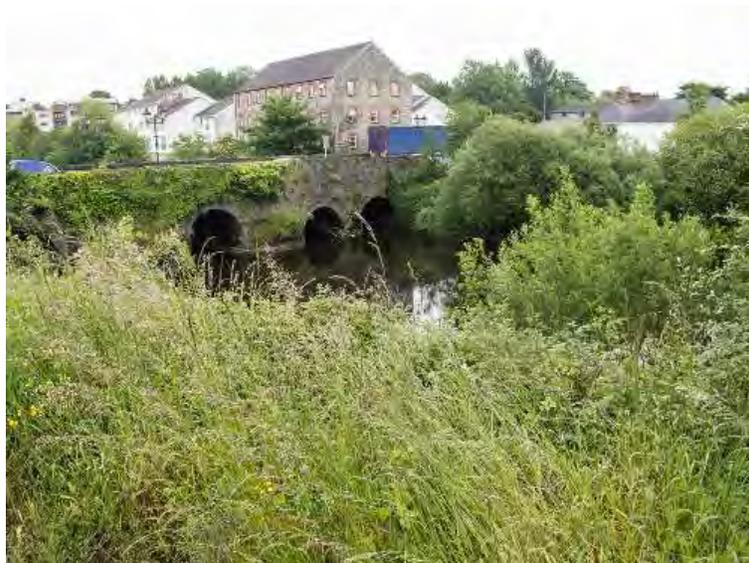
**Figure 6: South-facing aspect of the bridge. Removal of the (mostly) ivy will enhance lichen growth provided the structure is not chemically cleaned.**

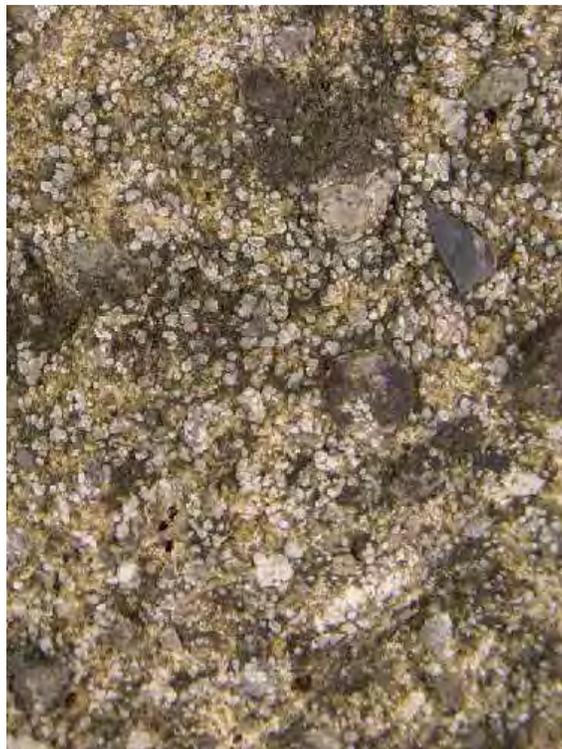
**Figure 8: *Aspicilia contorta subsp. contorta* on the poor render on the bridge.**

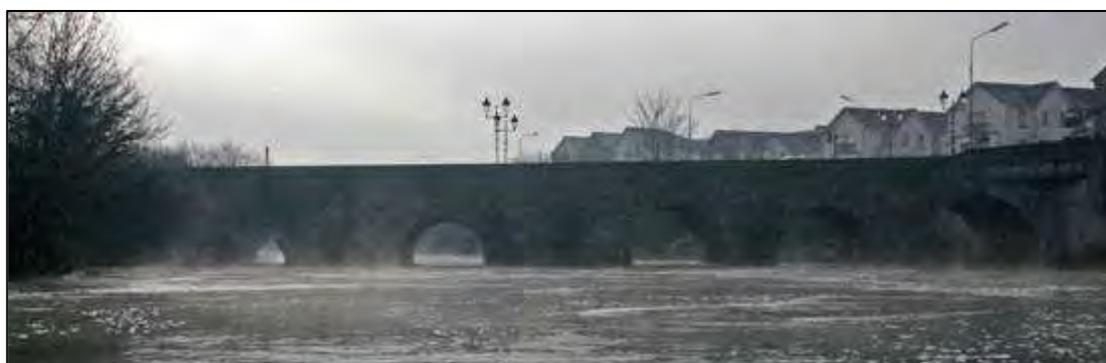
New Bridge is a six-arched masonry bridge that runs east-west to connect Athlumney on the right bank of the Boyne with the town of Navan on the left bank. The bridge was inspected for the purposes of this report on the morning of 9th January 2013. The weather was dry, calm and cool with some bright intervals at the time of the inspection, and there was a significant level of mist that remained all morning, making photography difficult, particularly from a distance. Although rainfall had been moderate over the period preceding the survey the river was relatively high and fast flowing. As a result of this detailed inspections beneath the arches was difficult and only a small number of measurements were taken in the interest of safety.

**Plate 1:** Downstream elevation of bridge (north)

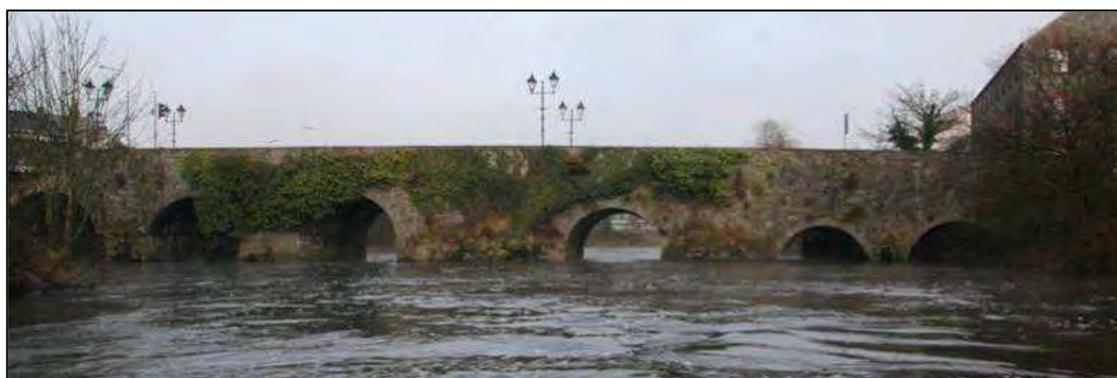
**Plate 2:** Upstream elevation of bridge (south)

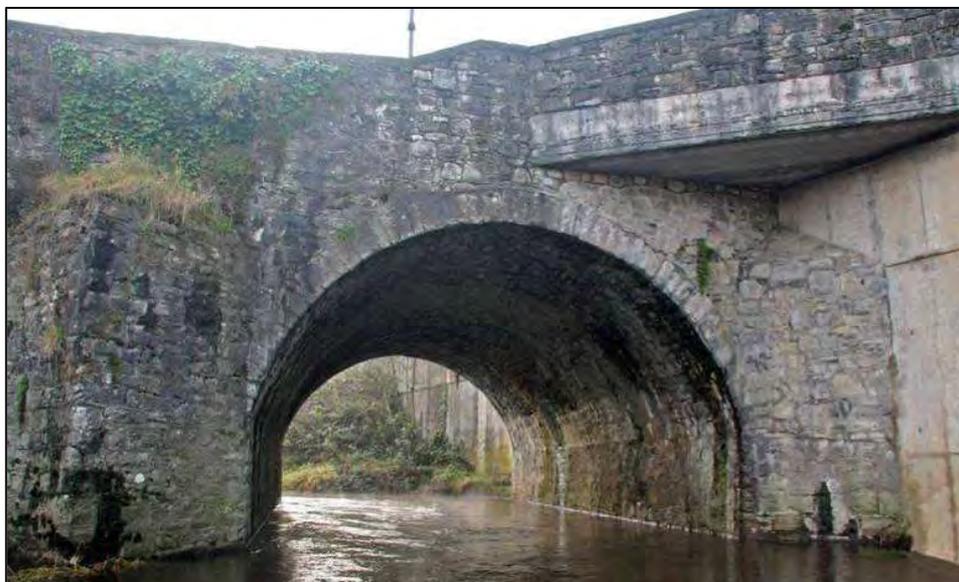
arches at the eastern side of the bridge, both with crowns significantly lower than the other four arches. Unusually, the fifth arch is smaller than the sixth, a reverse of the norm in which arches nearer to the banks are usually the same size or smaller than those nearer the centre.

**Plate 3:** Downstream side of western arch

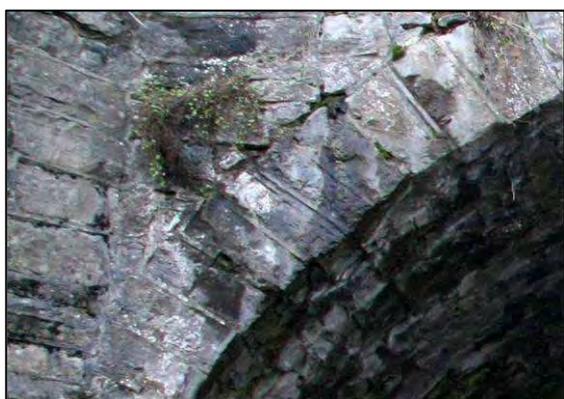
**Plate 4:** Detail of arch ring on downstream side

The voussoirs on the downstream side of the bridge are of squared limestone blocks, brought to shape, but not dressed. The arch ring is parallel. The cutwaters, spandrels and parapet are of rubble limestone.

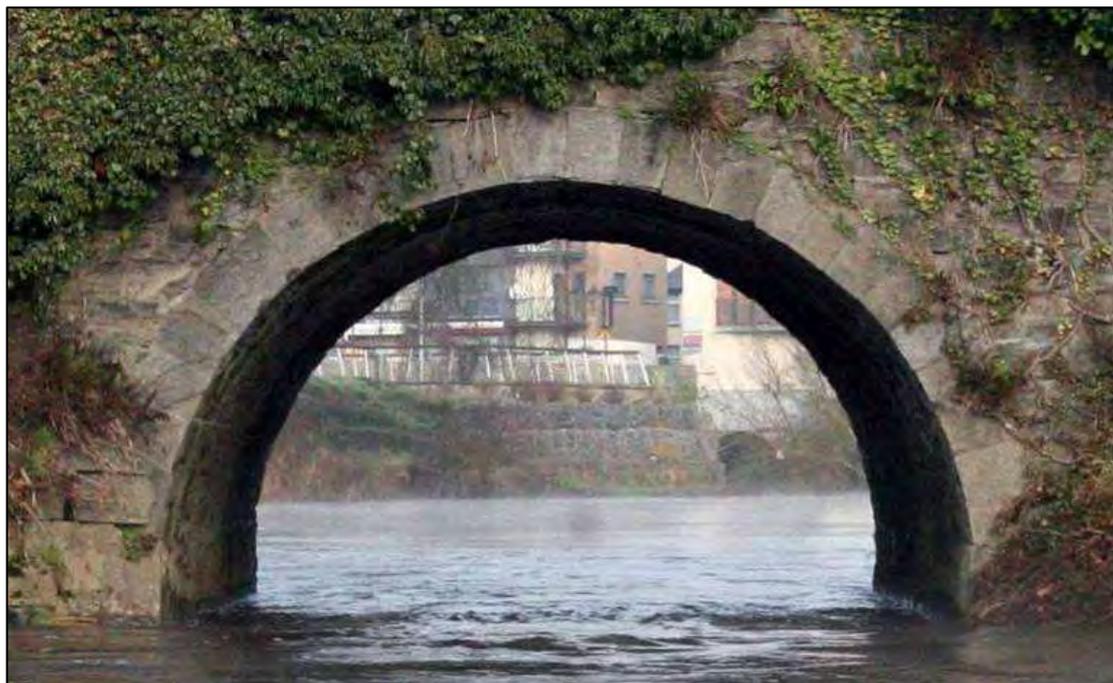
**Plate 5:** Upstream side of fourth arch from west

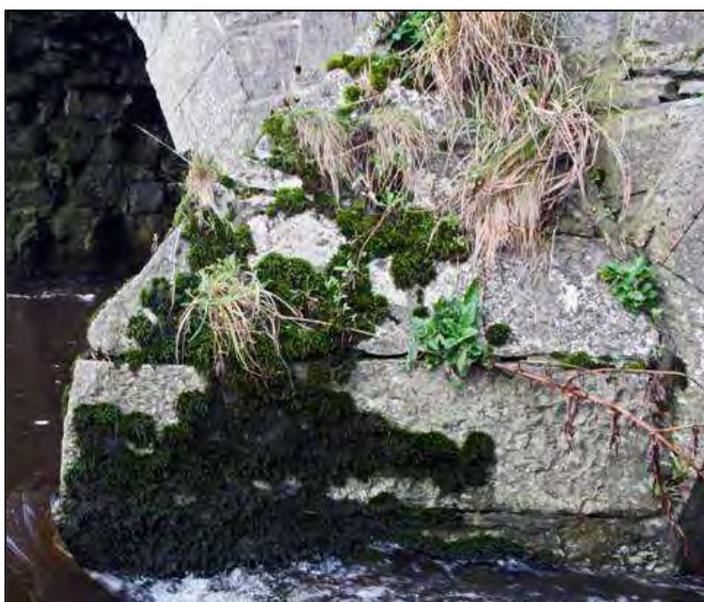
The cutwaters on the upstream side are lower than those downstream. The two cutwaters on the western side rise to the spring of the arch and have a prismatic capping above this. The easternmost cutwater rises only 300 or 400mm above the spring of the arch before terminating with a prismatic capping. These cutwaters are faced with hammer dressed limestone of similar quality to the stones in the arch ring.

**Plate 6:** Easternmost cutwater on upstream side

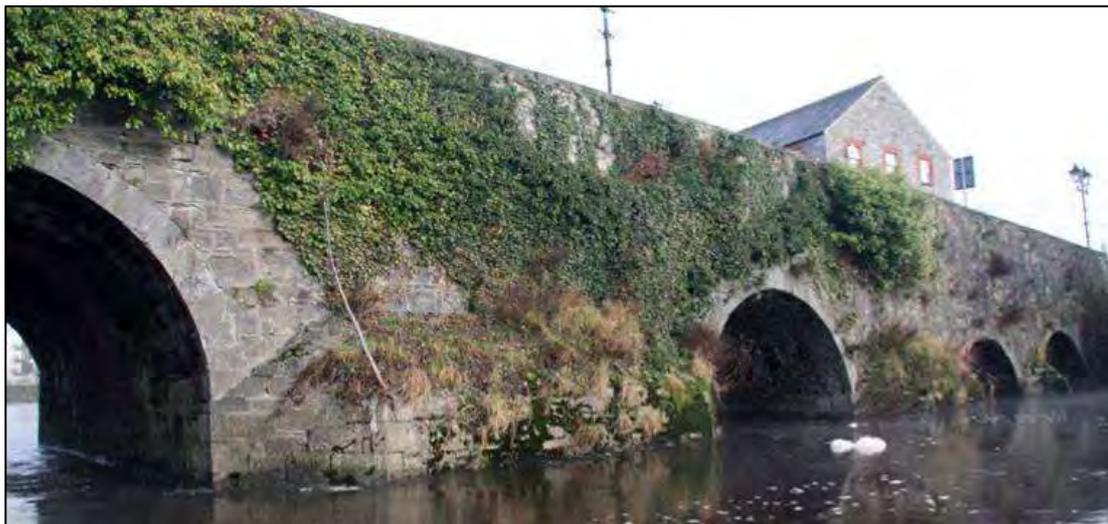
**Plate 7:** Upstream side of bridge, looking eastwards

The two larger cutwaters on the upstream side are massive. They are of similar height to the others, rising from the spring of the arch and having a prismatic capping, while the thickness of the piers ensures that there is a broad expanse between the ends that is faced on the river side by a vertical wall of hammer-dressed limestone, above which the capping slopes back to the bridge.

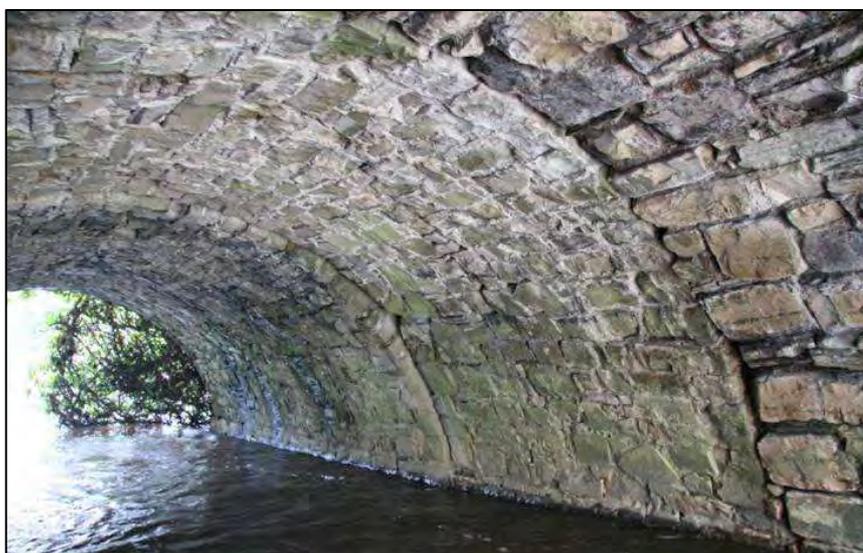
**Plate 8:** Barrel of vault inside the fourth arch from the west

The reason for the difference in the nature of the arches and cutwaters on the two sides of the bridge is seen on the interior of the arches. There are two vertical joints through the masonry running from one side of each arch to the other and in some cases the joint is several centimetres wide. There are slight differences in the curvature of the arches on either side of the joints. These joints represent two extensions to the original bridge in the years after its original construction.

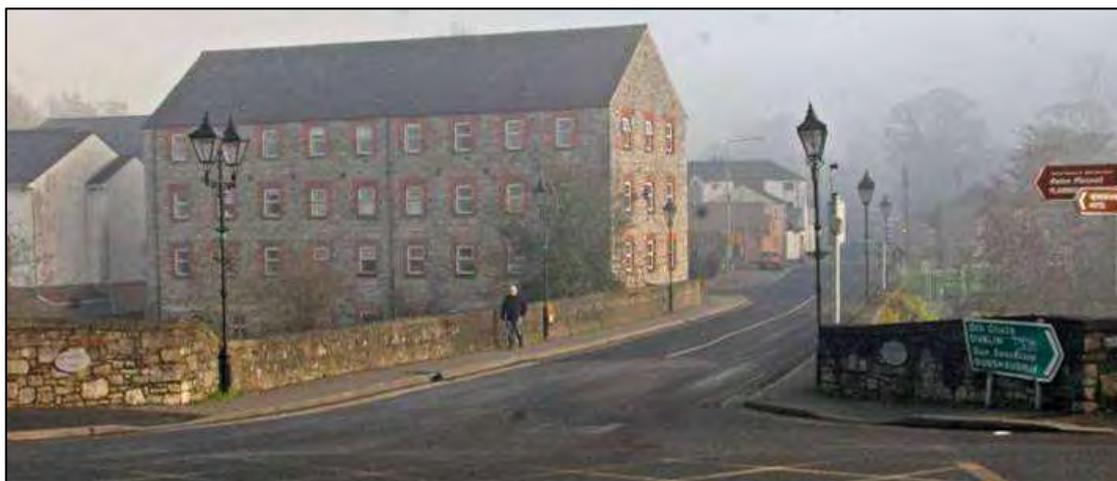
**Plate 9:** View eastwards across bridge from Navan towards Athlumney

The bridge deck slopes towards the east, as noted above, with the parapet on the eastern end rising 1280mm, while at the western end it is 925mm. The road crossing the bridge is single-carriageway with one lane in each direction. There are footpaths on each side, both surfaced with concrete paviors and both relatively narrow.

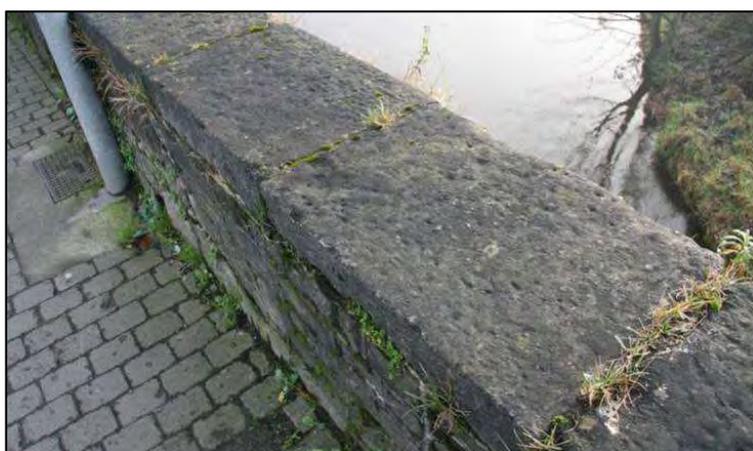
**Plate 10:** Detail of parapet wall and coping stones

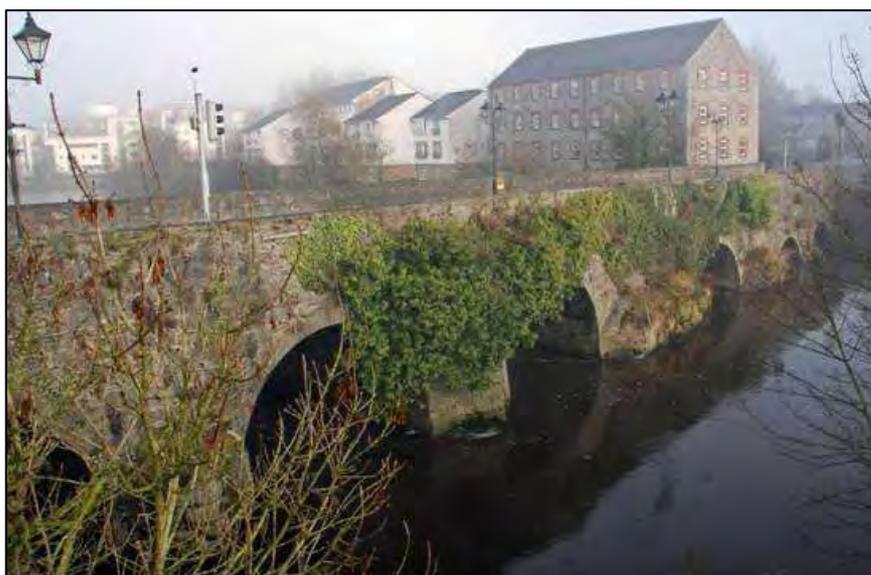
As it happens, the works would be confined to the newer part of the bridge and would not extend back far enough to encroach on the original mid-eighteenth century bridge structure. Nonetheless, the bridge is a protected structure and the works would affect the protected fabric directly.

**Plate 12:** Upstream side of New Bridge, seen from the western bank

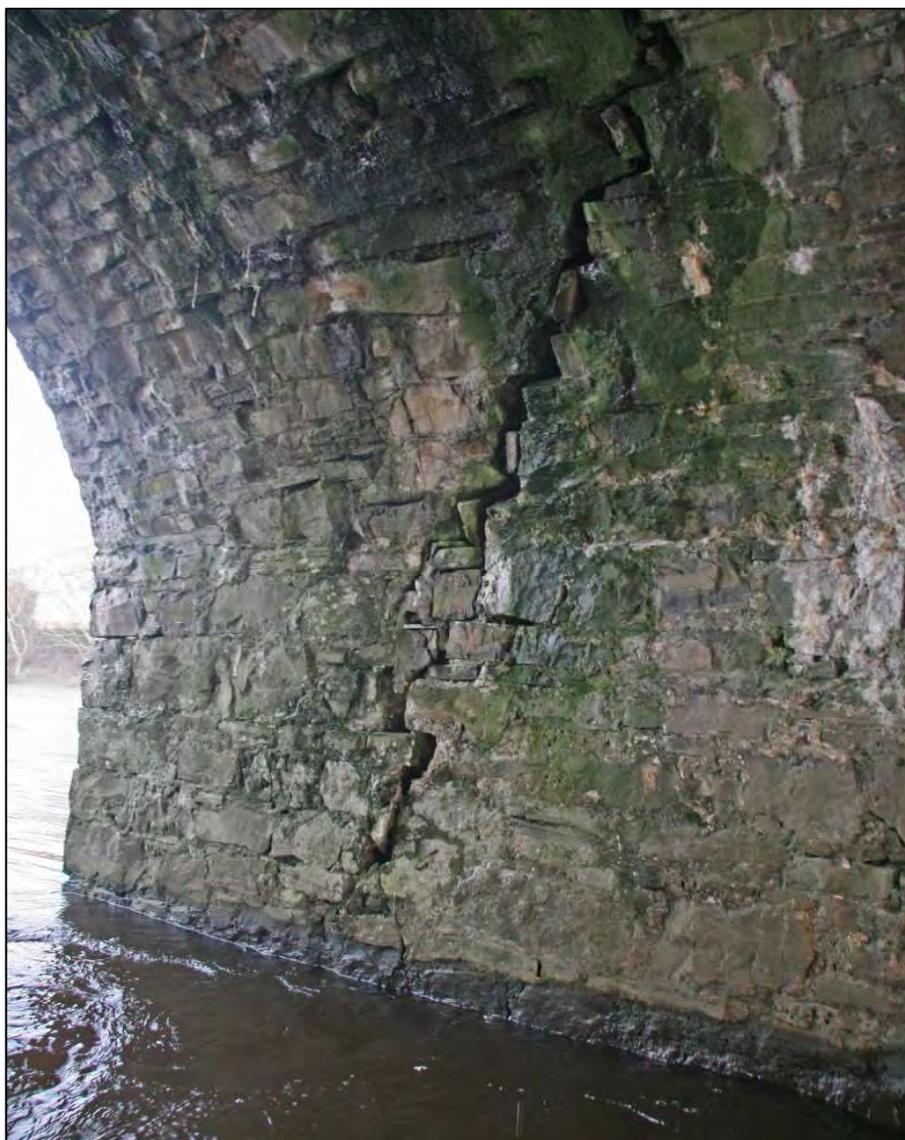
and could possibly have catastrophic consequences. It is recommended, therefore, that if the first option is selected no work should commence on the provision of the proposed pedestrian and cycle-bridge until a comprehensive programme of repair has been carried out to the masonry of New Bridge and that this work should be carried out to full conservation specification and supervision.

**Plate 13:** Crack in third arch from western side of bridge
