ARCHAEOLOGICAL
CONSULTANCY SERVICES UNIT

Archaeological Assessment at Trim Visitor Centre, Market House, Castle Street, Trim, Co. Meath

17th April 2023

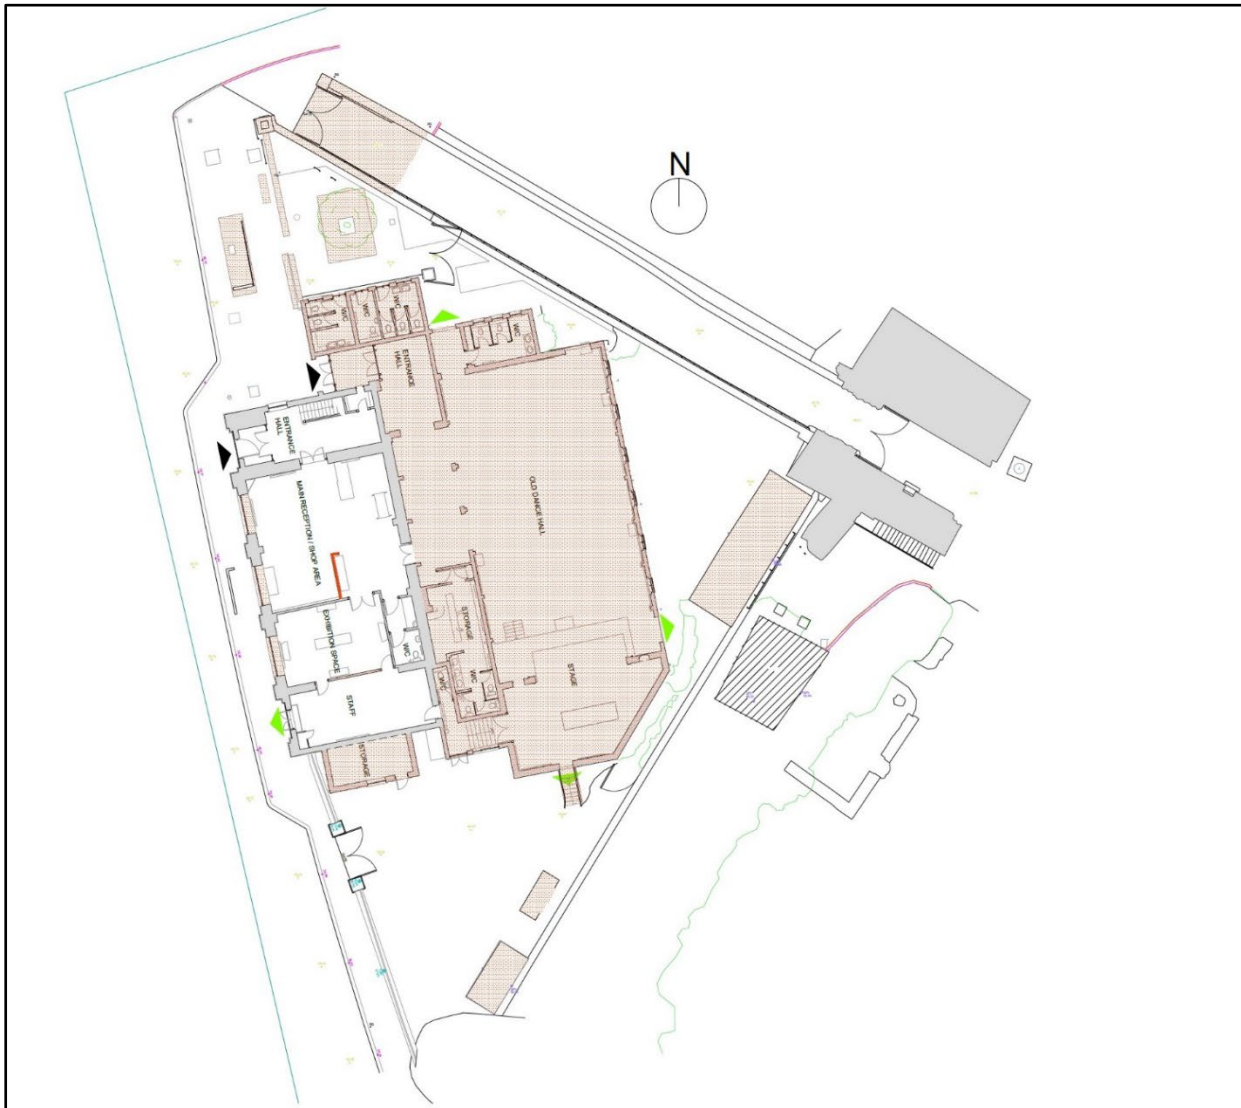
Figure 14: Proposed demolition works

- the demolition of some of the 20th century extension buildings on the site, principally the dancehall, fly-tower, external sheds and toilet block
- refurbishment of the Market House including a new internal lift
- construction of a new extension to the rear of the Market House on part of the footprint of the dance hall
- new covered walkway from the building to the causeway leading to Trim Castle
- landscaped area to rear

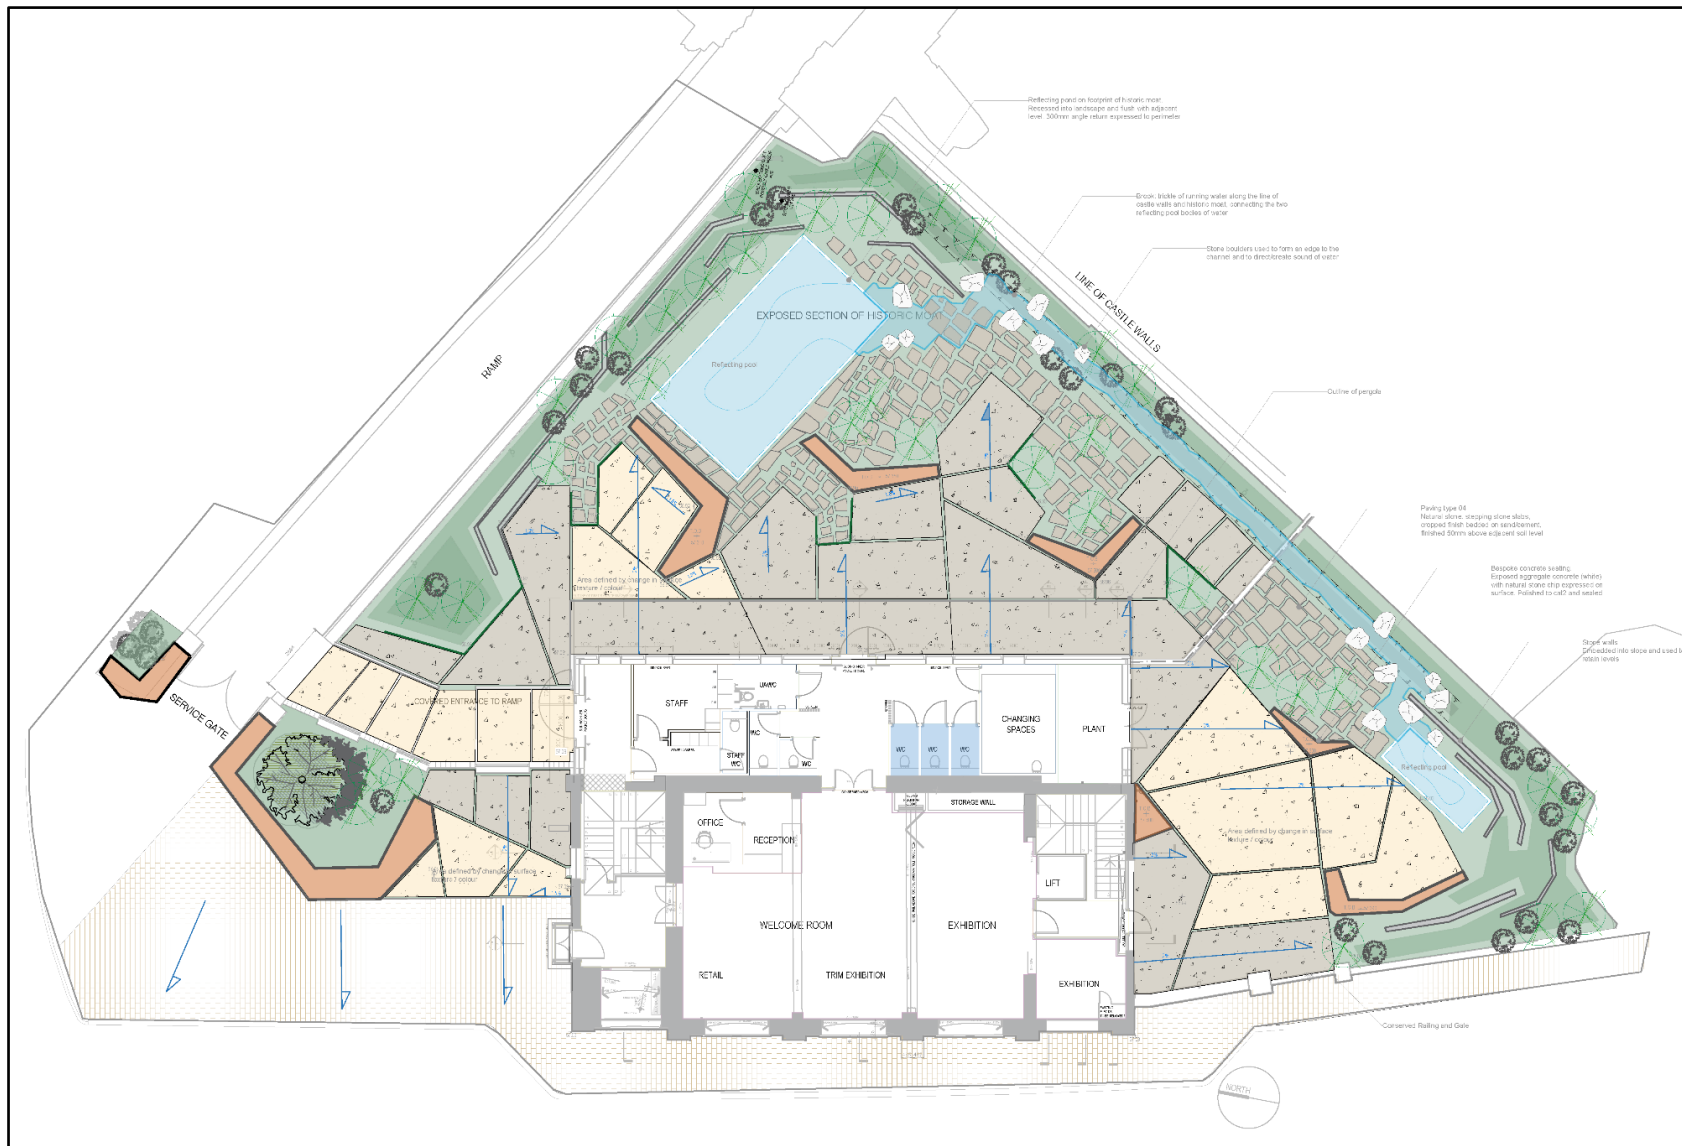
Figure 15: Proposed site layout and landscape plan

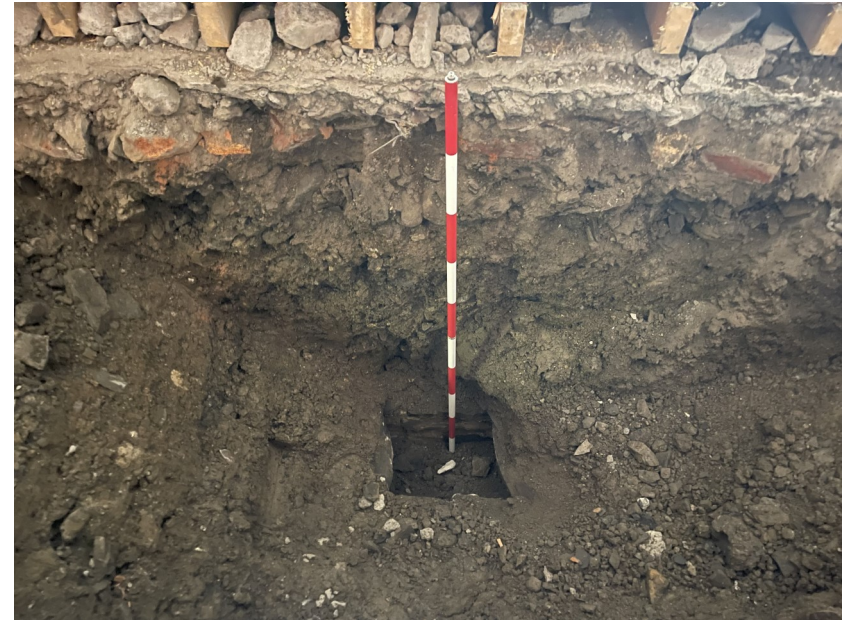
Plate 6: Drain in base of trench 1, looking east.

The proposed works The testing has confirmed that the upper 2m to the south and east of the Market House are disturbed or represent imported material to the site. This was probably done when the Market House was being constructed along

with the uncovered mortared drain to the rear. Given this level of disturbance across the four trenches excavated it is unlikely that the proposed new building will have any impact on archaeological features. The only potential impact could be from piles or foundation levels deeper than 2m. All future demolition works of the extensions to Market House including the ballroom, stage area, fly tower, public entrance area, public toilet facilities, and the service areas to the rear and side of the building will be monitored under ministerial consent C001167. Excavation of geotechnical trial pits and all groundworks associated with the development will also be monitored under ministerial consent C001167, and will also include metal detection (R000605) to scan relevant deposits to aid in artefact recovery. It will also be necessary to carry out further test trenching to the north of the site, when access is available following demolition of the ballroom and other extensions, to attempt to identify the edge of the moat in this part of the site if such survives below the 2m limit achievable during the current testing. In addition a test trench will be required at the junction of the proposed new covered walkway and the causeway/ramp leading to Trim gate. As the moat has the potential to contain waterlogged deposits and organic finds, their retrieval and preservation/conservation will also need to be addressed if there is to be any impact in this area. Once the site investigation works are complete and a detailed layout and foundation design is prepared, a more detailed impact statement will be submitted. Further mitigation could include archaeological excavation in areas to be impacted by development.

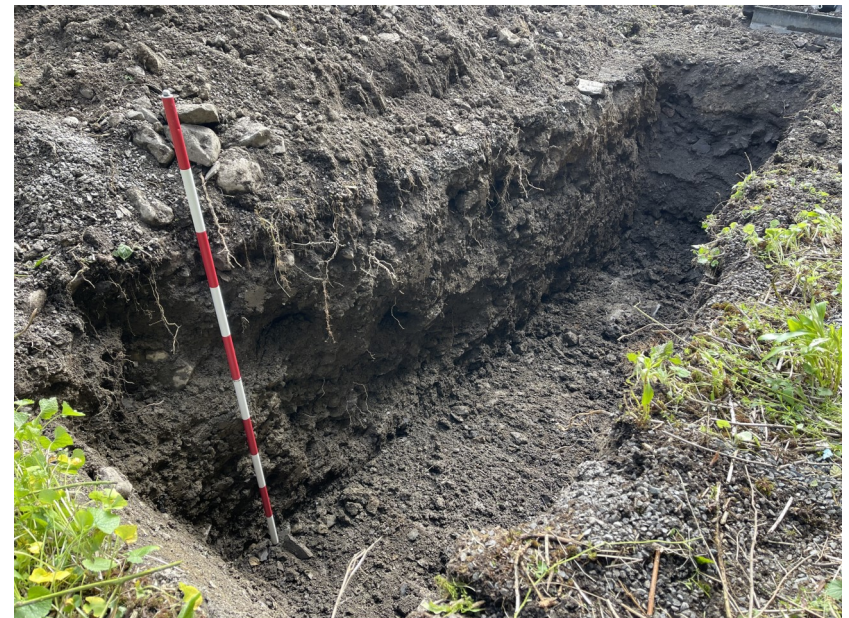
Plate 8: Close up of east section of Trench 2, looking east.

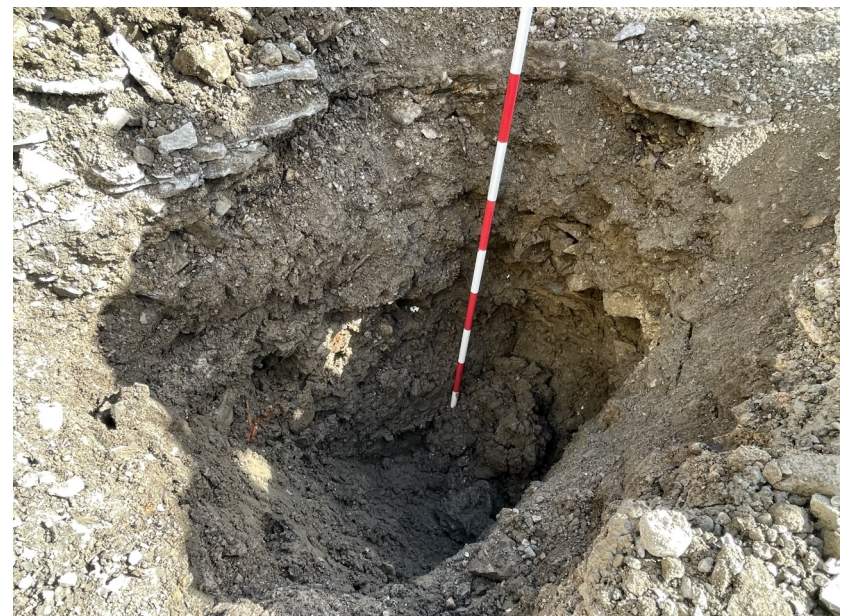
Plate 12: Close up of Trench 4, looking southeast.
