Ratoath Pedestrian & Cycling Scheme

Ecology Report

Meath County Council

March 2022

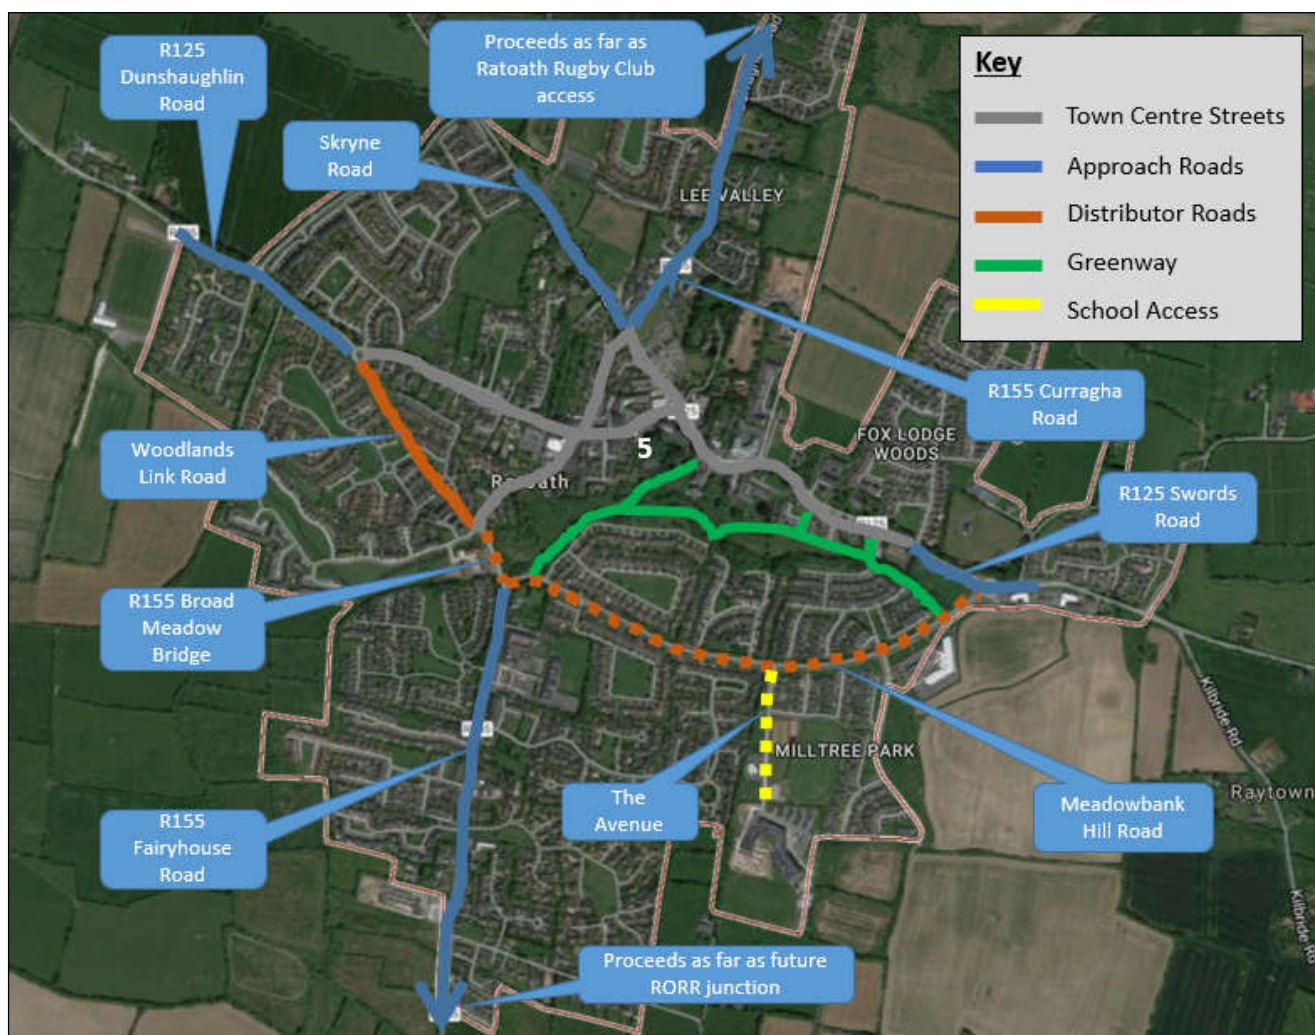
Figure 1.1 Proposed Project Location.

The proposed scheme has been broken down into general sections (see Figure 1.1). These sections are as follows: -

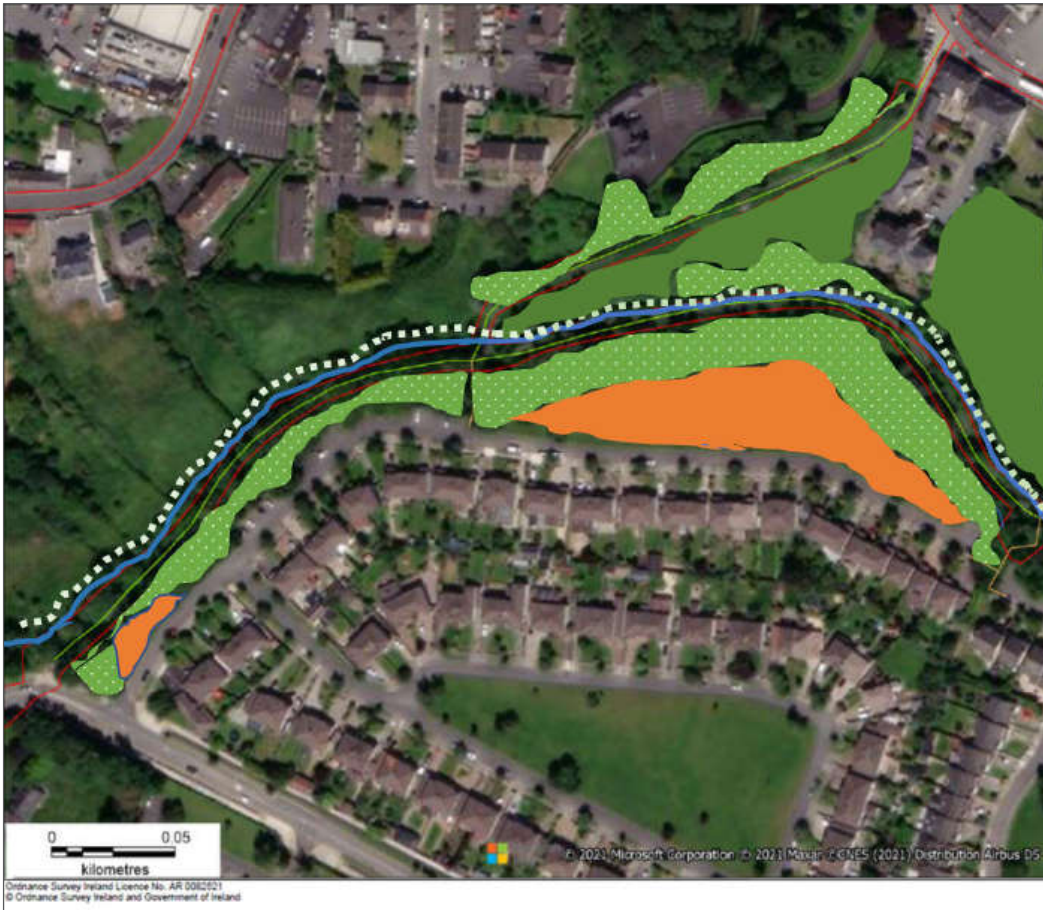
Figure 4.2 Habitat Map (Section 1-3).

(Orange = amenity grassland, solid dark green = rank grassland, spotted green = woodland, Pale green square dots = tree line, blue = river).

An existing path is present in this section which will require resurfacing. The following are a series of photographs illustrating existing conditions along the pathway. See Figure 4.1 for location of Sections and bridges. A habitat map is presented in Figure 4.2, above).

There is an existing path (BL3) in Section 3 (see Figure 4.1) which will require resurfacing (see Plate 4.18). A habitat map is presented in Figure 4.2, above).

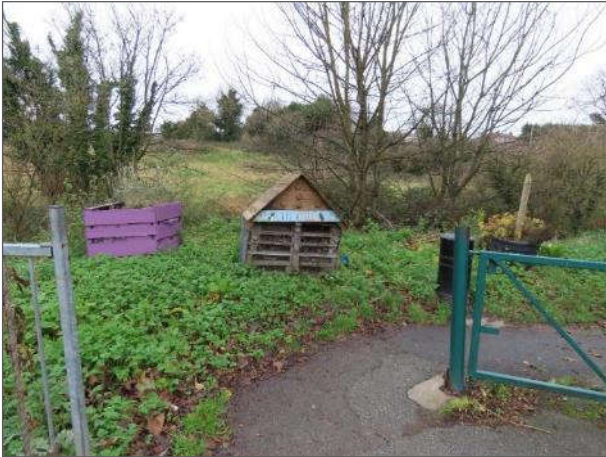
Plate 4.1 Western entrance to river walk - opens from Meadowbank Hill Road.

An existing path (BL3) is present along this section of the proposed pathway, which will require resurfacing and minor widening at pinch points. The western entrance to the river walk opens from Meadowbank Hill Road. At this point the distance to the river is ca. 7m.

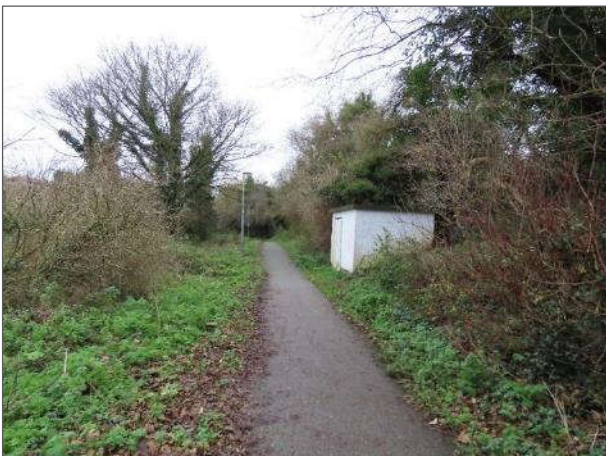
Plate 4.3 Small concrete shed on southern side of track.

A small concrete shed is located on the southern side of the track. The potential for this structure to support roosting bats was considered. As it has potential to act as a bat roost, it should be surveyed for roosting bats by an appropriately qualified ecologists prior to demolition. Should any bats be recorded it will be necessary to apply for a Derogation licence under Regulation 54 of the European Communities (Birds and Natural Habitats) Regulations 2011.

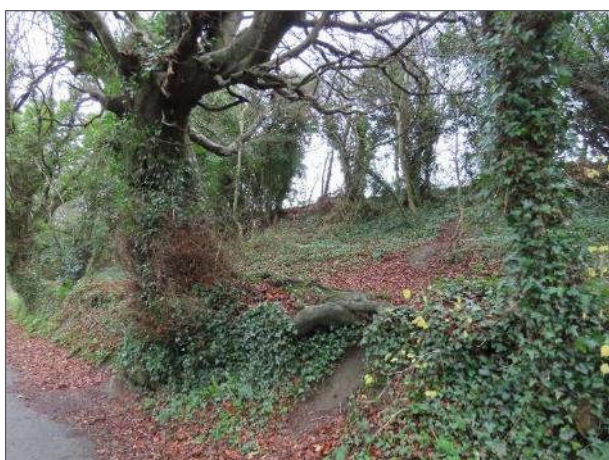
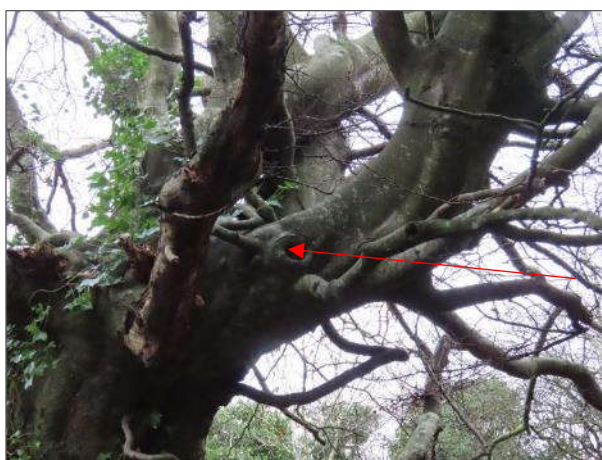
South of the proposed pathway is a strip of deciduous woodland (WD1) – in this area the woodland is approximately 20m in depth. A notable mature beech is located adjoining the path. A potential roost site for bats in this tree is highlighted in Plate 4.6.

Plate 4.6 Notable beech tree adjoining the path (IG ref. - 01956 51694), with potential roost features for bats.

As noted a small concrete shed is to be checked for roosting bats prior to demolition. Potential roosts have also been identified in a number of beech trees adjoining the path (see Chapter 4.0). There are no proposals to remove these trees. Bridge 2 (James Corbally Bridge) is a single arch masonry structure – cavities in the arch do offer roosting opportunities for bats. These will not be impacted by the proposed works.

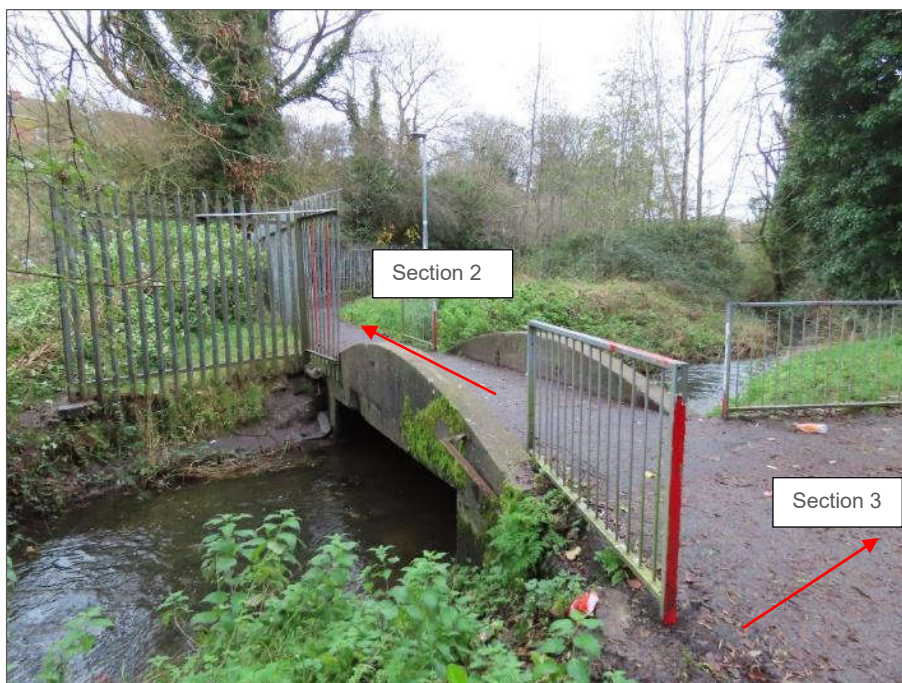
Plate 4.9 illustrated the junction point between Sections 1, 2 and 3 as labelled in Figure 4.1. Here the pathway splits with one section crossing over the Broadmeadows River via Bridge no 1; an existing concrete culvert which crosses the river. It is not proposed to replace the bridge, nor are any instream works proposed.

Plate 4.9 Bridge 1 – concrete culvert spanning Broadmeadow River.

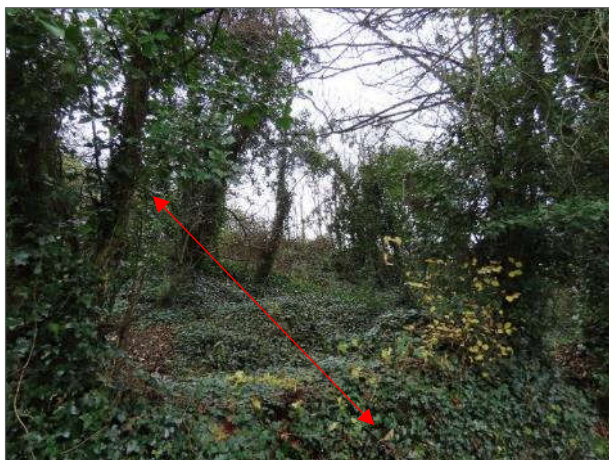
Plate 4.10 Woodland on embankment south of Bridge 1; adjoining Meadowbank Hill Estate.

Immediately south of Bridge 1 – the embankment adjoining the existing pathway is covered by a narrow strip (ca. 20m) of deciduous woodland (WD1). Meadowbank Hill Estate is located at the top of the embankment (see Plate 4.10).

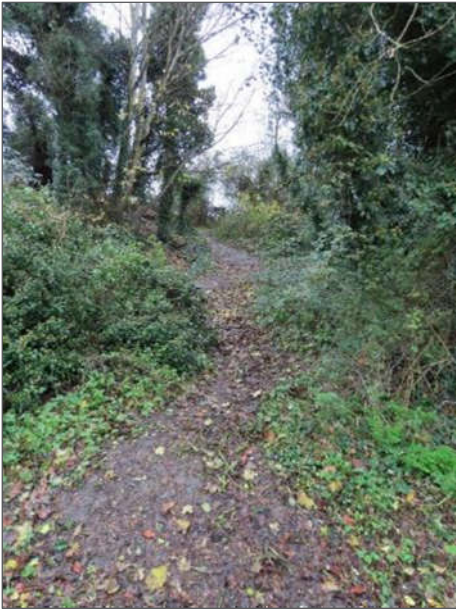
Plate 4.11 Existing track up to Meadowbank Hill Estate from Bridge 1.

There is an existing informal path up to Meadowbank Hill Estate from Bridge 1 (see Plate 4.11 and 4.12) – this path will be resurfaced and widened. Care should be taken to ensure the alignment works with the existing path line, but also is adjusted to avoid notable trees.

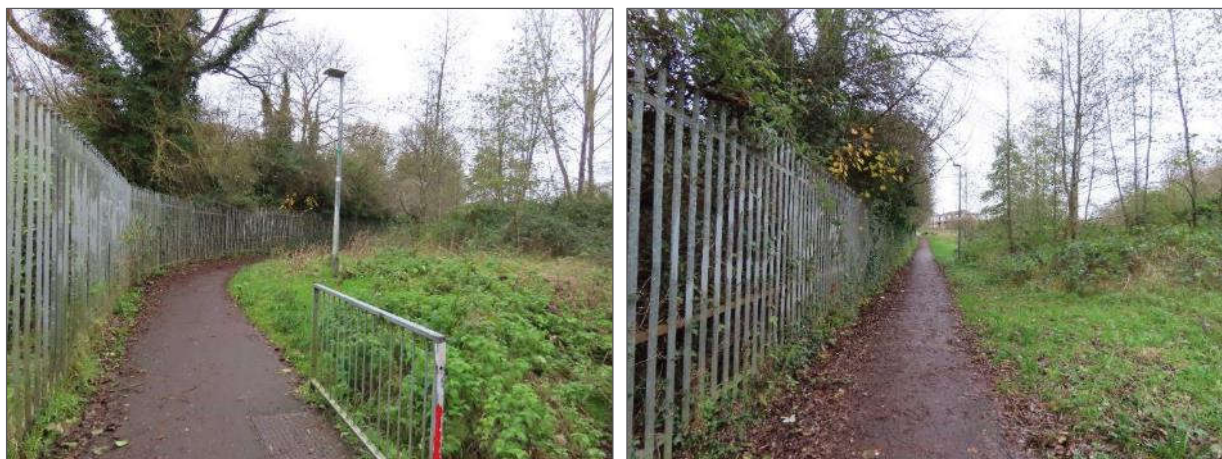
Plate 4.13 Existing path along Section 2 – immediately north of Bridge 1.

To the west of the existing path (BL3) is a ca. 2m palisade fence; behind which is a treeline (WL2) of sycamore, hawthorn and ash. To the east are areas of rank grassland (GA1/GS4) with some planted trees (see Plate 4.13). The grassland within 2-3m of the path is frequently cut. Dense areas of bramble are present adjacent to the river. Pockets of pendulous sedge (*Carex pendula*) are present with willow (*Salix cinerea*), vetch (*Vicia* sp.), clover (*Trifolium repens*), sedges (*Carex* spp.) and hard rush (*Juncus inflexus*), ribwort plantain (*Plantago lanceolata*), dock (*Rumex* spp.) and bramble (*Rubus fruticosus*). The habitat present in this section is evaluated as *Local Importance (Lower Value)*.

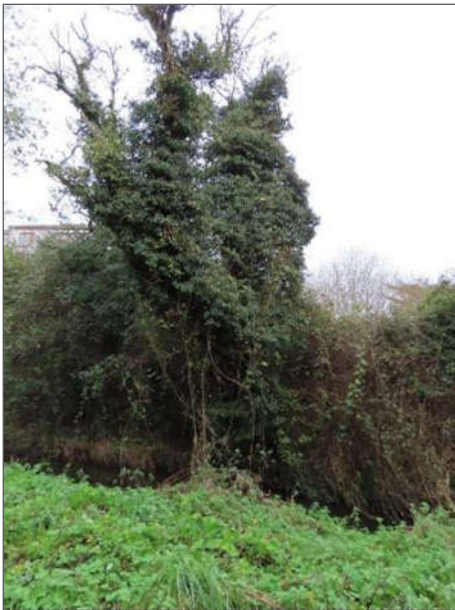
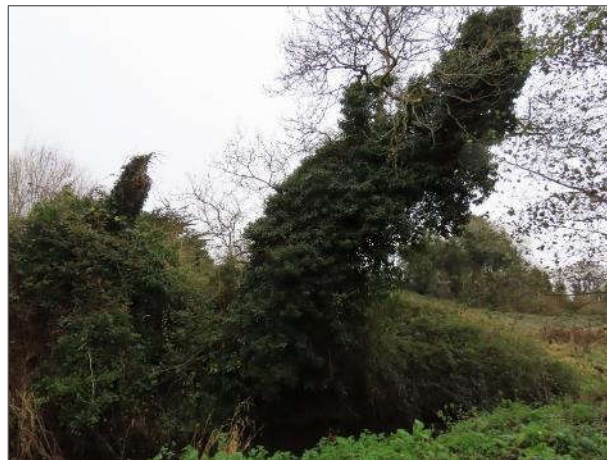
It was noted that an ash tree growing on the north side of the path was showing signs of severe ash-die back (IG ref. – 02213 51728). This tree is leaning across the Broadmeadow River. A bat survey would be required prior to its felling (see Plates 4.20-4.21). A second ash tree with severe die-back disease is located immediately to the east (IG ref. - 02220 51723).

Plate 4.20 Ash tree with severe ash die-back disease on northern river bank – heavily covered in ivy.

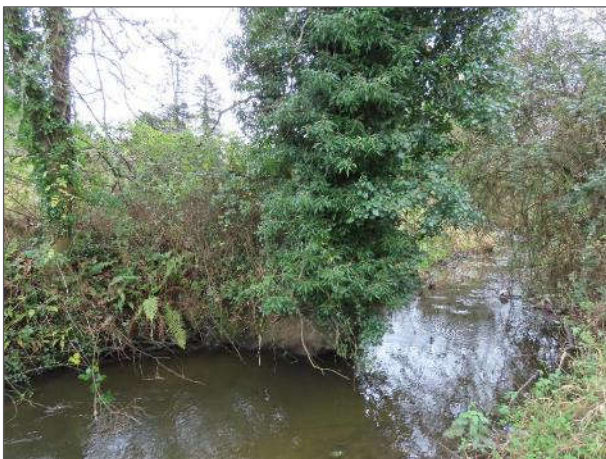
Plate 4.21 Base of same ash tree in Broadmeadow River.

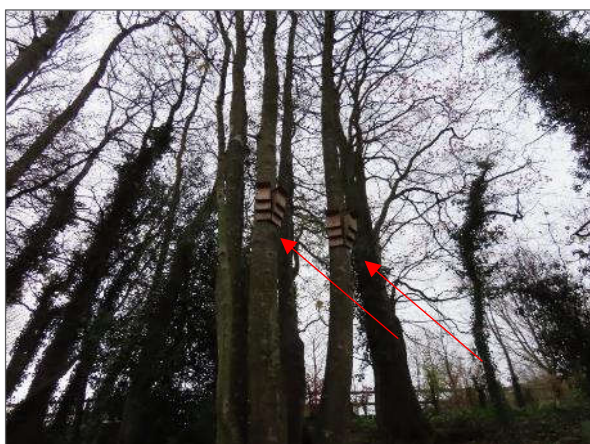
Plate 4.24 Wooden wedge-style bat boxes mounted on beech trees.

To the south of the bridge there is an informal trail which runs up the hill through deciduous woodland towards Meadowbank Hill Housing estate (see Plate 4.23). A number of wooden bat boxes are attached to trees adjoining this pathway (see Plate 4.24). Wooden wedge-style bat boxes have been mounted on beech trees on southern river bank just east of Bridge 2. A single Common pipistrelle (*Pipistrellus pipistrellus*) was recorded in the westernmost box (IG ref. - 02282 51655).

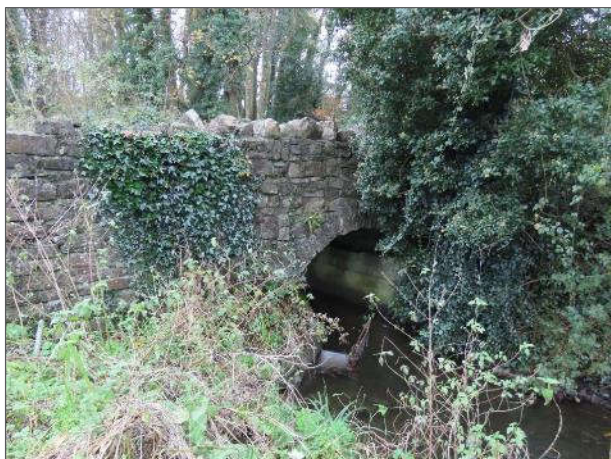
Plate 4.26 Bridge 2 (James Corbally Bridge) – upstream elevation – single masonry arch with concrete abutments.

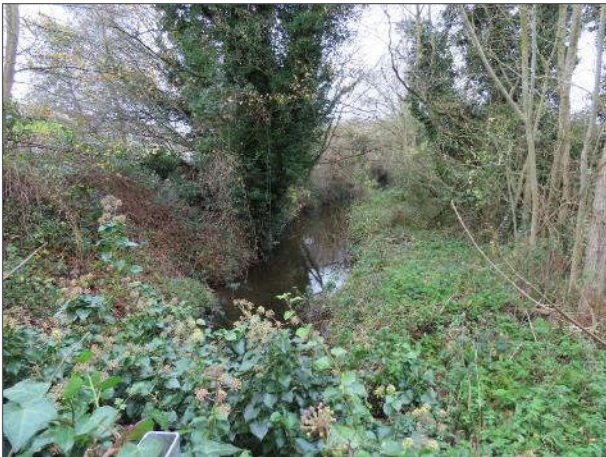
Plate 4.36 Broadmeadow River upstream of Bridge 3 (Section 4).

Bridge 3 is shown in the following Plates. A significant amount of flood debris was trapped under the arch when visited in December 2021.

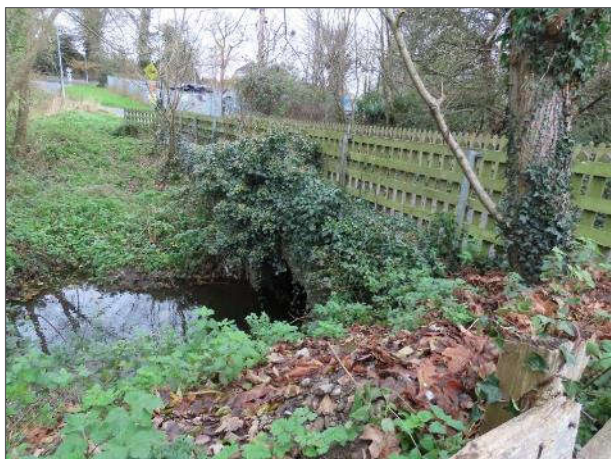
Plate 4.38 Bridge 3 – upstream elevation – heavily overgrown with ivy.

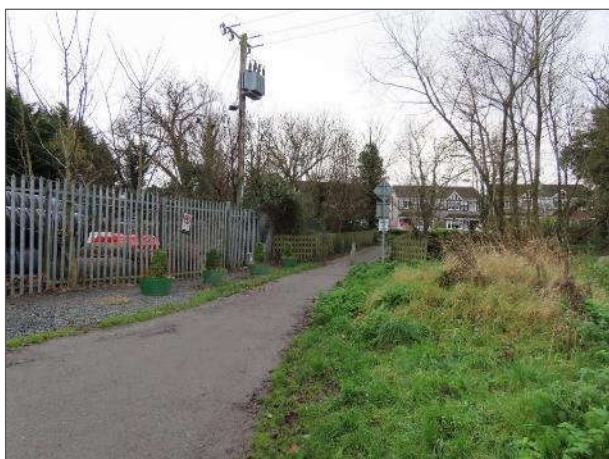
Plate 4.39 Existing road with Council depot on left (paved track turns south to cross Broadmeadow River via Bridge 3).

This section consists of an existing road entrance (BL3) which leads to Bridge 3. Bridge 3 carries a paved path over the Broadmeadow River. The path then turns east to run to the entrance to the pathway at the eastern end of Broadmeadow Hill Road.

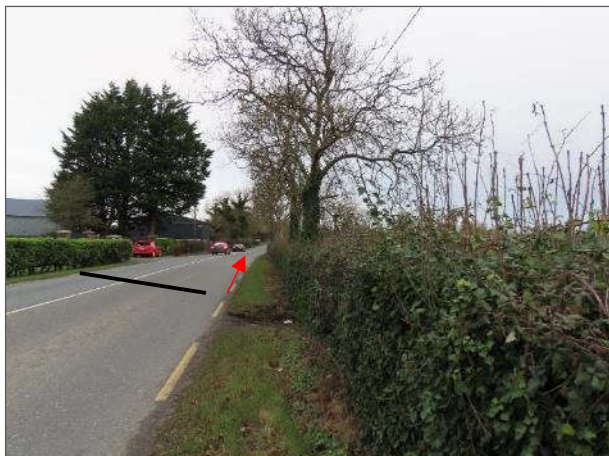
Plate 4.42 Eastern side of the Fairyhouse Road.

This 450m stretch of Fairyhouse Road was walked from north to south on 13th December 2021. The proposed pedestrian cycle route runs on the eastern side of the road and will necessitate the removal of roadside verges in some locations. Existing hedgerows (WL1) will not be removed. The road will be narrowed where necessary. No ecological issues were identified.

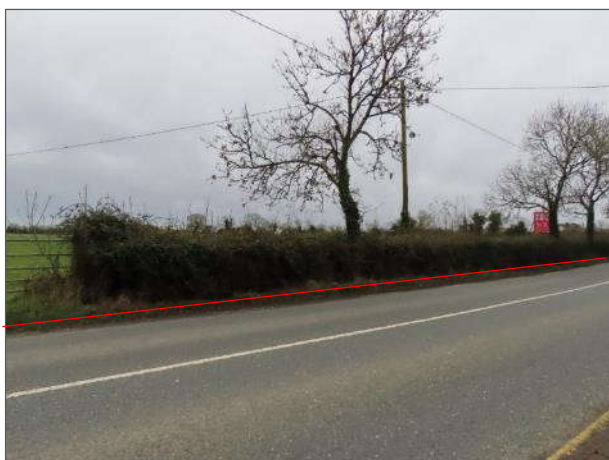
Plate 4.43 Immature single ash trees in hedge alongside verge.

The southern end of section on Fairyhouse Road looking north is illustrated in Plate 4.43. The pedestrian/cycle lane commences approximately at red line as indicated. Verge in this location is c. 1.5m wide. Pedestrian/cycle route to be 3m wide and paved.

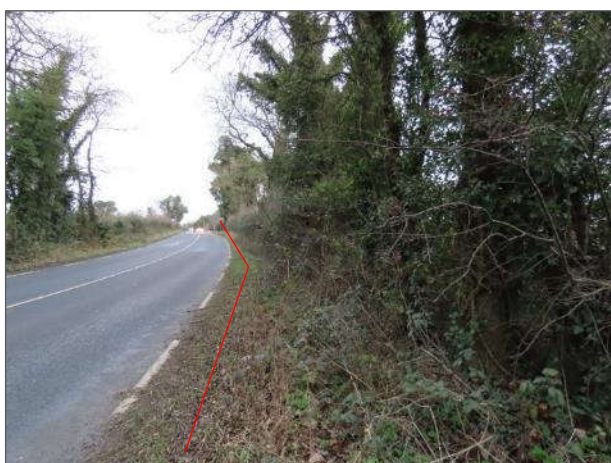
Plate 4.48 Verge north of speed limit sign with ivy covered ash in hedgerow (evidence of ash die-back disease).

It is evident that Ash Dieback Disease had taken hold in at least eight of the trees located along the Fairyhouse Road. These trees are predicted to die over the following few years and as such it is recommended that they are felled to minimise the potential for falling deadwood as well as the spread of the disease to other trees. Unfortunately, it is considered likely that the disease may have already infected some adjacent Ash trees nearby, with possible early symptoms already suspected in some. 'Ash dieback' is a disease caused by the *Hymenoscyphus fraxineus* fungi which is developing rapidly across Ireland since its presence was first detected in Ireland in 2012. The disease is spread by windborne spores and once a tree is infected it will lead to its terminal decline within a few years.

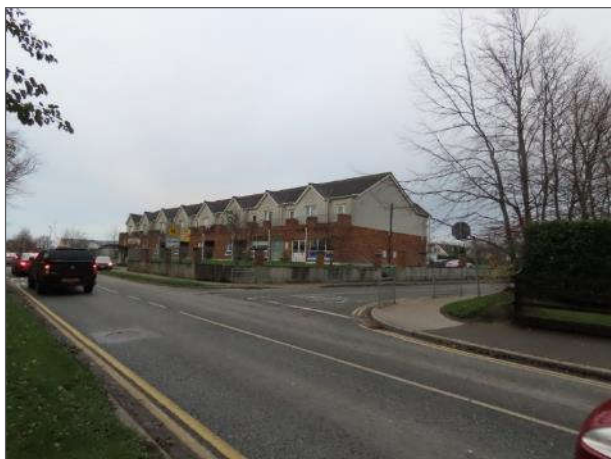
Plate 4.50 Proposed passing in front of commercial units (with residential units above) and the entrance to Fairyhouse Lodge estate.

Beyond Carraig na Gabhna cul-de-sac the route passes entrance to L5020. The existing footpath is to be widened to facilitate 2.5m minimum width shared pedestrian and cycle path. The proposed route passes a block of commercial units with residential units above and entrance to Fairyhouse Lodge estate; the footpath is to be widened to facilitate 3m minimum width shared pedestrian and cycle path. The route continues on past the school, along Milltree Park Road and Fairyhouse Road. All this work is within the urban fabric of Ratoath; these areas are not of ecological value.

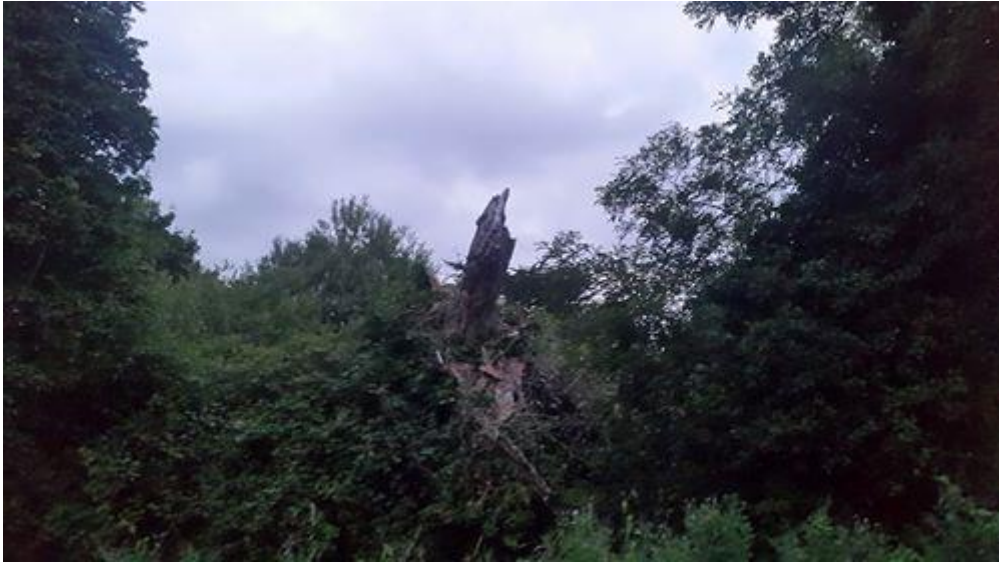
This tree has crevices suitable for bat usage.

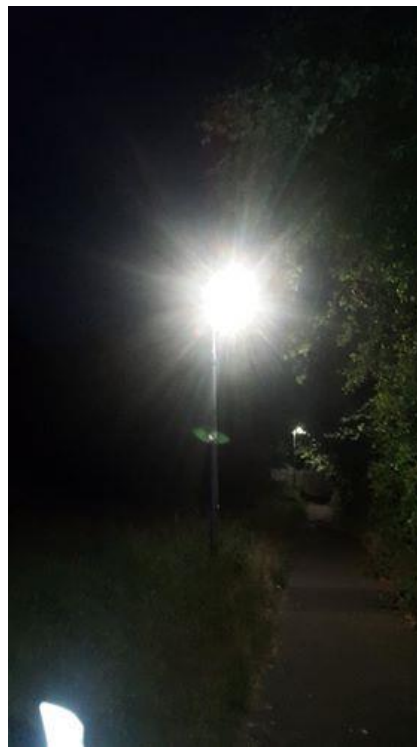
There is considerable light pollution, particularly along the western entrance at Meadowbank.

Light pollution with spillage into the sky at the western entrance

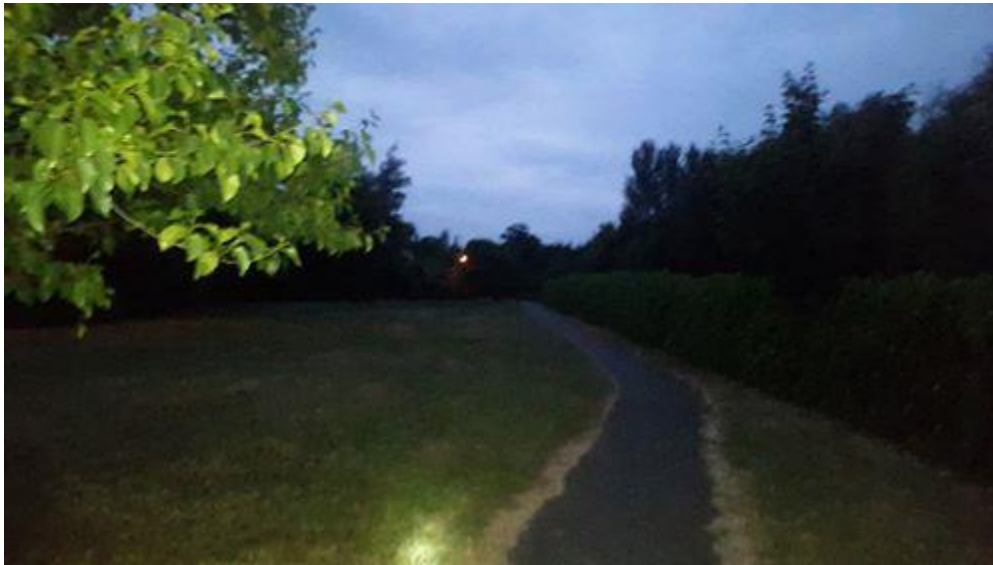
Some areas beside the river are intensively sprayed and cut and planted with laurel – which is toxic to both people and wildlife.

This area near the Jamestown estate is very poor for wildlife.

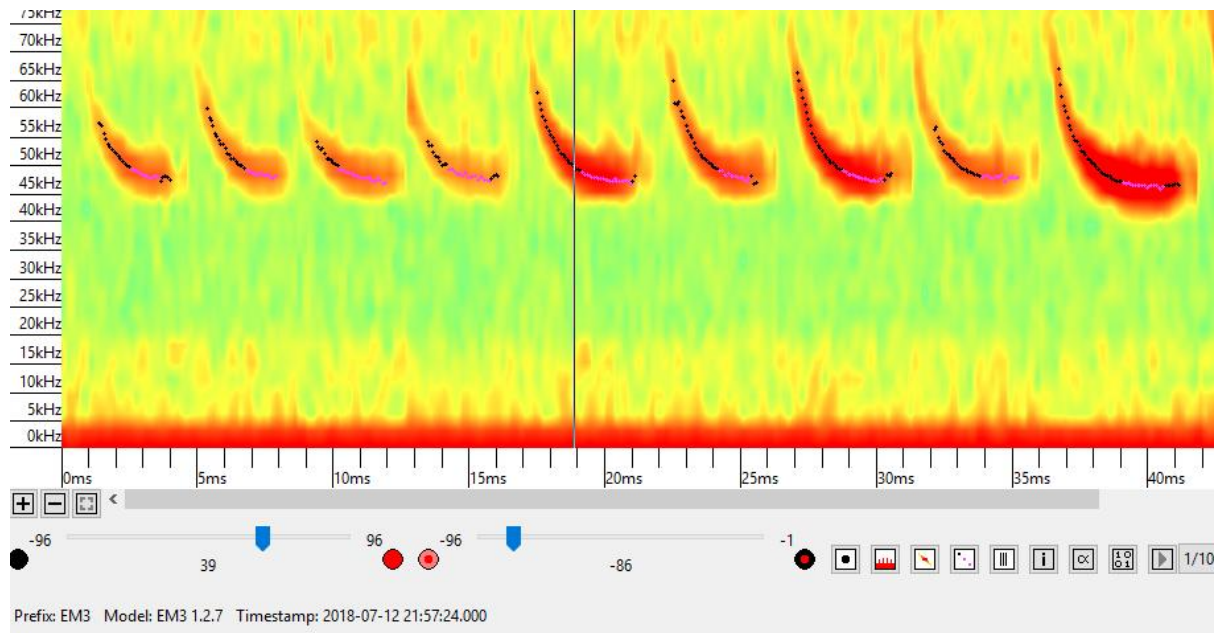
Common pipistrelle recorded at the eastern bridge

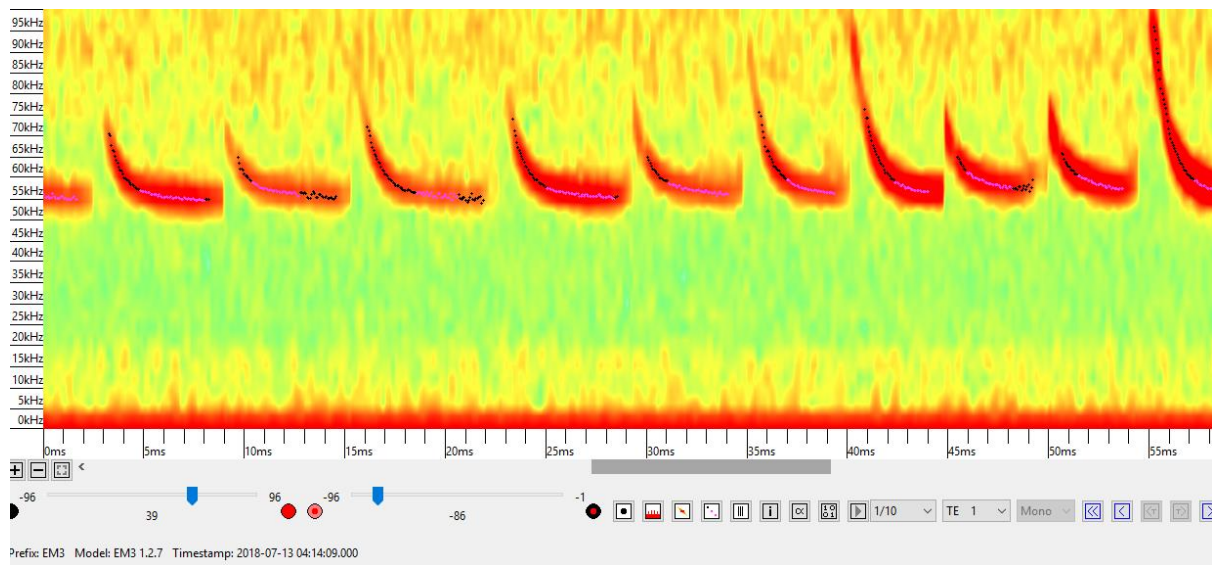
A soprano pipistrelle was recorded at 4.14 by the river

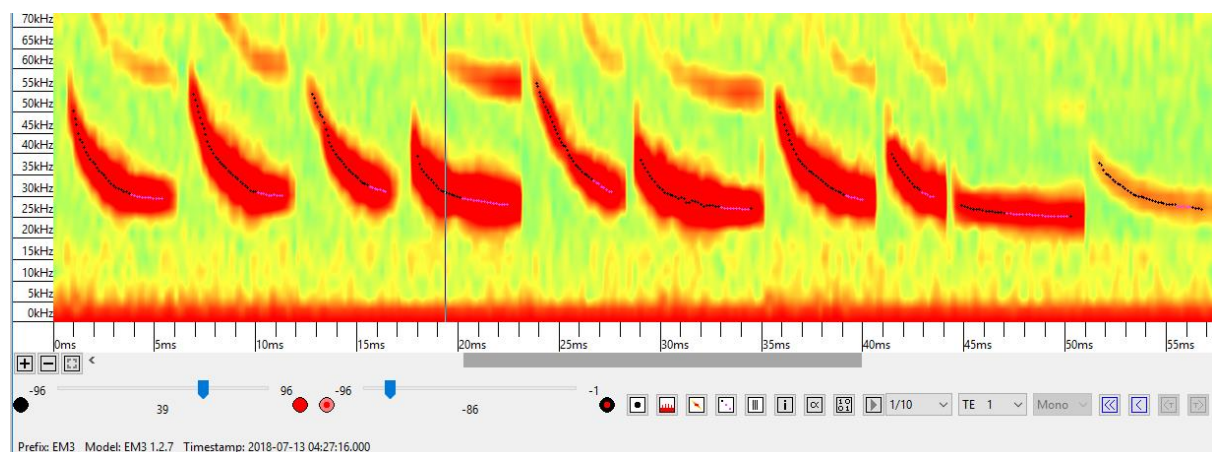
Leisler's bat feeding at tree

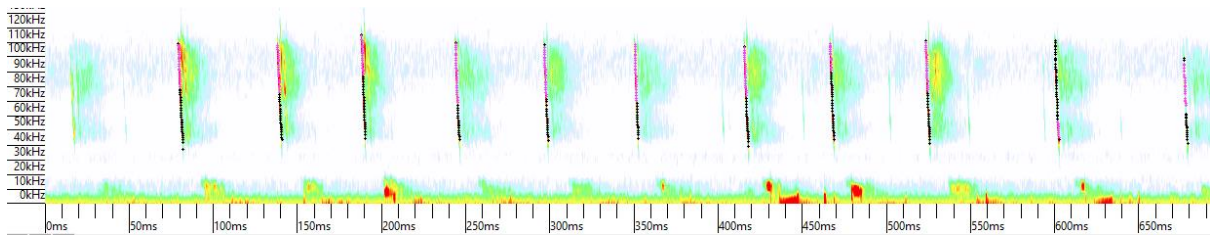
Natterer's bat at 0414 hours along the darkest section of the river

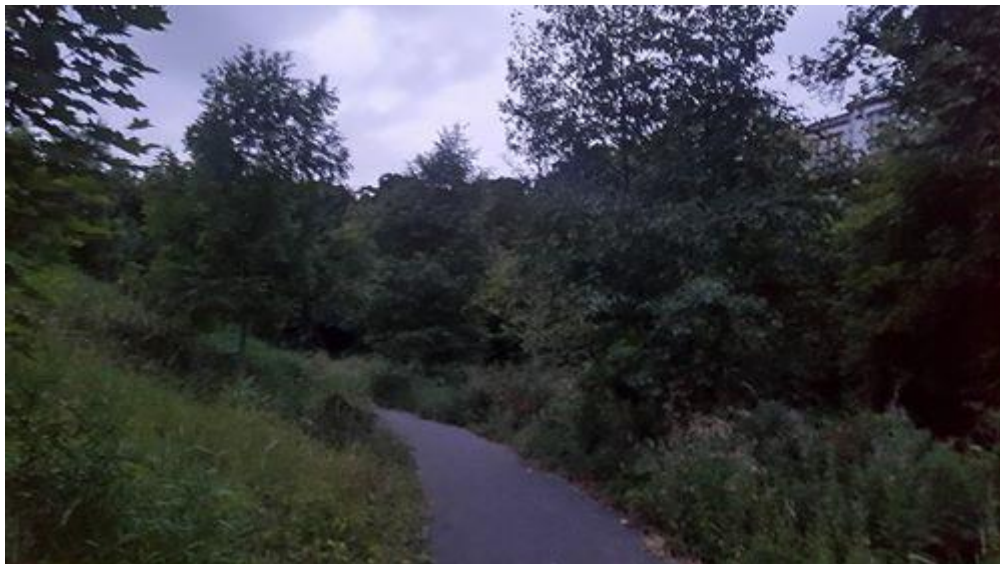
This is the area where young bats were taking their first flights.

Note the tall vegetation.

Both common and soprano pipistrelles fed under tree cover all along the river at dawn. Young bats were taking their first flights, and groups of two and three bats were seen flying together. This is clearly an important feeding area for bats taking their first flights.

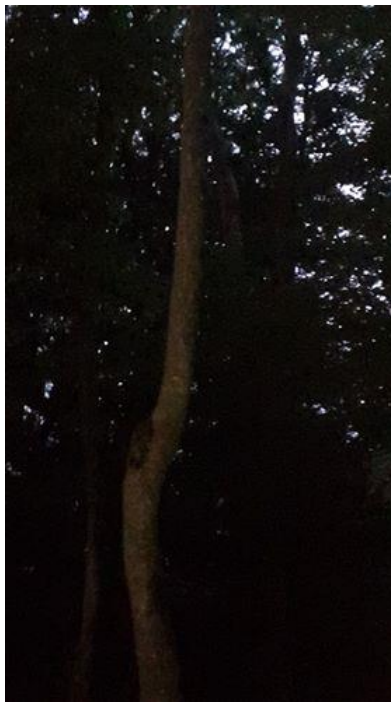
This tree would be suitable to hang a bat box from, as it has no underlying branches

(3) Bat boxes- 4 bat boxes should be placed along the cycleway – Two 2FN Schwegler bat boxes and 2 NHBS Kent boxes. These should be placed on trees, at least 4m high, with a clear drop below (no underlying branches – as bats need to drop to start their flight). These can be purchased from online companies principally based in the UK such as www.nhbs.com.

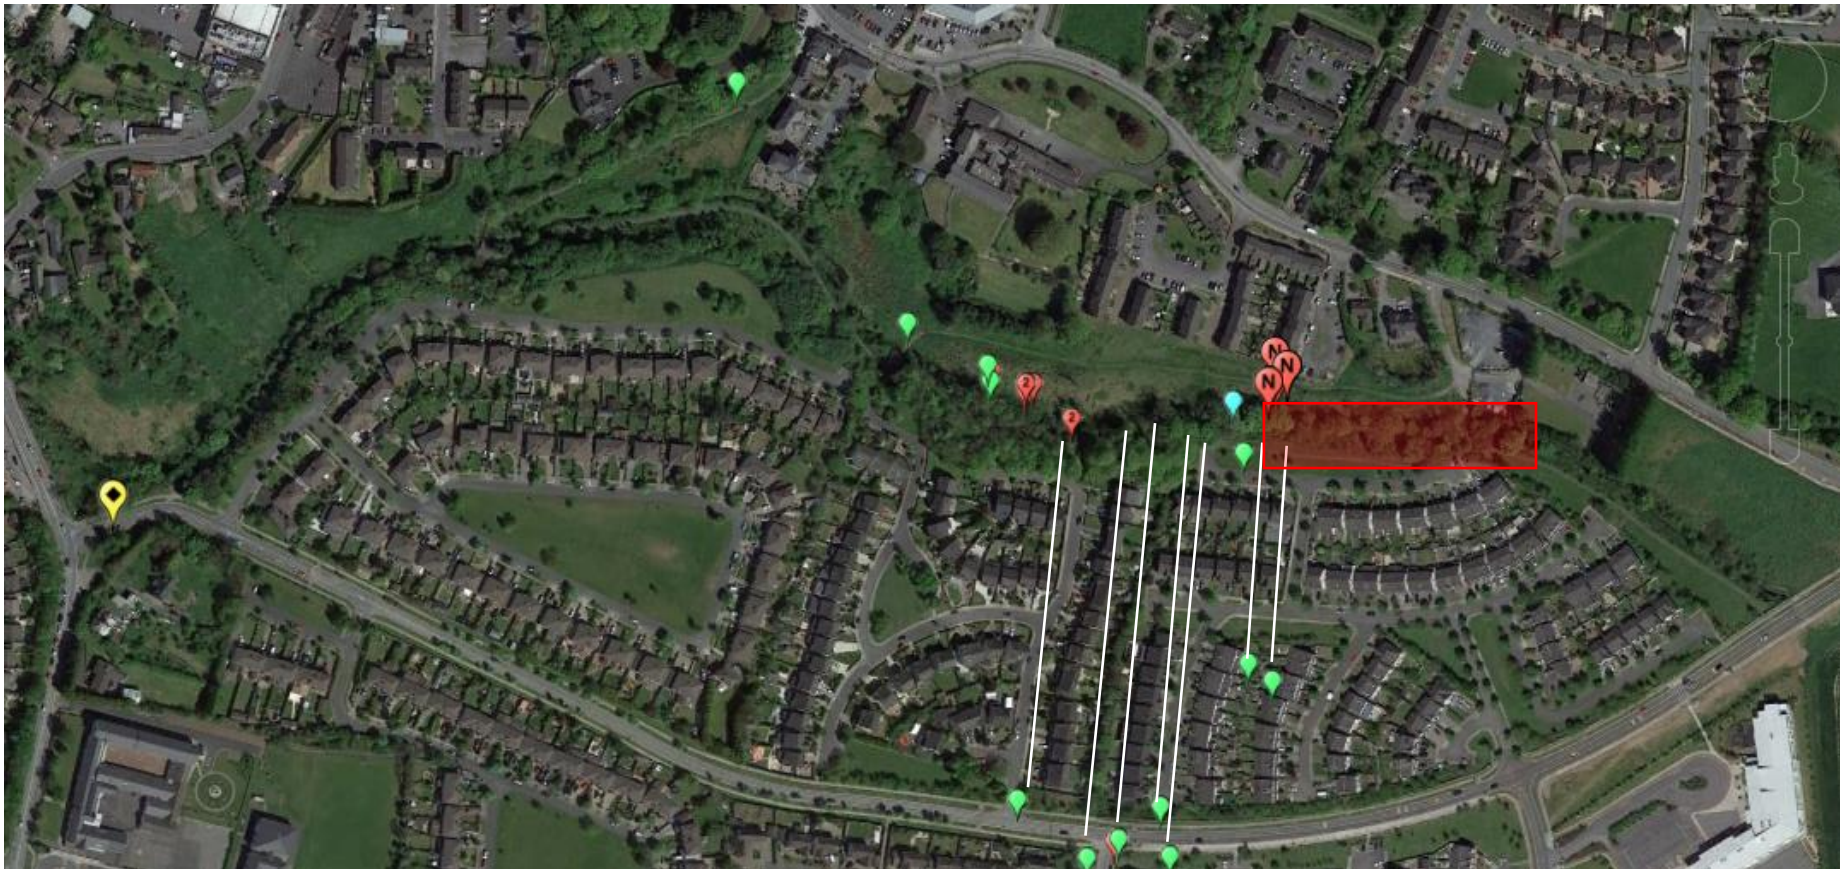
Bat activity along the Broadmeadow River July 12th and 13th 2018
