Trim Visitor Centre, Market House, Castle Street, Trim, Co. Meath

Archaeological Impact Assessment

ACSU Ref.: 2240

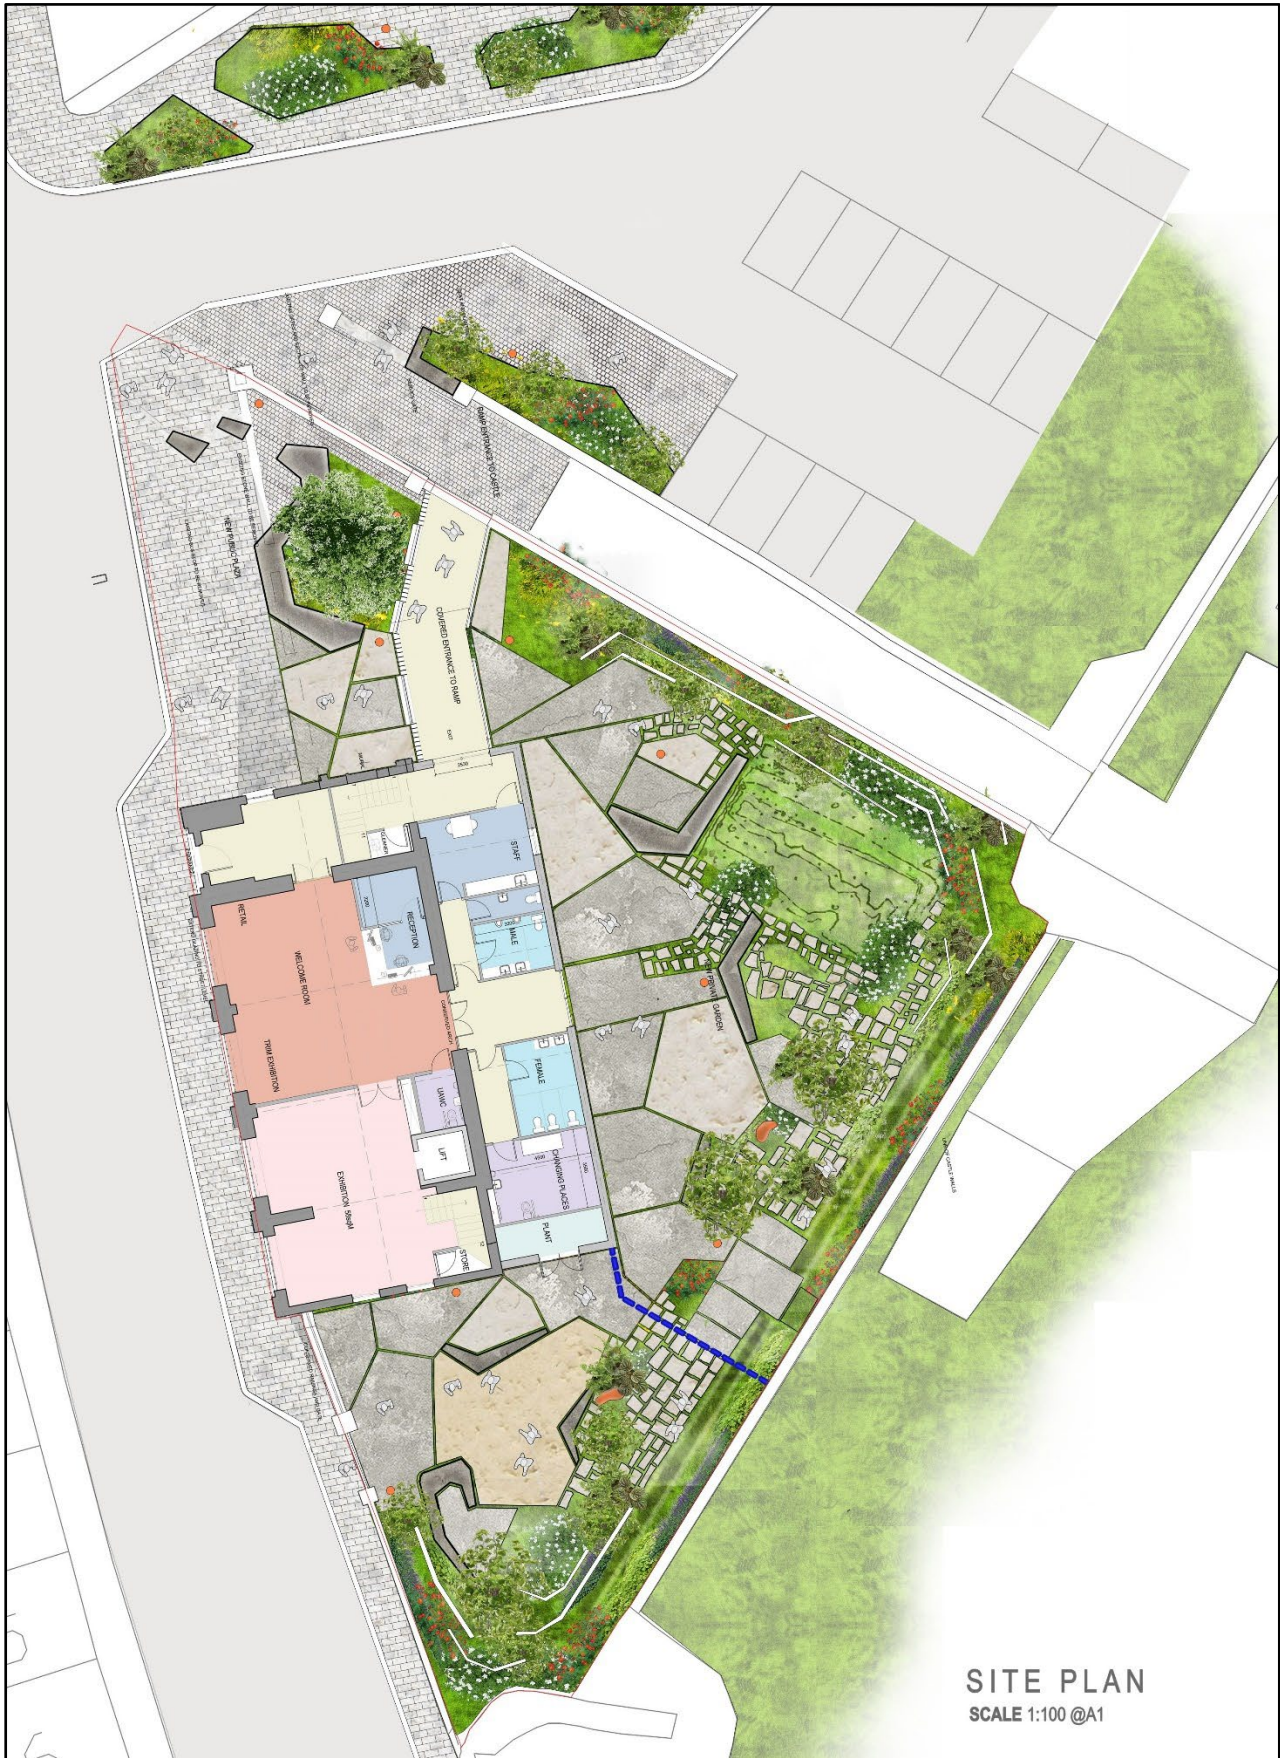
Figure 15: Proposed site layout

The proposed covered walkway (Figure 15) will connect the refurbished Market House/Visitor Centre with the existing ramp which presently provides access to the castle through the Trim Gate. The ramp runs along the line of the medieval causeway (Figure 4) which is shown on Charles Pratt's illustration of 1820 which would have also been ramped and allowed access into and from the town across the moat and through the gate. The ramp presently extends down almost to the junction of Frenches Lane (Plate 27) but the proposal will be to penetrate the market yard wall on the south side of the causeway further up so that the ramp can be accessed from the covered walkway. The wall is of 19th century date as it is not shown on Pratt's illustration and was probably built at the same time as the Market House. It is shown on du Noyer's sketch of 1859 (Figure 6) and clearly marked on later OS editions. The wall also appears from a visual examination to have been repaired at this location (Plate 29) so the removal of a section of the wall here is viewed as acceptable.

The proposed new extension to the Market House will be much smaller in plan than the original ballroom and will be constructed within the footprint of the hall (Figure 15). As a result the area of its construction is likely to have been disturbed and whether or not significant archaeological deposits survive here can only be determined through test excavation.

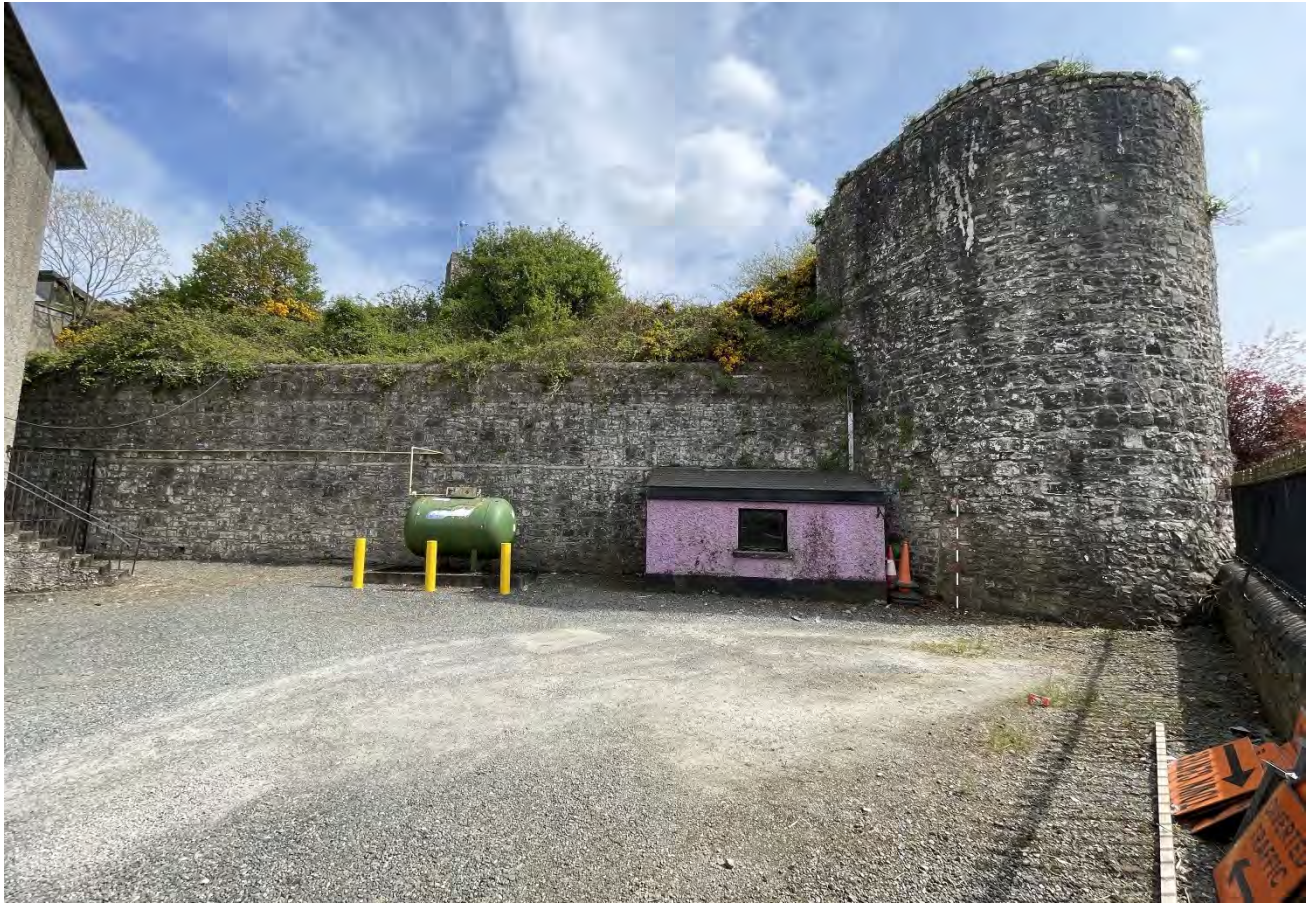
The two boundary walls of the Market Yard along the east side of the site and the north side date to the 1850s when the Market House and yard were constructed. There is no evidence for medieval masonry in any of the outer faces but there will be no impact on these walls for the most part. The eastern wall (Plates 9, 13, 16) is effectively a retaining wall with a 4m drop between the interior of the bawn and the surface of the Market yard. This wall was built up against the original 1352 earthen bank and what may remain below ground level of the original curtain wall (Figure 11). At the north end of the wall where it joins the Trim gate (Plates 18-19) the original base batter of the gate's foundation protrudes into the site and the original walls projecting south and west from the gate are clearly visible and separate from the walls of the Market yard (Plate 18). At the southern end of the east wall where it meets the roadside wall and railings, Tower A projects into the site and is part of the National Monument (Plate 9).

Plate 9: Projecting tower of National Monument and 19th century modern wall related to the Market Yard built in front of the line of the curtain wall, facing southeast.

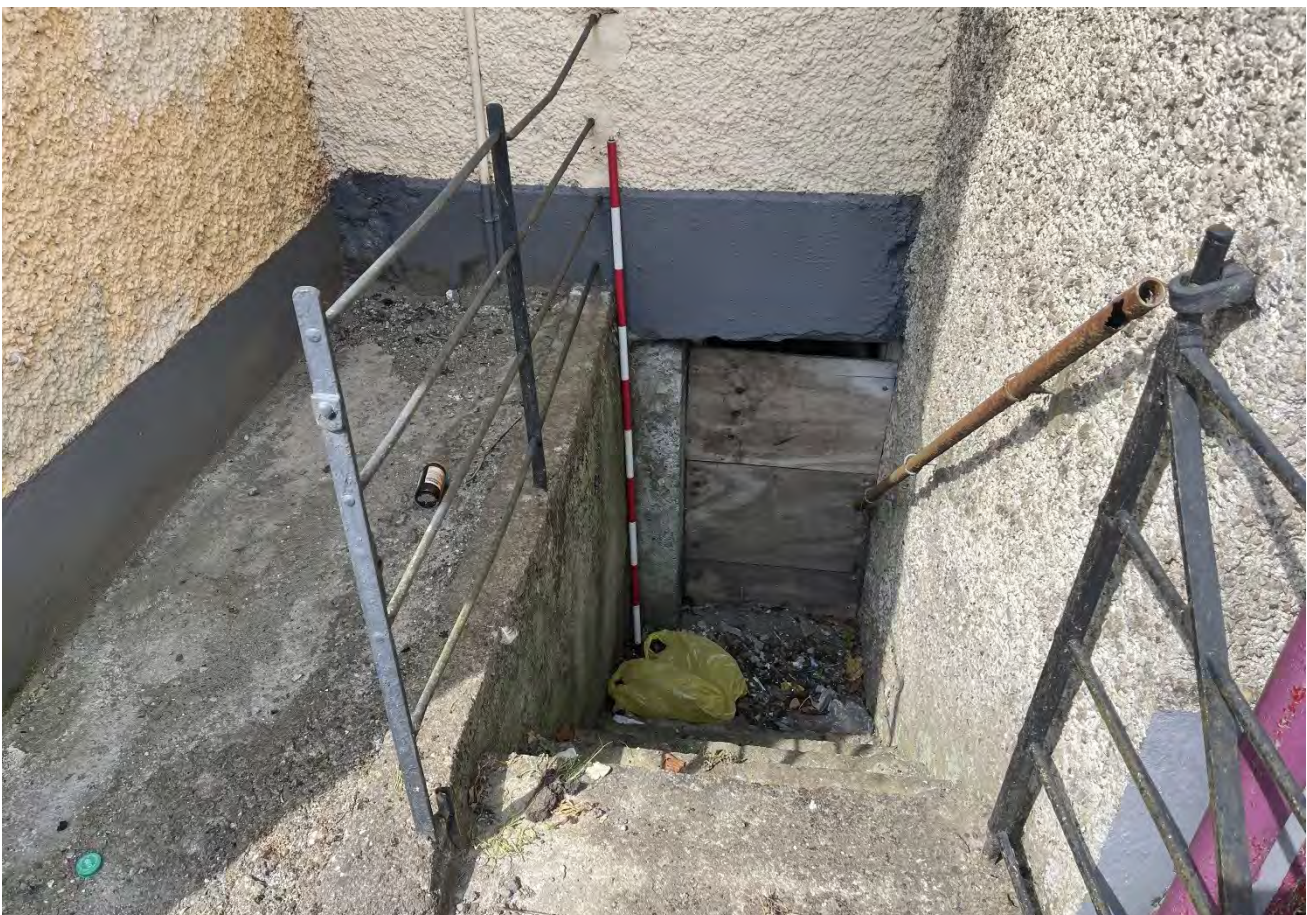
The Market House was burned in 1920 (Figure 8) and no original interior features survived. The additional bay on the north and south date from 1925 and there is access to what appears to be a small basement area below the south-east corner of the additional bay on the south side (Plate 12) which is approximately 1.4m below existing ground level. The ballroom behind the Market House was constructed in the 1950s and consists internally of the wooden dance floor (Plate 23) and stage to the south end (Plate 24). There is a fly-tower above the stage area (Plate 10) and there is access to the under-stage area from outside where a series of steps lead down approximately 1m below existing ground level (Plate 11). This under-stage area and the adjacent basement below the south-east corner of the Market House are highly likely to have disturbed archaeological deposits during their construction. Similarly the foundations of the Market House and the Ballroom and other extensions are also likely to have disturbed deposits relating to the Moat. The line of the moat that surrounded the castle was exposed during archaeological investigations carried out along Castle Street by Finola O Carroll in 2003 (Figures 16-17). The upper edge of the moat was exposed at a depth of 0.6m below modern ground level where significant ground disturbance has occurred due to services along the street. Within the Market house area the disturbance may not have been as significant and archaeological deposits have the potential to survive at higher levels.

Plate 12: Access to a basement area below south-east corner of 1925 southern additional bay of Market House, facing north.

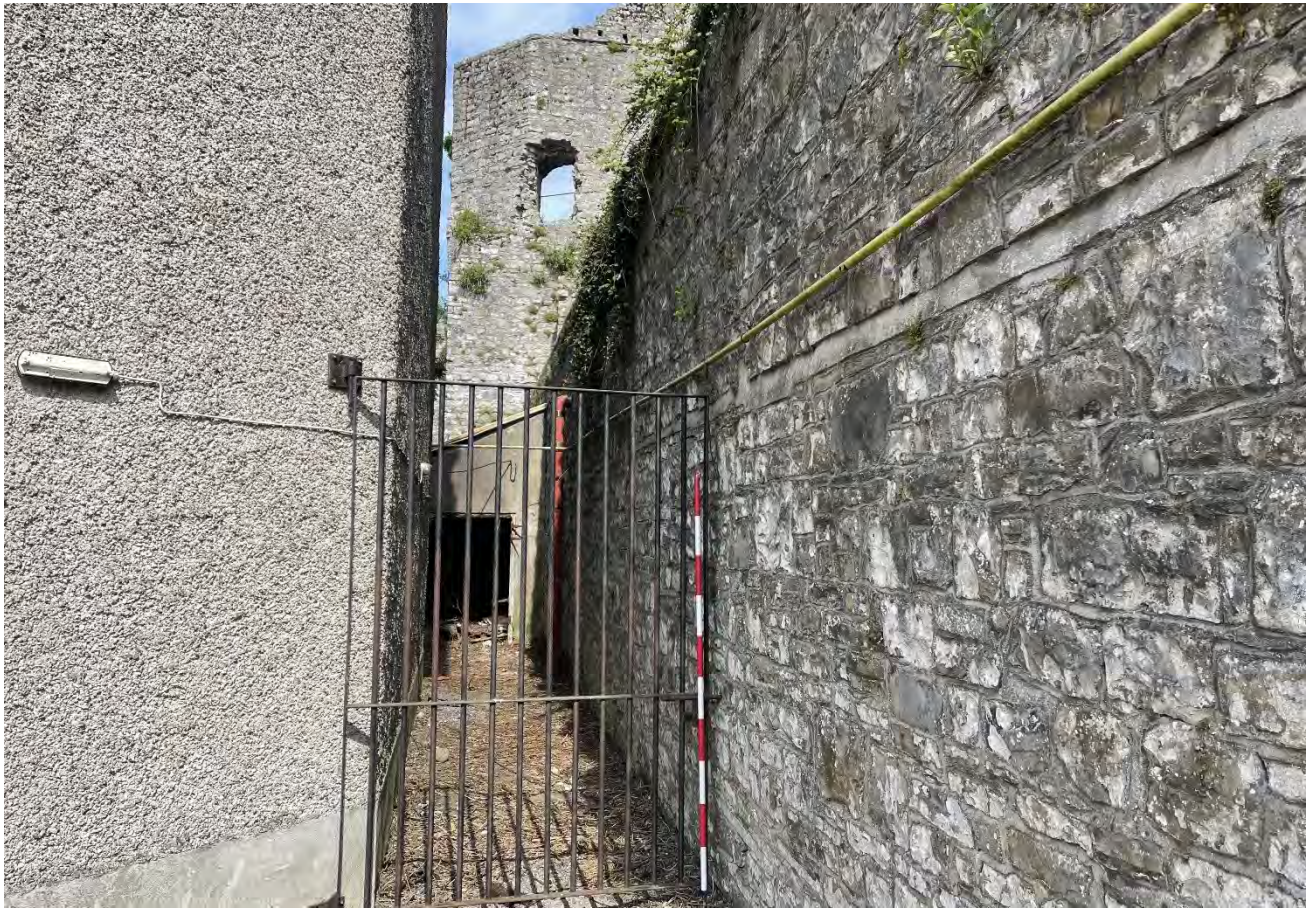
The walls of the ballroom and in particular the fly-tower are very close to the curtain walls along the east side of the site and in places only a little more than a metre distant (Plate 13). The walls will need to be demolished in a controlled fashion that prevents any material falling onto or against the walls of the market yard. The basement area below the stage could provide a good opportunity to investigate the moat as some amount of disturbance has already taken place here and the area impacted equates roughly with the size of the stage above. The removal of the foundation walls of the basement should in effect provide a section or part thereof through at least the upper fills of the moat without causing any further disturbance to archaeological deposits through test trenching in undisturbed areas.

Plate 13: Access to the rear along the south extent of the site, facing northeast.

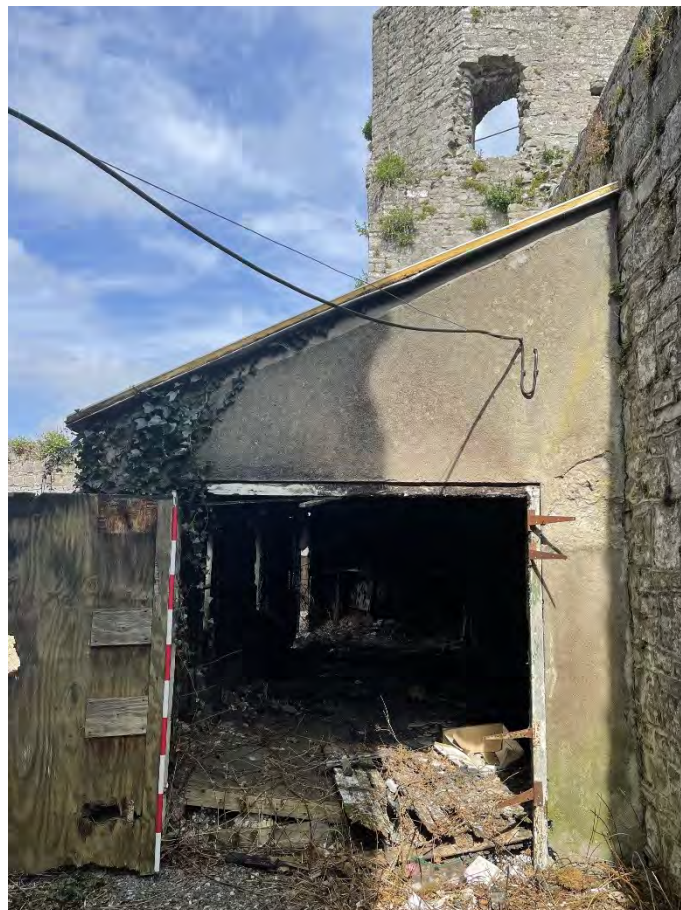
Plate 14: Lean to shed, of modern fabric, along line of structures shown on Du Noyer sketch of 1859 but no evidence for earlier features, burnt inside, facing northeast.

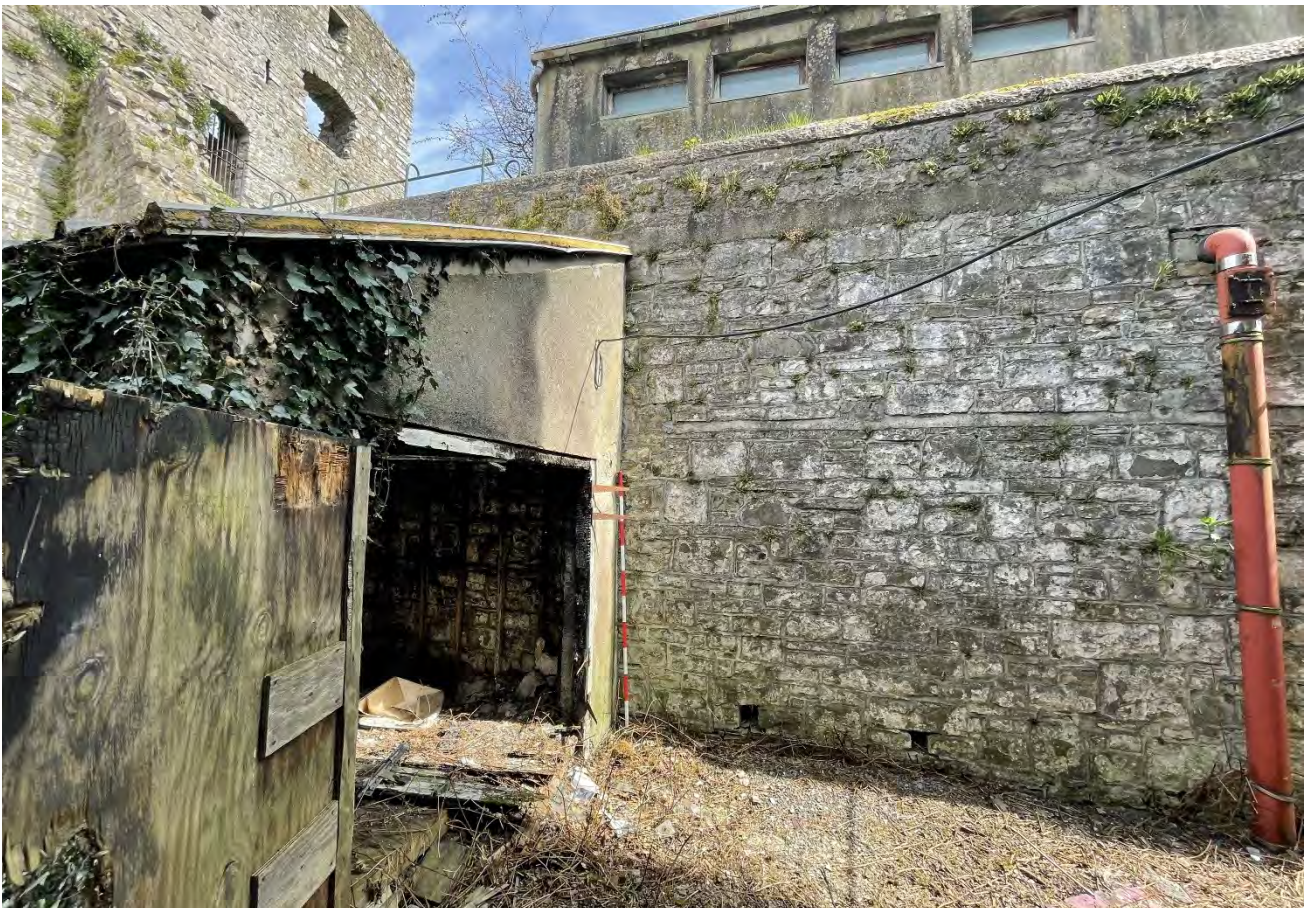
Plate 16: Detail, lean to shed built against the 19th century modern wall. Sewer pipe visible, of toilet building above within the keep, facing south.

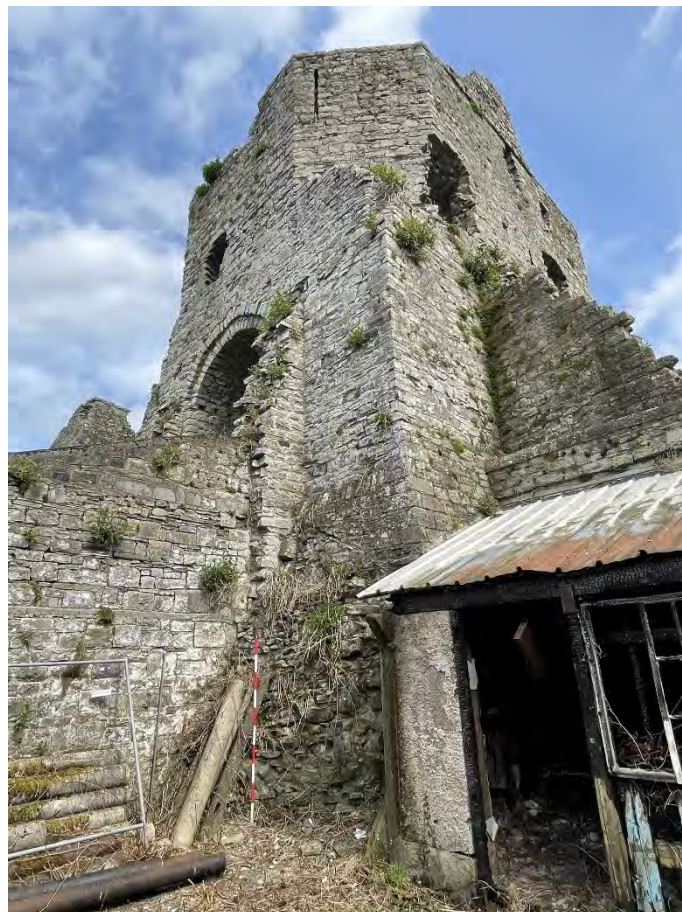
Plate 18: Detail; Trim Gate, with rough base of the foundation batter of tower visible, facing east.

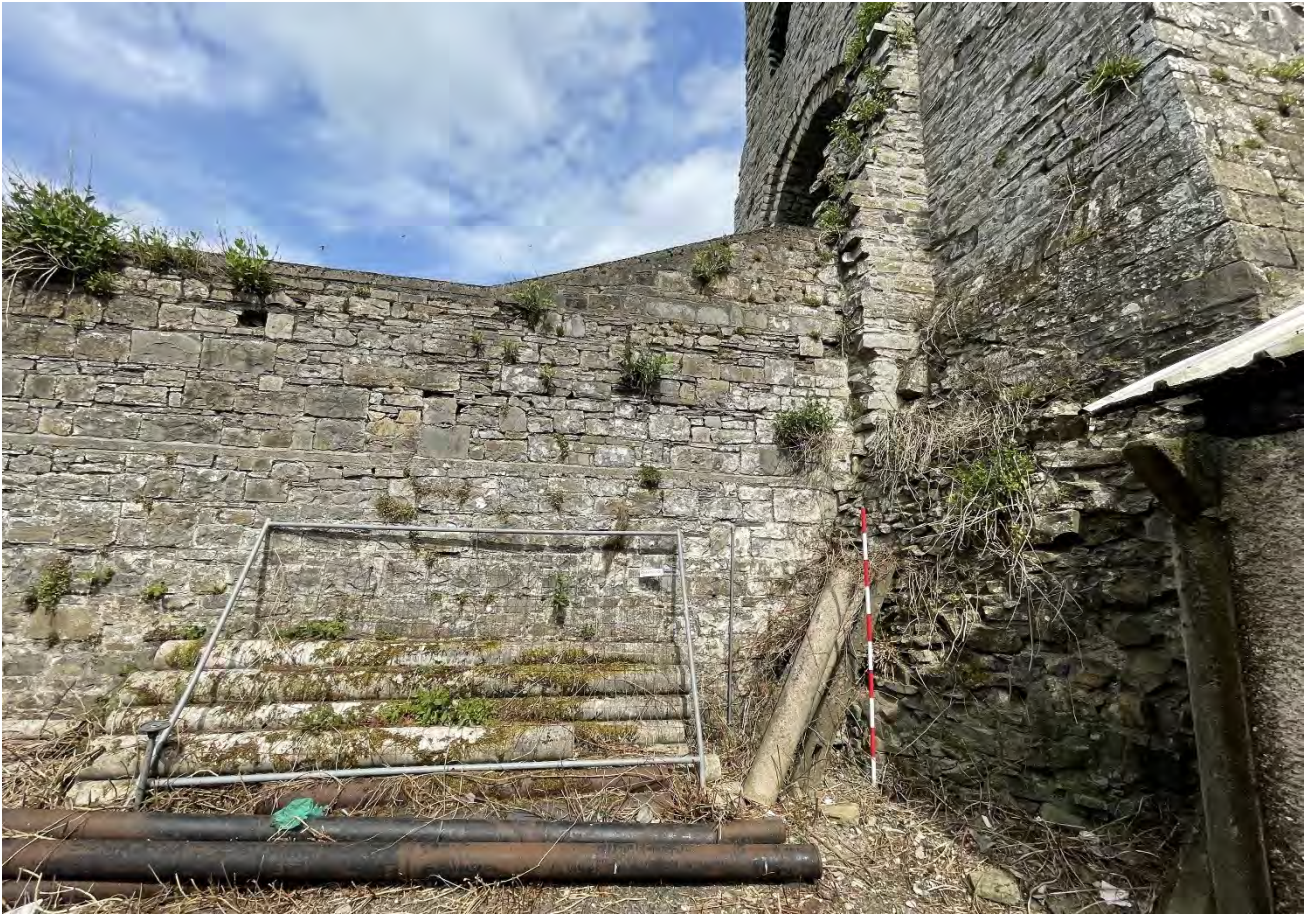
Plate 19: South façade of the causeway wall, external base batter/glacis of Trim Gate visible, facing northeast.

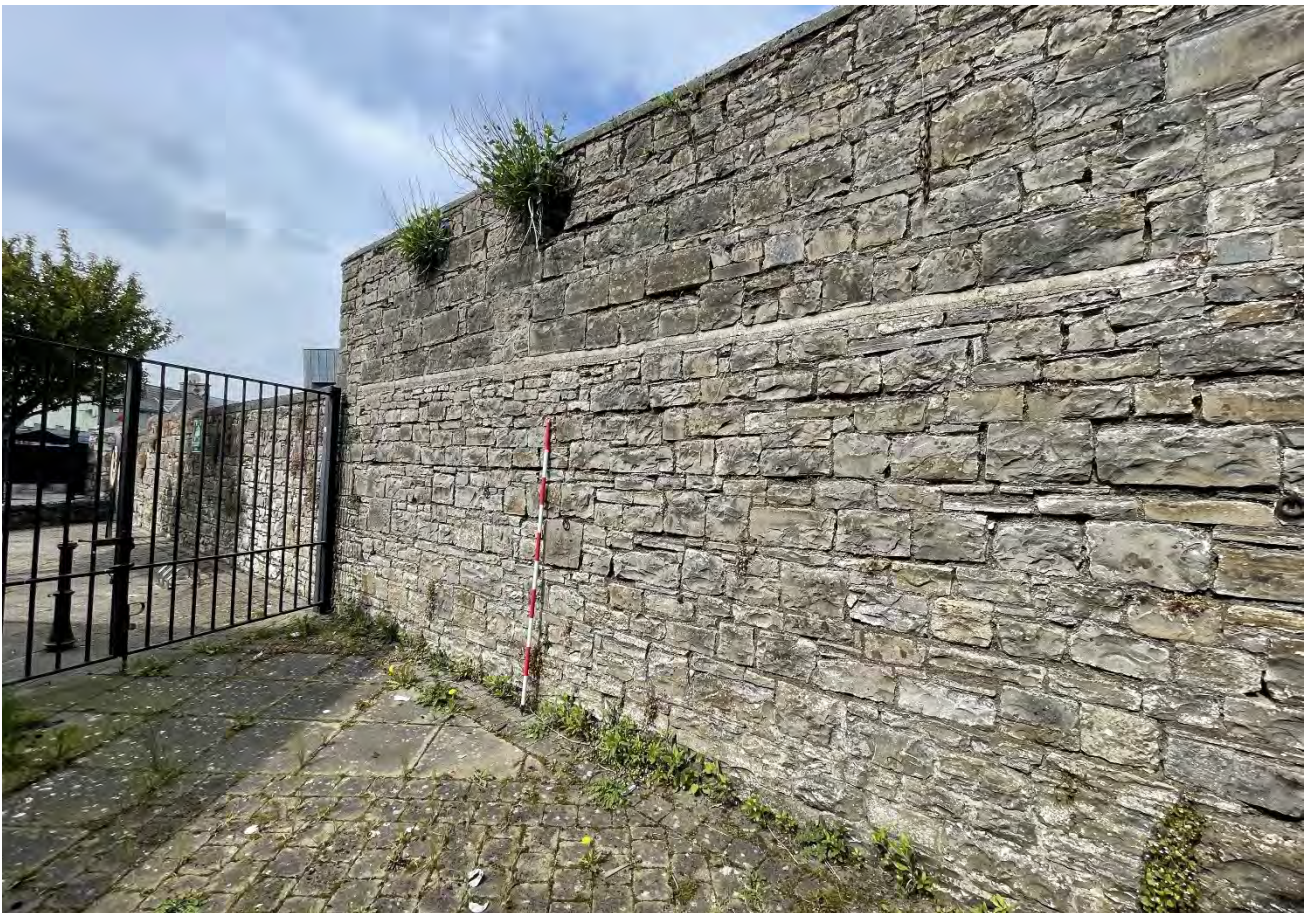
Plate 26: South façade of causeway wall, rear of the site, facing southeast where proposed walkway will penetrate wall

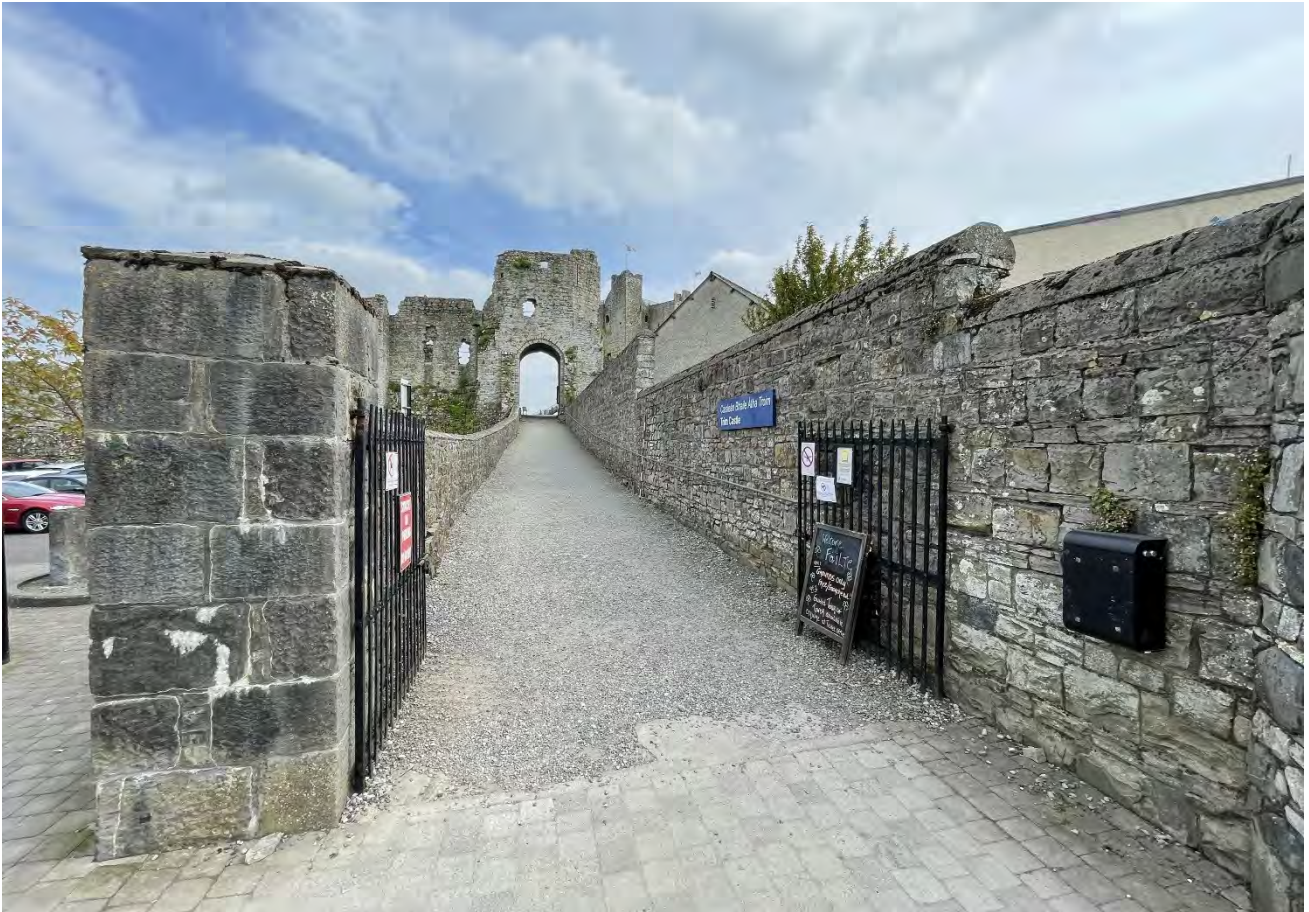
Plate 27: Causeway leading to Trim Gate, facing southeast. Proposed walkway will penetrate at location of range rod

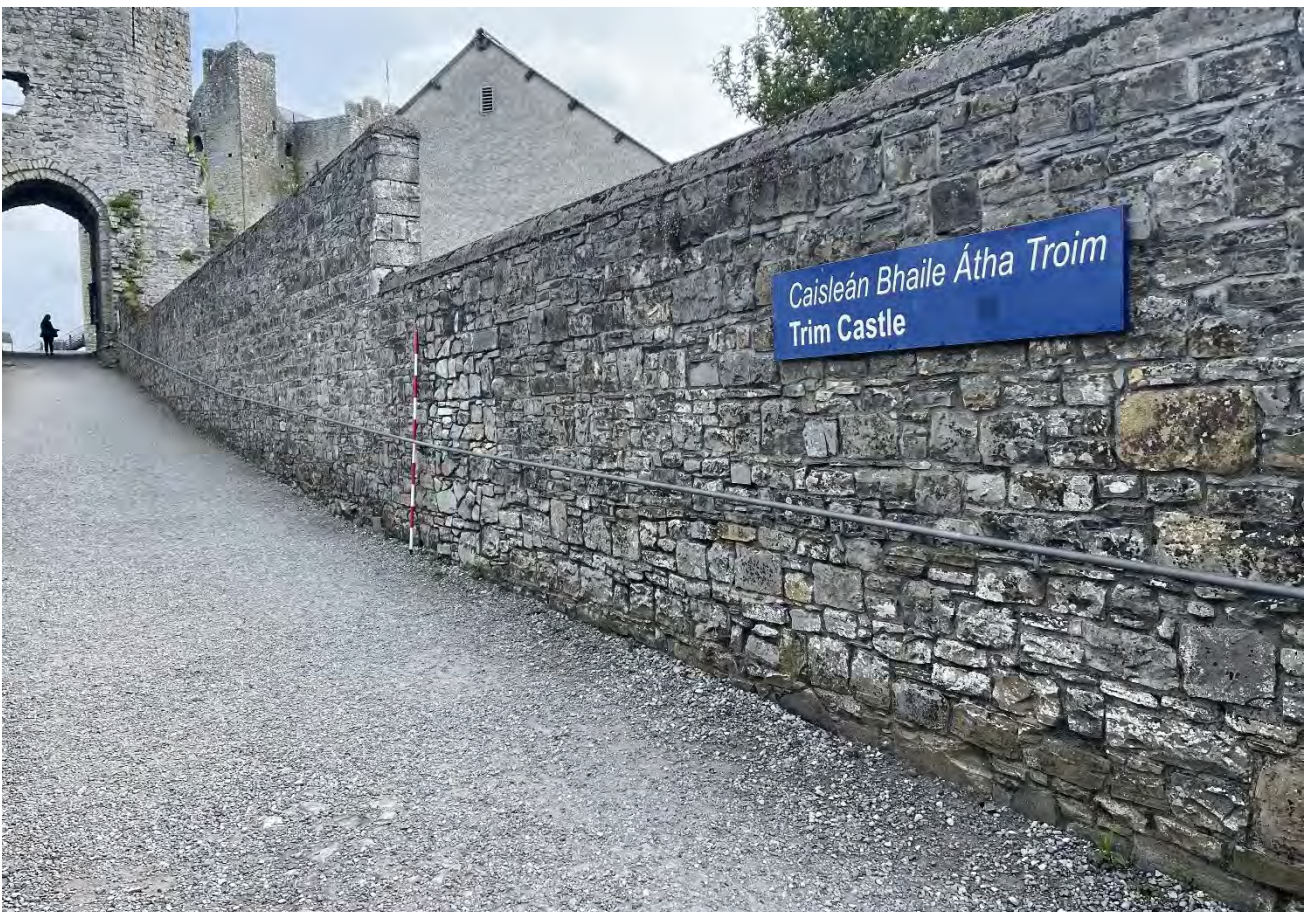
Plate 28: North façade of the south wall flanking the causeway, facing southeast. Proposed walkway will penetrate at location of range rod approximately

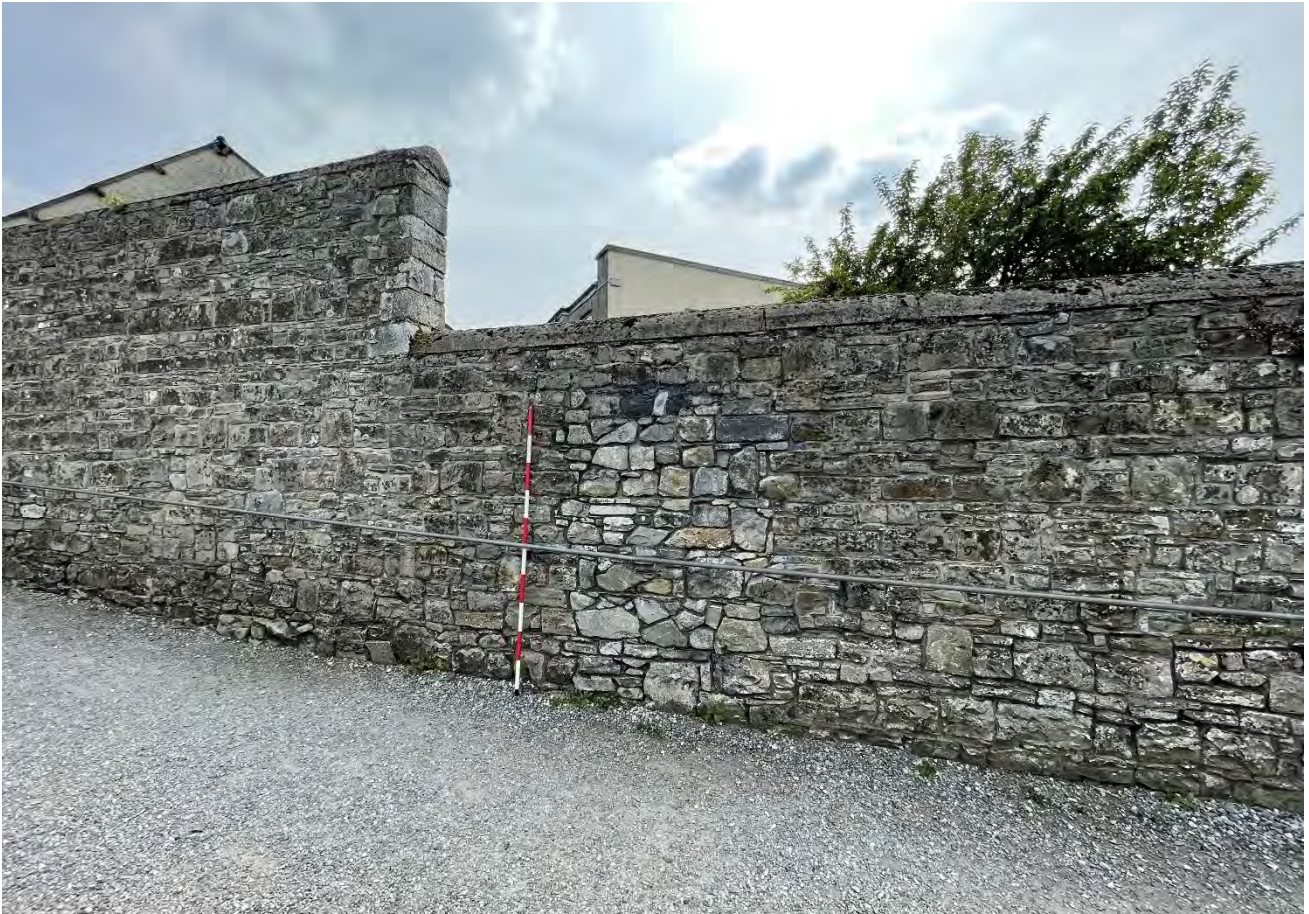
The northern wall of the Market yard defines the southern edge of the medieval causeway which was used to traverse the moat and gain access to the castle through the Trim Gate (Plates 25-32). This wall is also related to the construction of the Market house and yard and is clearly visible in du Noyer's 1859 sketch (Figure 6) with lean-to structures up against it. There is no evidence on this wall for the lean-to structures and there are several points of repair visible (Plate 29). This wall also

Plate 29: Detail; repair visible in the north façade of the south wall flanking the causeway, facing south.

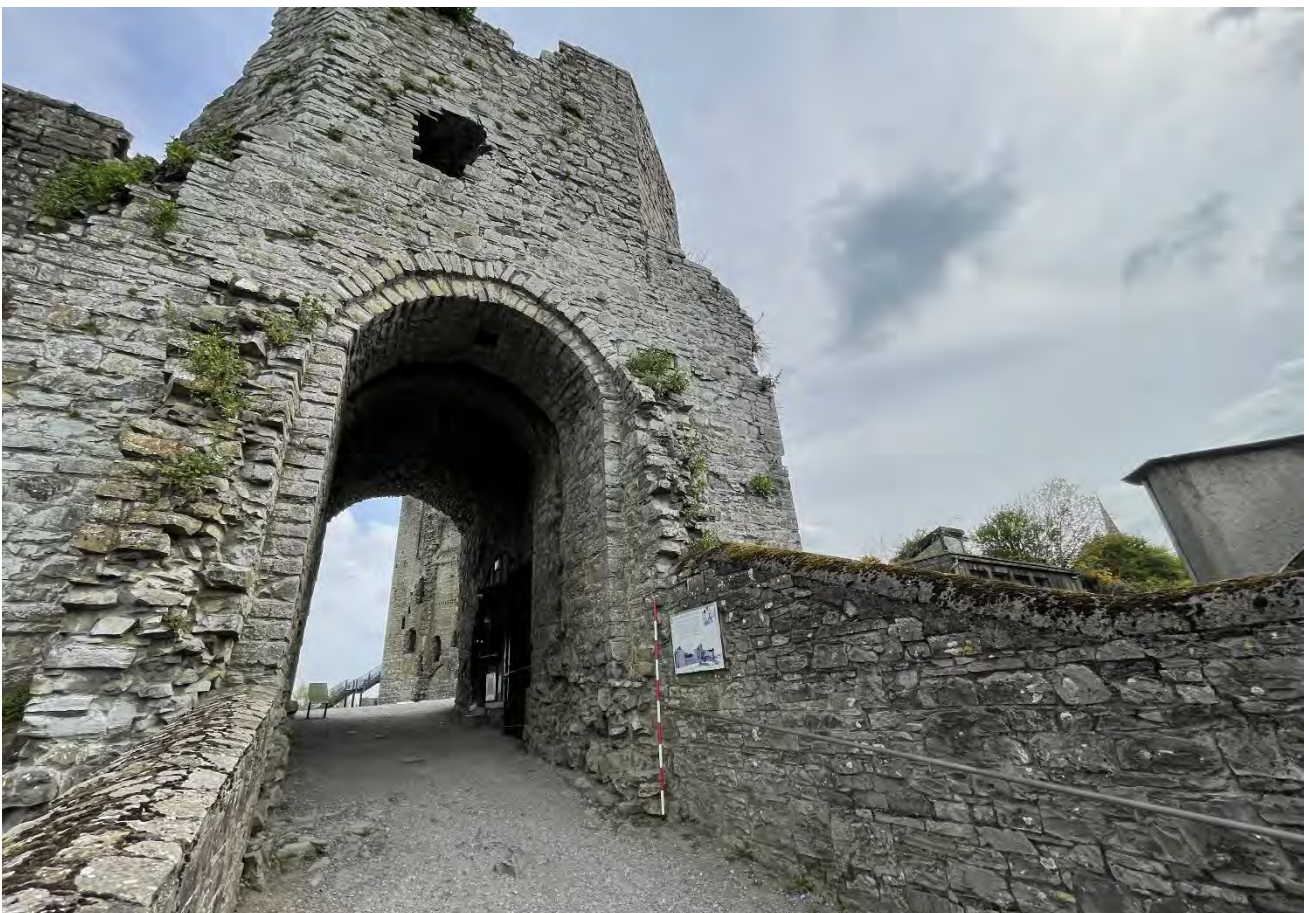
Plate 30: Trim Gate, with stub remains of original flanking walls visible, facing southeast.

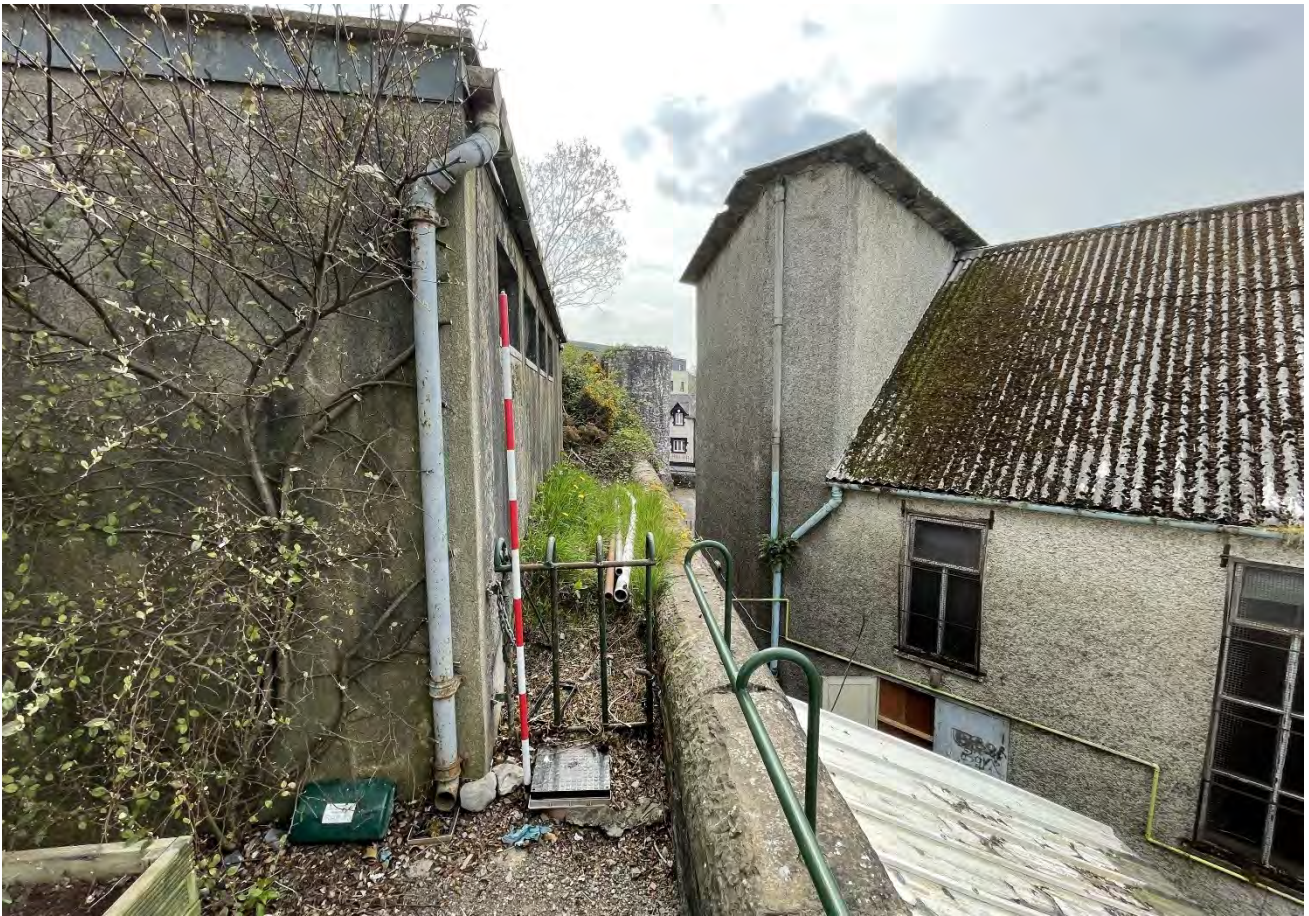
Plate 37: Toilet building within keep, built on the top of curtain wall footprint, facing southwest.

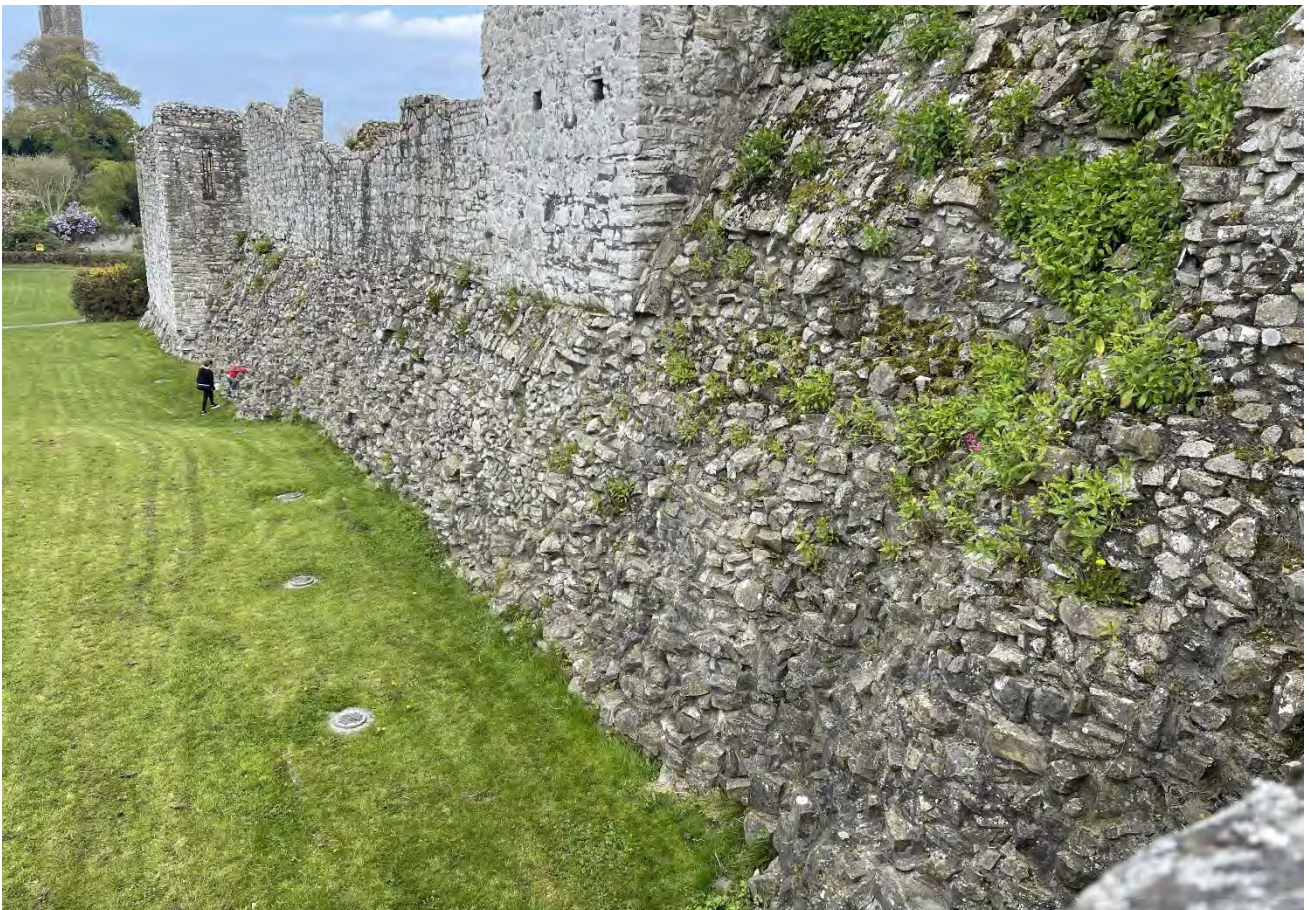
Plate 42: Northwest facing façade of the curtain wall with sloping, external base batter visible, to the north of Trim Gate, facing northeast.
