## ARCHITECTURAL HERITAGE IMPACT ASSESSMENT

ST KINNETH'S CHURCH Ballivor, County Meath

de Blacam and Meagher ARCHITECTS

JANUARY 2021

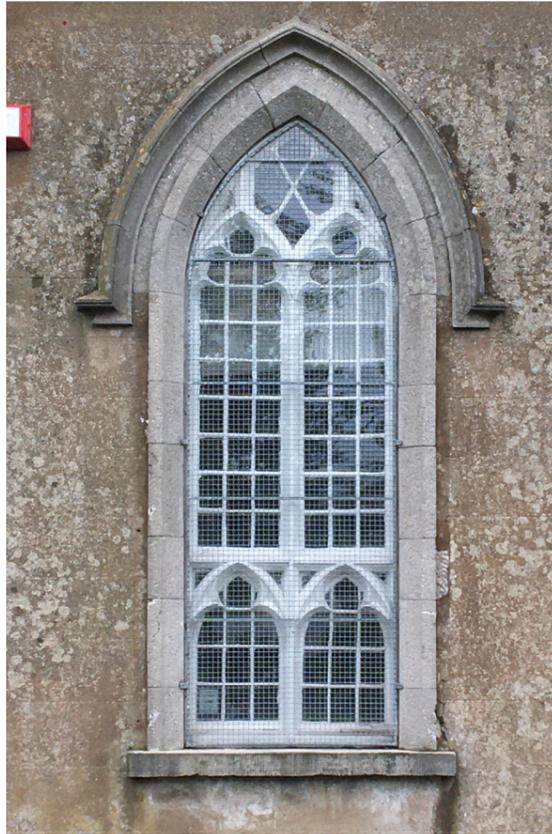
The nave is a simple rectangular room with three traceried pointed arch windows on the south wall, made from white painted timber with clear glass. They are set in cut stone surrounds with hood mouldings and are in a relatively good state of repair. They have been covered with a modern steel mesh grid on the outside to protect them from vandalism.

South window to the nave (one of three)

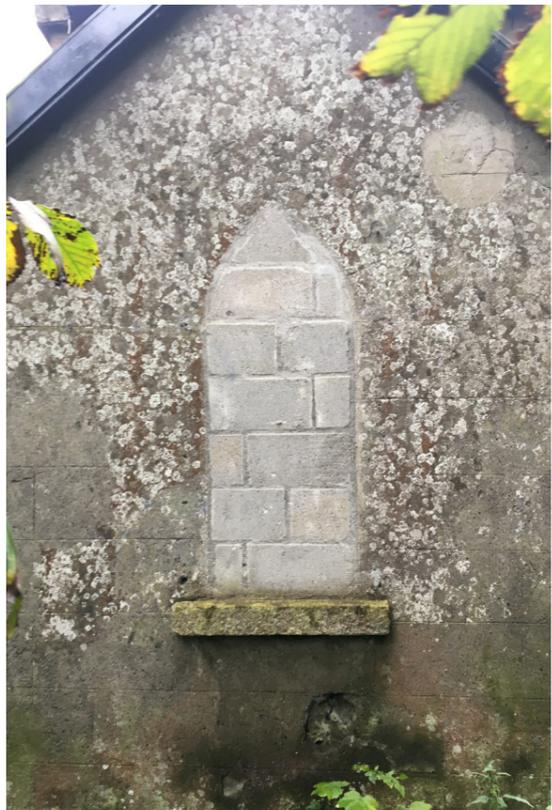
Blocked up window on north of vestry

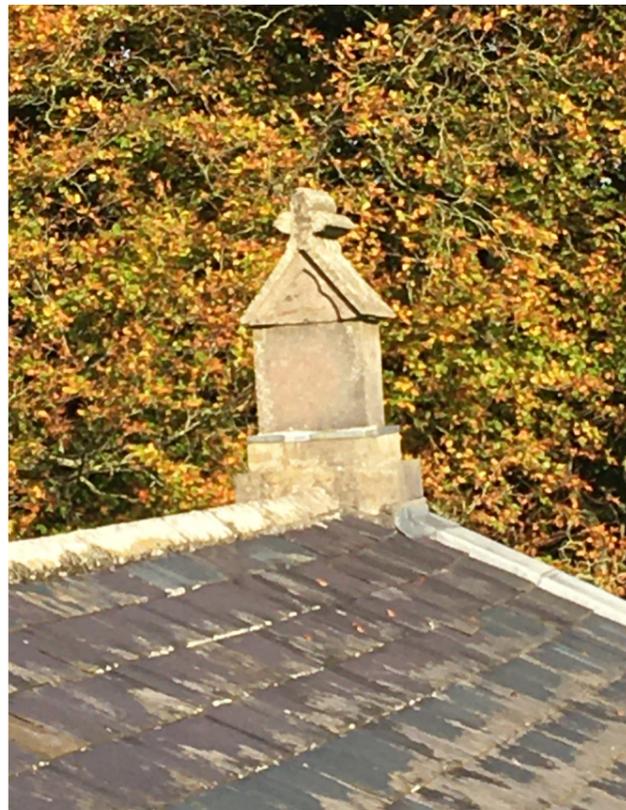
The roof over the nave is of cut timber construction and is finished in natural slate with stone ridge tiles. It is detailed in lead around the edges with cast iron rain water goods (some of which have been replaced with pvc).

Detail of roof over nave

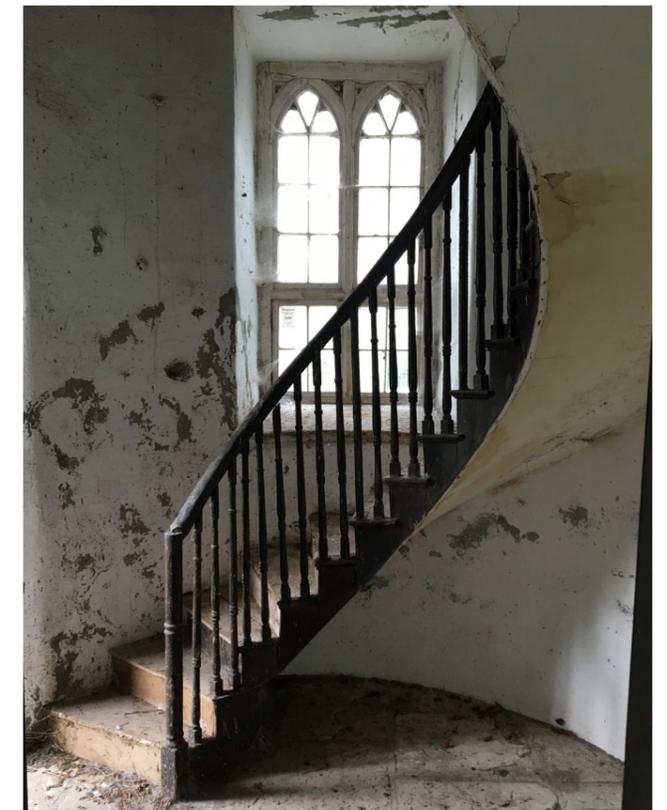
4. The stair up to the gallery is in reasonable repair but is loose in places and requires refurbishment.
5. The first floor gallery is constructed in timber and has been damaged in places by water ingress.

Curved stair up to gallery

- Replace the leadwork at the base of the spire which appears to be a source of water ingress.
- Carry out repairs to the curved timber staircase and landing.

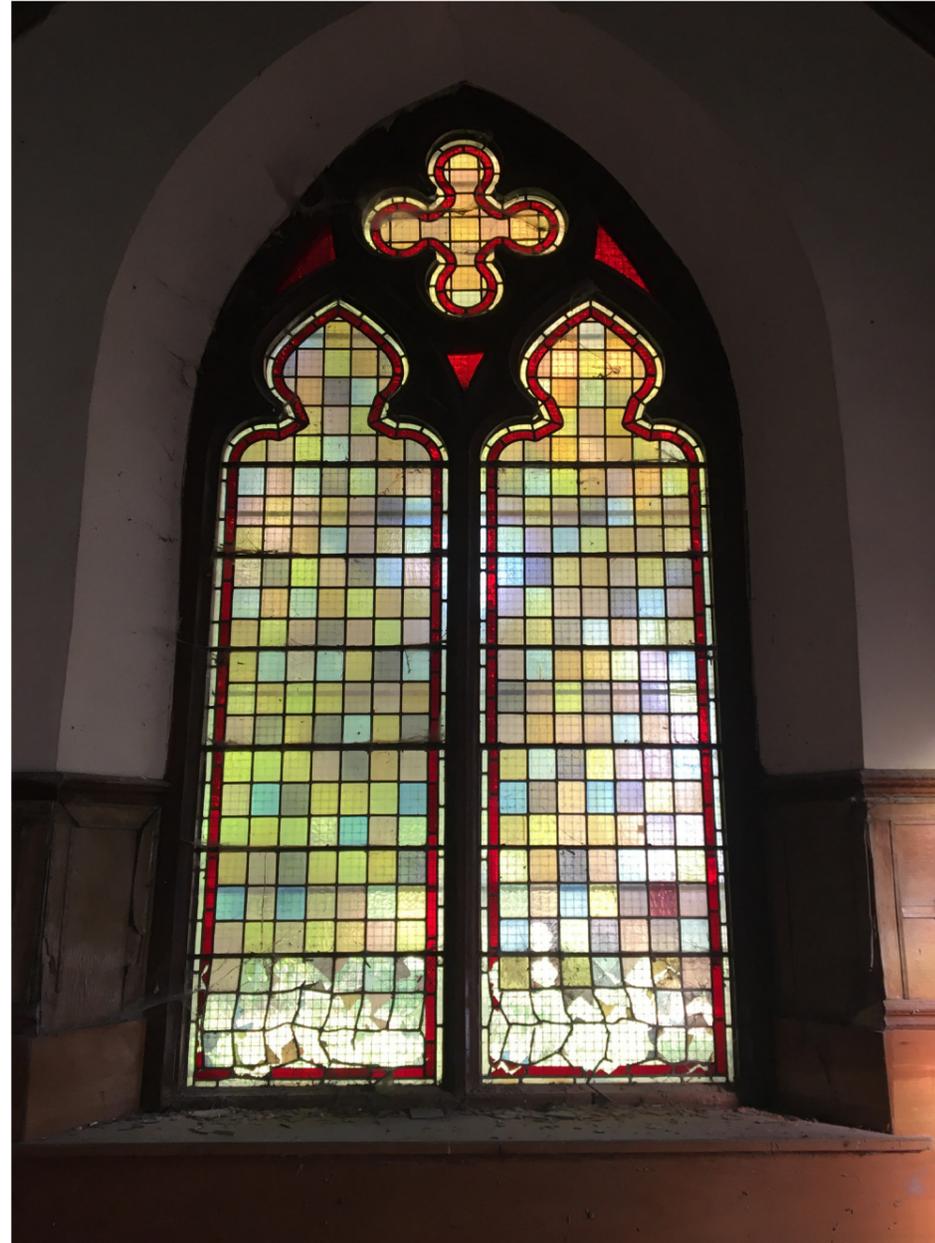
2. The bottom panels of the three stained glass windows to the chancel have been vandalised and are badly damaged. Mesh screens have since been installed on the outside to protect them.

East window

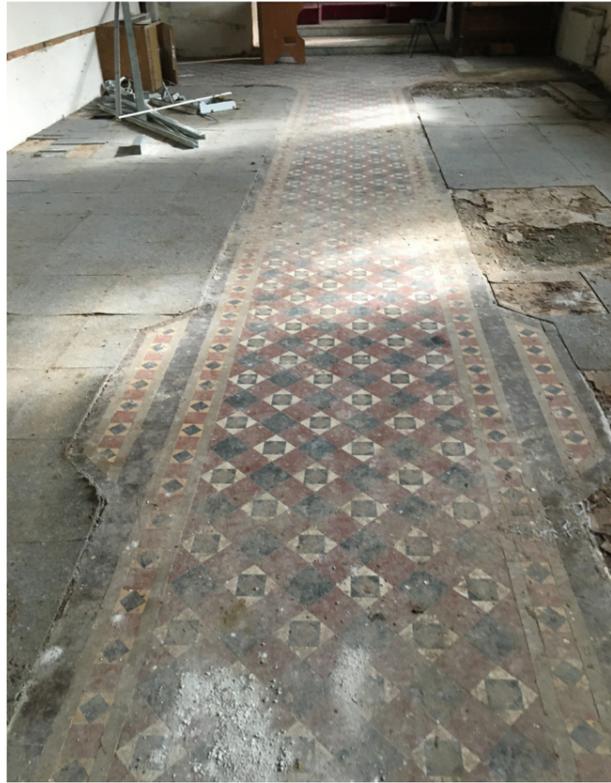
Tiled floor to central aisle

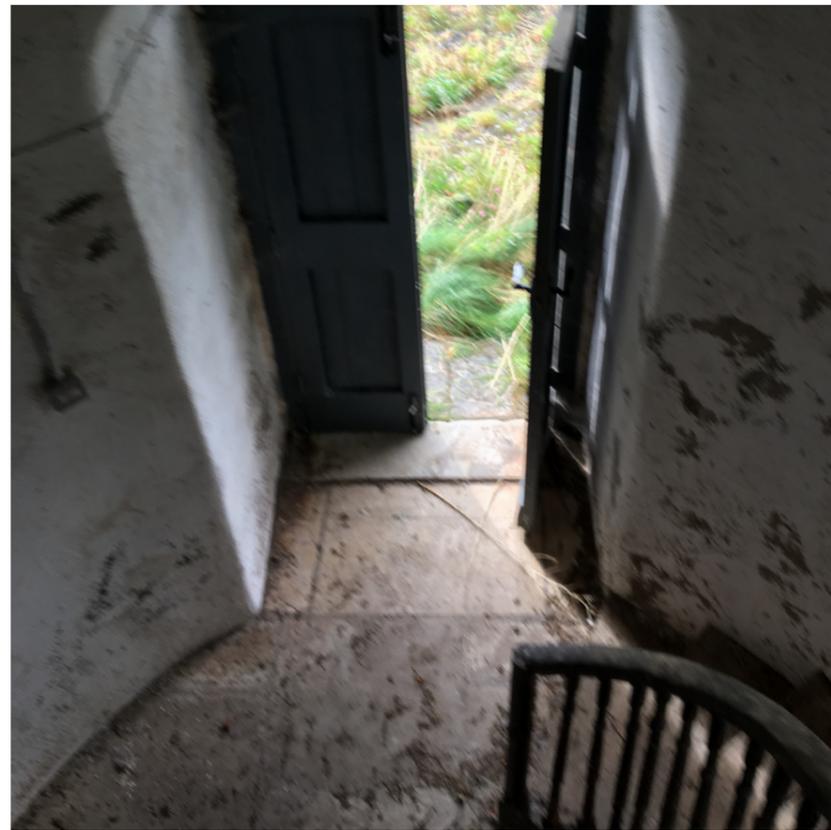
Stone floor to base of tower

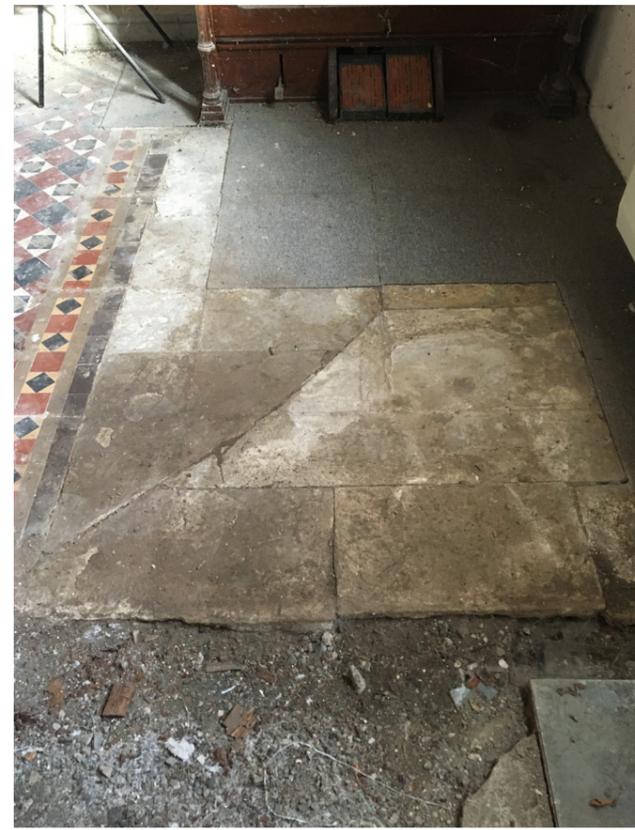
Stone floor to south east corner of nave

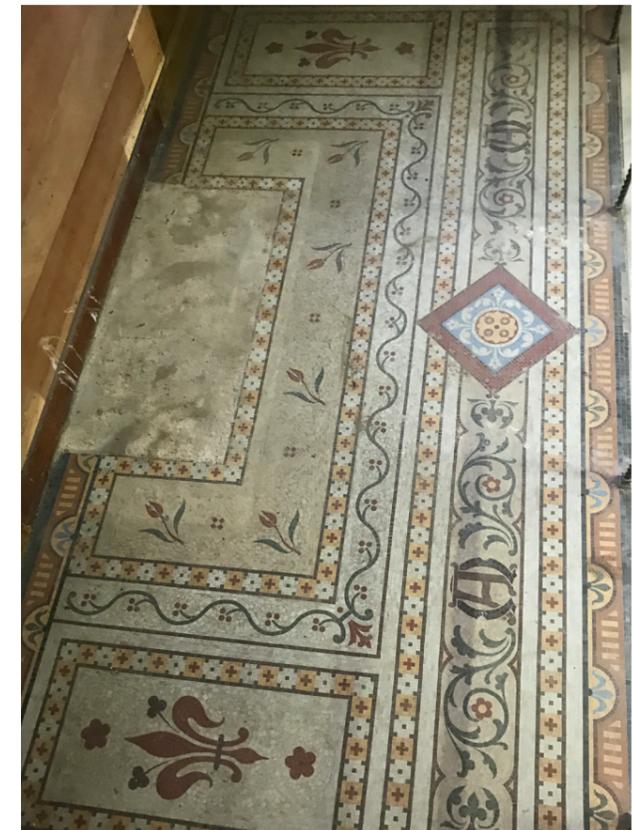
Mosaic tiles to chancel floor

The removal of the modern built in tiered seating revealed the full extent of the stone mosaic tiling beneath. This is largely intact and in good condition. There is a rectangular section centred to the rear which has no tiles and is infilled in concrete. The border pattern on the tiles suggests that this area was never tiled and was the location of a piece of furniture. There are also minor areas where the mosaic tiles are missing and should be replaced.

- Carry out minor repairs to the mosaic tiles.
- Remove 1960s veneer panelling and make good walls behind.

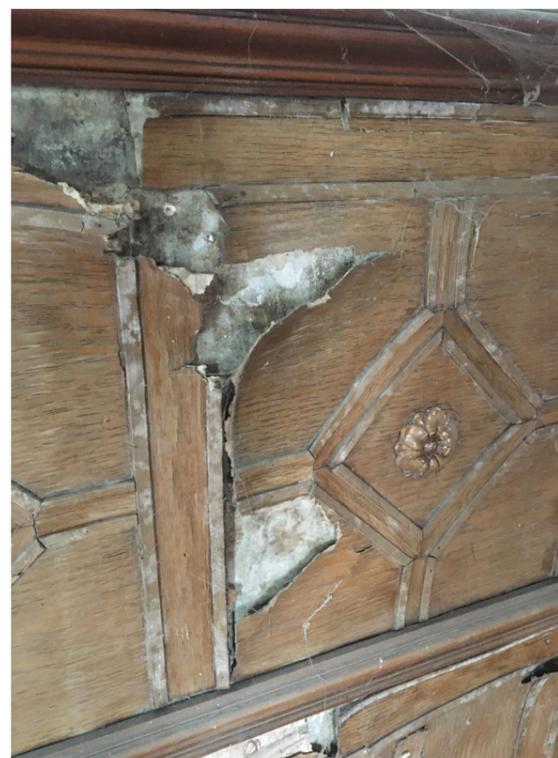
Timber veneer panelling detail

The 1960s veneer panelling around the Chancel is also in poor repair and is proposed to be removed.

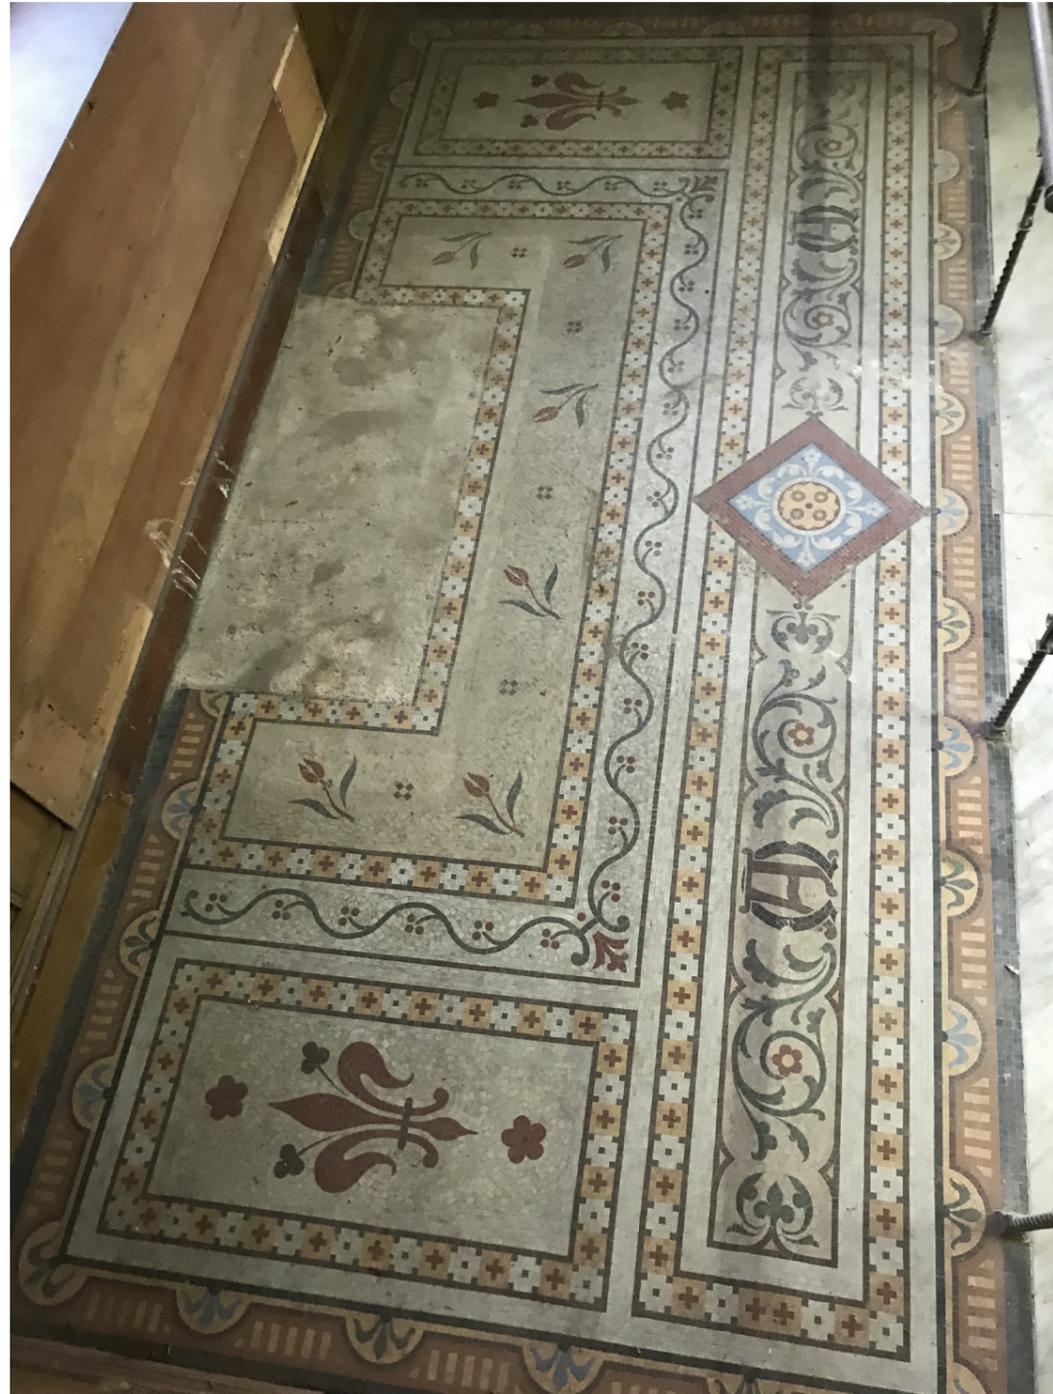
Chancel floor

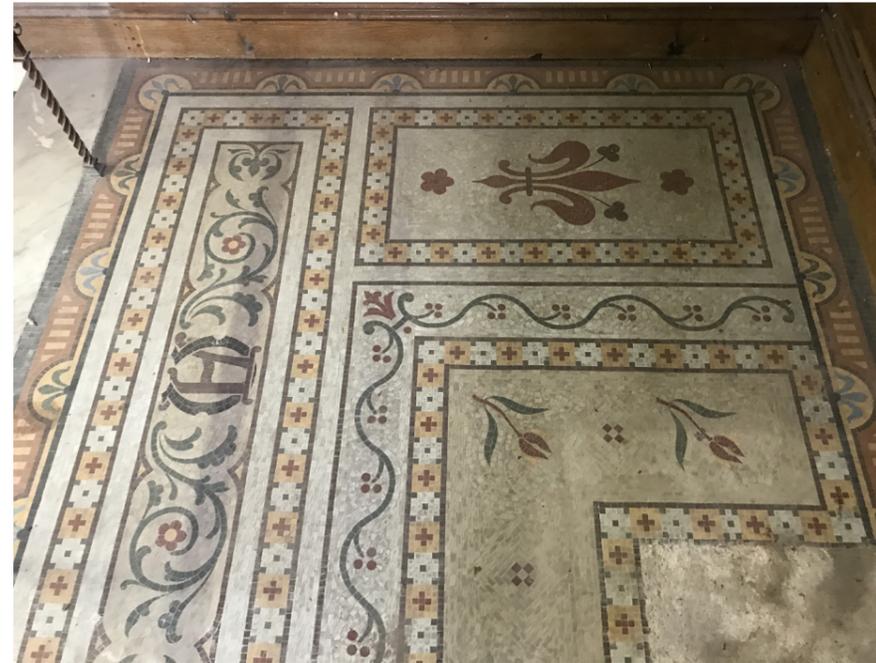
Chancel floor, detail

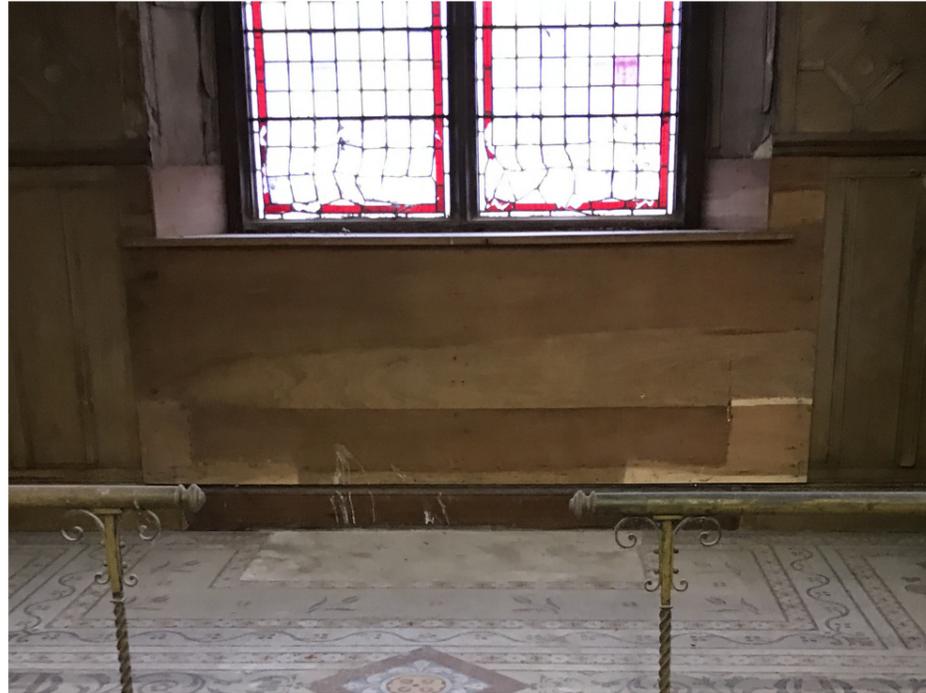
East wall of the chancel, with plywood board in place.

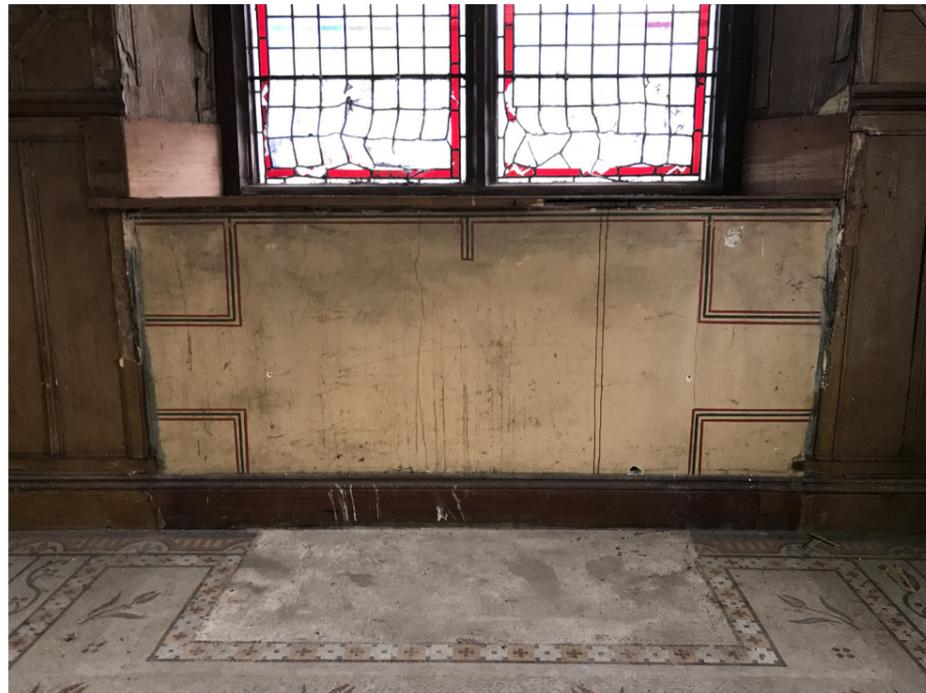
Following removal of the tiered seating, a piece of plywood fitted directly below the east window of the chancel was removed. This revealed some decorative painting on the plastered wall in a geometric pattern of red and green lines. There is also evidence of this painting behind the veneer panelling around the chancel. However, the panelling has been glued directly to the wall and the painting behind is therefore largely concealed by the adhesive.

East wall of the chancel, with plywood removed

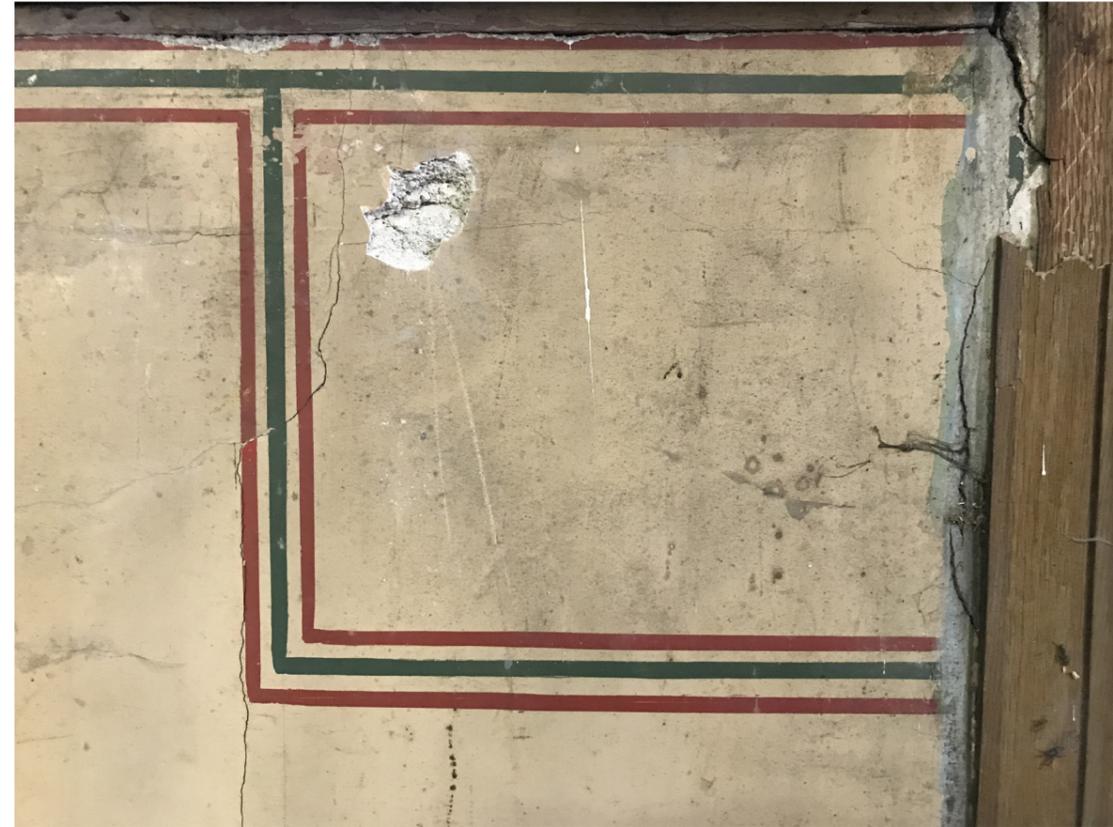
Detail of wall painting

It is noted that there are areas of murals on the north wall of the nave, around the nave windows and the Chancel Arch and on the rear wall of the Chancel. These areas will not be painted and will be retained in their current state.

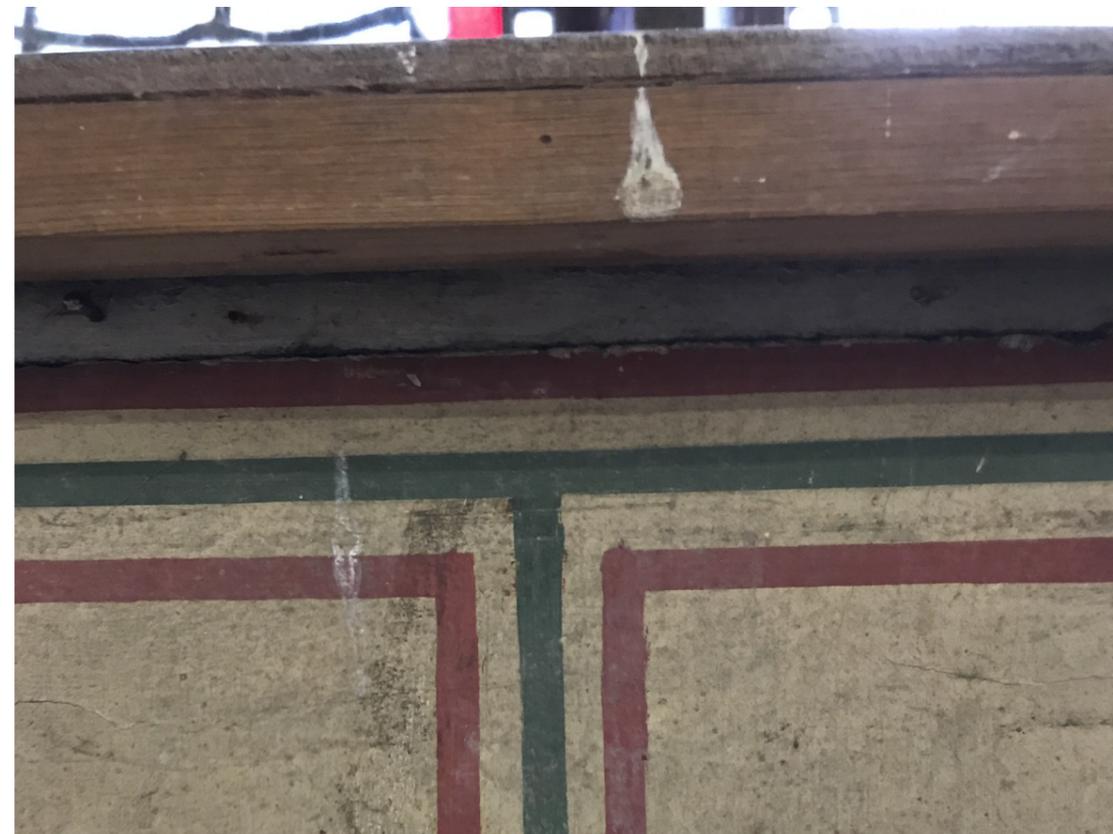
Detail of wall painting

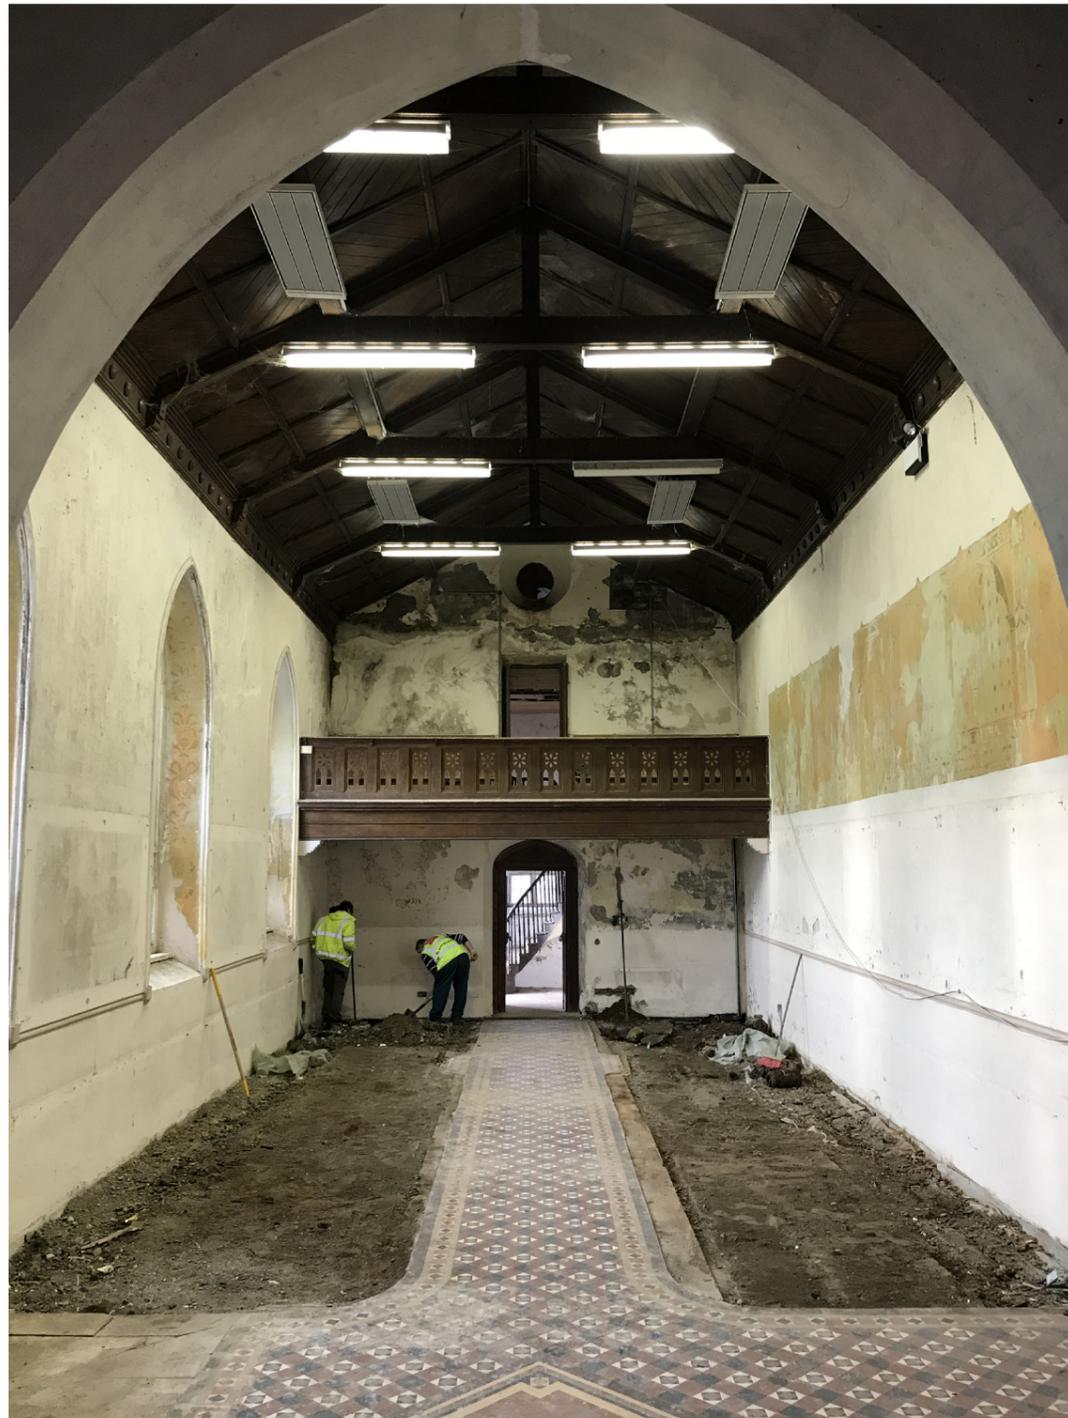
View of the nave looking west while trial holes are being dug.

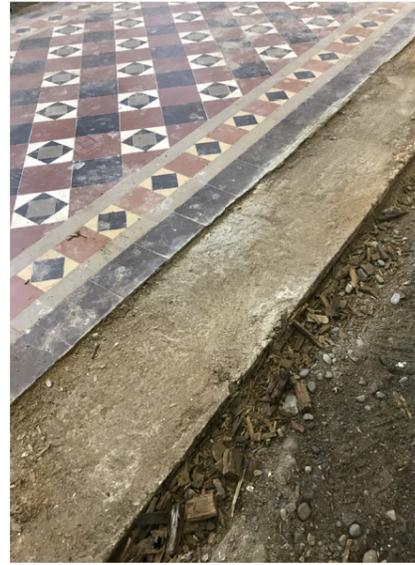
The central aisle has modern tiles laid on a 75mm thick insitu concrete base, with no damp proof course.

Detail of concrete base below aisle tiles

It is therefore proposed to remove the entire floor of the nave and replace it with an insulated slab and underfloor heating throughout. It is proposed that this will be finished in terrazzo to provide a high quality, natural finish, in a muted tone. The tone of the terrazzo to be similar to the tone of the stone flags in the base of the tower.

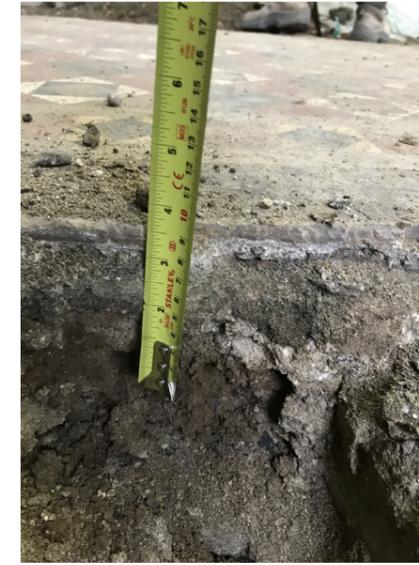
The base below the aisle tiles is approx. 75mm thick lean-mix concrete directly onto soil.

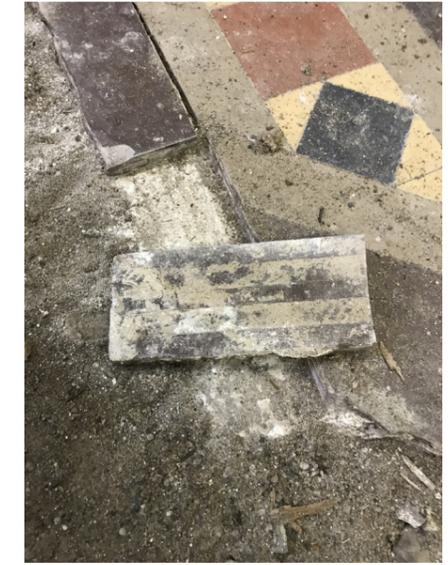
The tiles to the aisle are modern ceramic tiles.

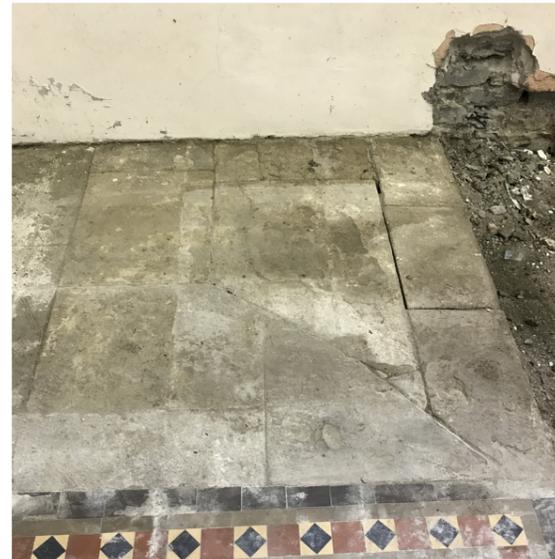
Area of stone flags laid directly on soil in the south east corner.

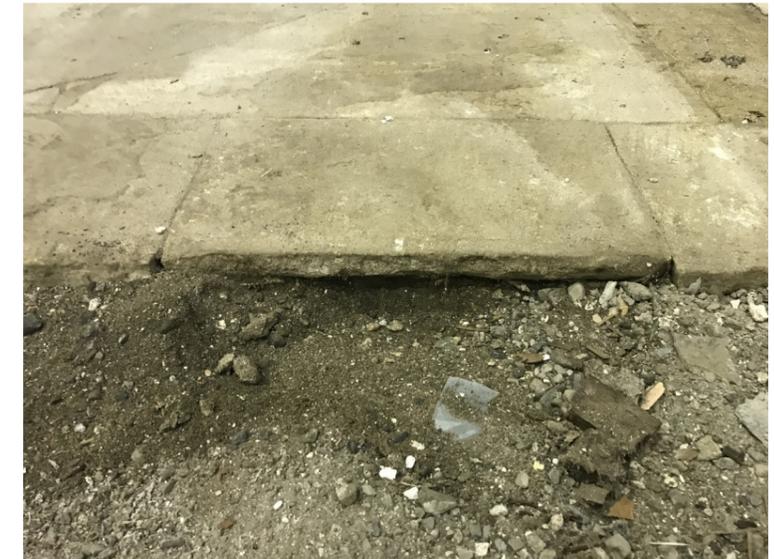
The flag stones are laid directly onto the soil below.

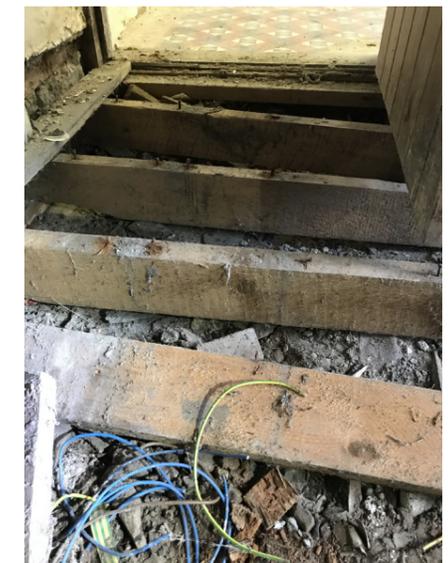
The floor boards of the Vestry were removed, revealing timber joists directly onto the soil below.

Vestry floor. Modern timber joists directly onto soil

H. Existing timber floor in vestry to be removed and disposed of off site. This is in poor repair and has been partly removed to add modern services. It is proposed to hand-dig a trial trench c. 600mm deep here to review the possibility of adding an insulated concrete slab to this area in the same manner as item B.

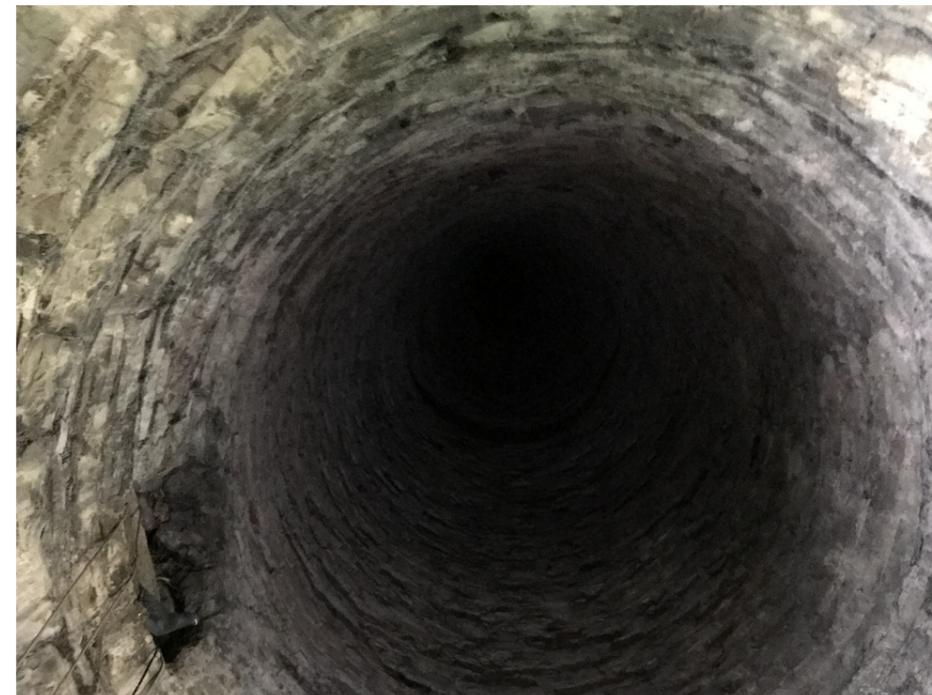
During the strip out works access was provided to inspect the interior of the tower. The stonework is in reasonably good condition, though there is evidence of damp throughout. The damp ingress appears to start at the base of the spire, which is roofed in lead, installed in the recent past. There is damp apparent on all sides of the tower, which has caused damage to the joist ends of the timber floors.

View up the interior of the spire

There is considerable water ingress at the tower. This is evident both inside the belfry and on the west gable of the nave. It appears that the most likely source of water ingress is at the leadwork between the base of the spire and the castellations. This lead has already been replaced in the recent past but appears to have failed and the water ingress is causing considerable damage inside. It is proposed to lift and replace the lead.

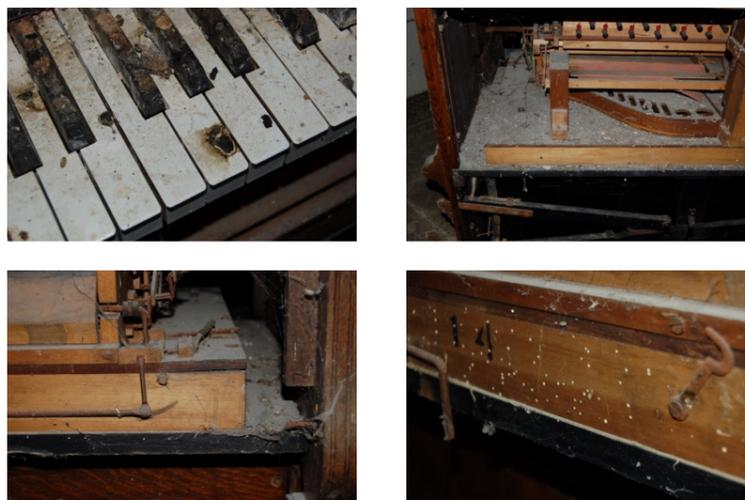
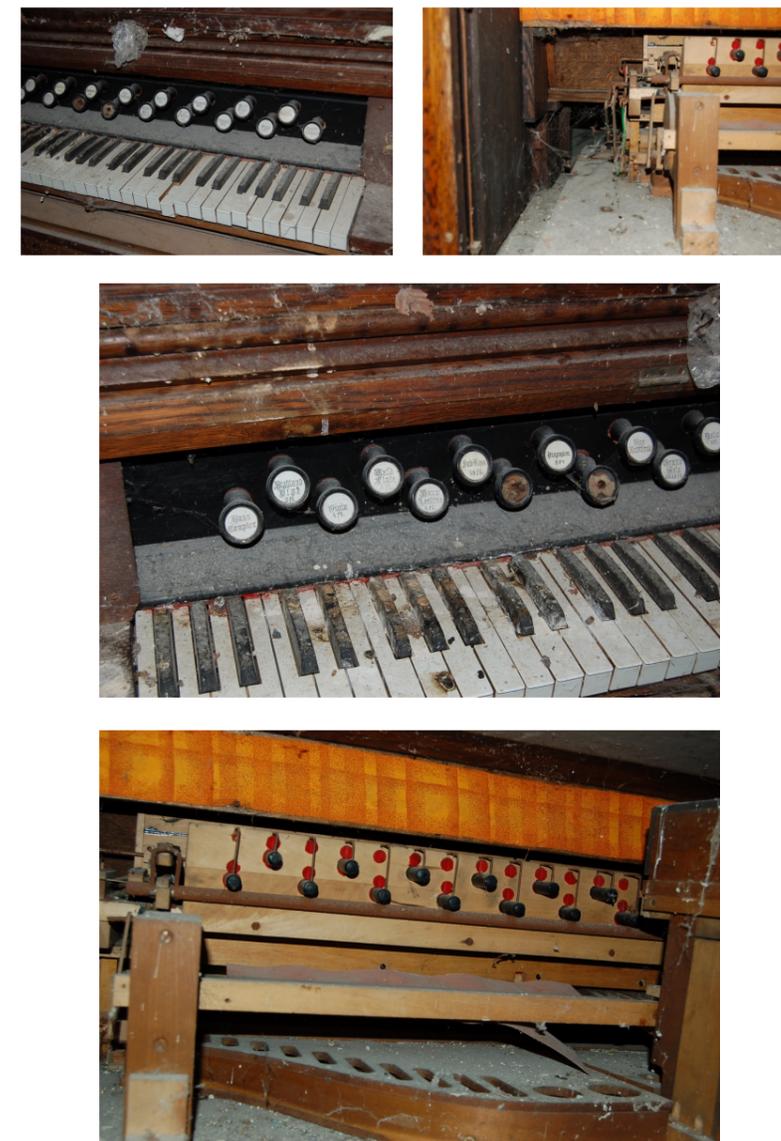
The upper action is intact with nothing significant missing. The only exception is the absence of two stop faces and a non-original replacement. These can be sourced.

There is evidence of woodworm in the lower front rail of the reed pan which is unlikely to be the cause of structural issues but is indicative of the high moisture content of the wood due to damp conditions.

The keys appear to be in very good condition and no evidence of woodworm is to be seen at the front end at least. All key tops and key fronts are intact.

Clearly it is not possible to comment on the interior condition of many components without a complete deconstruction but I can speculate that the coupler mechanism is likely to need a complete rebuild. The extent of the rust on other visible ferrous metal parts would indicate this.

Some stop-linkages have been poorly repaired at some stage. This will need to be corrected.

No visible issues with the upper action would appear to be insurmountable or cause of great concern.

All linkages for the stop mechanism, great and swell mechanism, and ancillary parts on the upper action, will be cleaned and renewed as appropriate. All other miscellaneous repairs will be made.

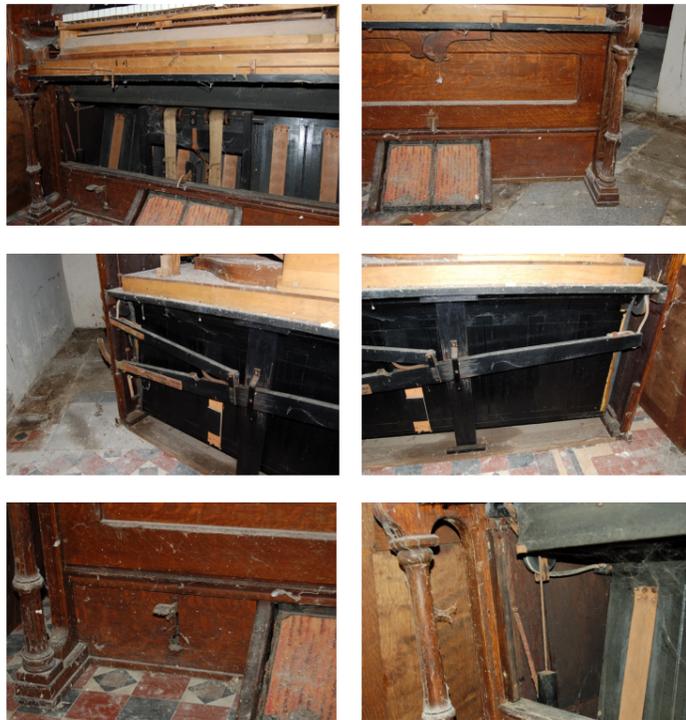
The bellows is intact and is of solid wood construction. Without dismantling the organ it is not possible to state the exact condition of the boards but they appear to be free from woodworm and in restorable condition.

This organ has a hand pumping mechanism which is missing its handle.

The bellows will be completely stripped, cleaned, re-sealed, new one-way leather valves installed, and re-covered with new bellows cloth. Pedals will be stripped and their mechanism renewed. The hand-pumping mechanism will be rebuilt to functioning condition.
