CUNNANE STRATTON REYNOLDS

TREE SURVEY

Pedestrian / Cycle Scheme,
Ratoath,
Co Meath.

March 2022

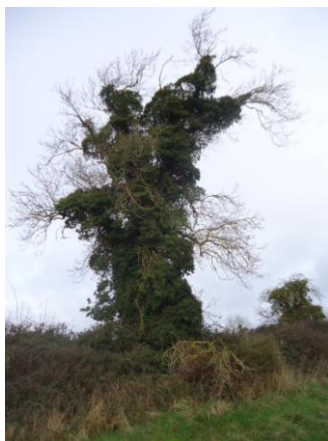
Tree Group 1

3.5 It is worth considering, as part of an ongoing management program, the selective thinning of a limited number of young trees within Tree Group 1. Removing those specimens which have bolted, and or are of relatively poor form, will facilitate improved development of other trees within the group which are currently overcrowded and have inadequate space for strong future development.

Most of the larger trees within this group are obscured by ivy, (which should be carefully removed to facilitate full inspection), however they appear to be in good physiological condition in general. Given their roadside location it would be prudent to consider a crown cleaning exercise to remove rubbing limbs, future compression forks and also reduce the length of limbs overhanging adjoining carriageway along with any other imbalances in growth.
