## Lough Bracken Enhancement Feasibility Study and Landscape Master Plan

**By:** Flynn, Furney Environmental Consultants **For:** Meath Partnership on behalf of the Meath LAG

**Date:** February 2022

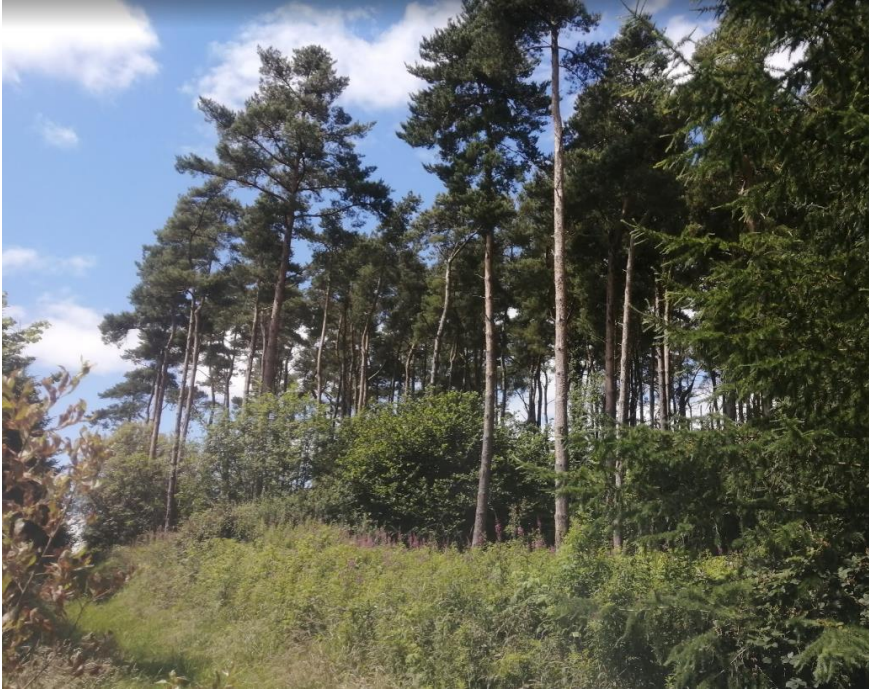
**Figure 3: Stand of Scots Pine**

Conifer plantations close to the water have historically caused significant impacts to water quality within the lough. Drains were created during planting, flowing towards the lough. This major release of sediments led to significant water quality issues including blue-green algal outbreaks. It is not believed that these trees are now having as significant an impact on water quality as in the recent past. However the acidic nature of pine needles and soil under pine trees is likely to have at least localised impacts to the inherently alkaline waters of the lough.

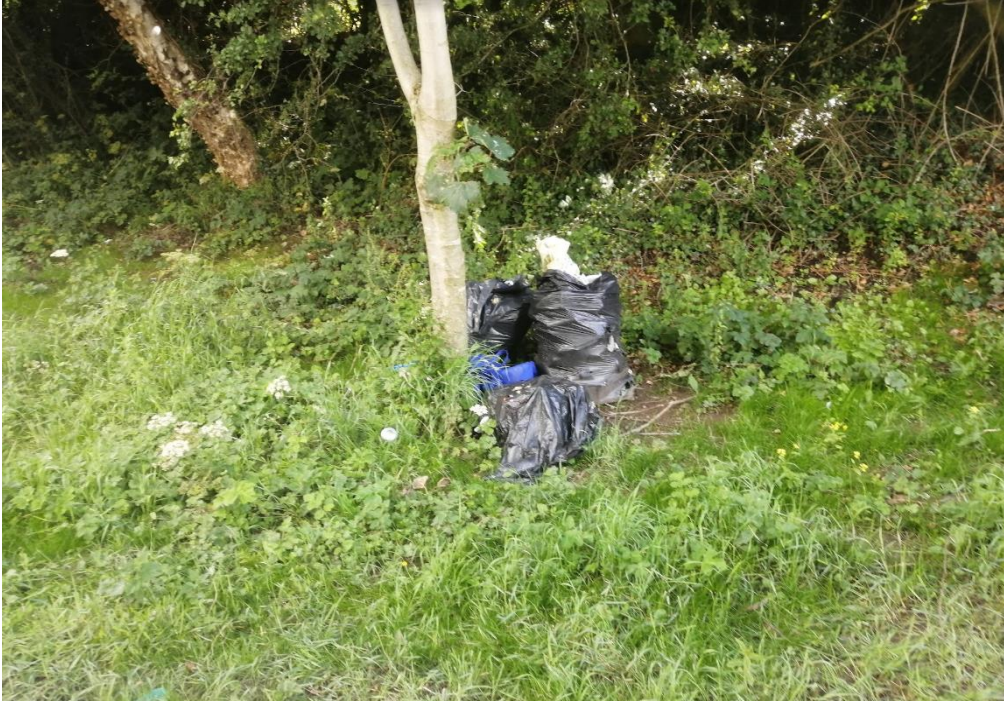
Evidence of public defecation and urination were seen commonly within the adjoining woodlands and scrub areas around the lake. The lack of public toilet facilities, particularly for users who may be at the lake for several hours, is further impacting the perception and safety of the lake for all users.

**Figure 9: Rubbish and fly tipping in the car park**

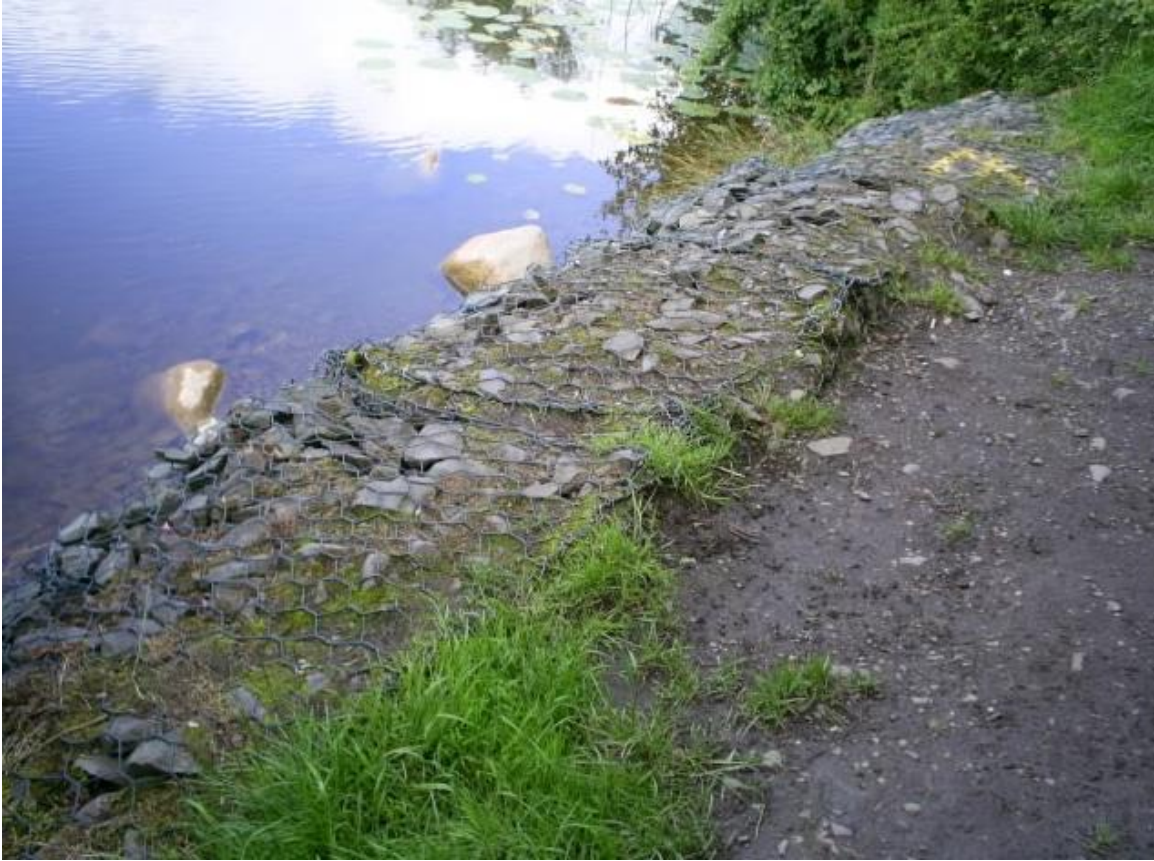
Collapsing and widening of angling stands is another major concern for the ongoing function of the lake. Year round use of the lake, coupled with a prolonged period where no maintenance has occurred, has left some areas becoming severely undercut. This has led to more losses of sediments and nutrients to the lake and impacts on the site's amenity value. This is particularly apparent along the eastern shoreline where the lake abruptly drops off to a higher depth. This issue is further exacerbated through anglers cutting back vegetation and making informal paths down to the water's edge.

**Figure 10: Gabions used to halt further bankside collapse. This area is also used as an informal angling stand**
